BAAL BONE UNDERGROUND

Annual Review
2023

Name of Operation	Baal Bone Colliery
Name of Operator	Baal Bone Colliery
Project Approval Number	09_0178
Name of Holder of Project Approval	The Wallerawang Collieries Ltd
Mining Lease Number/s	CCL749, MPL261, CL391, ML1302, ML1389, ML1607
Name of Holder of Mining Lease/s	The Wallerawang Collieries Ltd
Water Licence Number/s	WAL27887, WAL34952, 80WA706034, 80WA706035
Name of Holder of Water Licence/s	The Wallerawang Collieries Ltd
RMP Start Date	1 st August 2022
Annual Review Start Date	1 st January 2023
Annual Review End Date	31 st December 2023
<p>I, Mark Bulkeley, certify that this audit report is a true and accurate record of the compliance status of Baal Bone Colliery for the period 1st January 2022 to 31st December 2022 and that I am authorised to make this statement on behalf of Baal Bone Colliery.</p> <p><i>Note.</i></p> <p>a) <i>The Annual Review is an 'environmental audit' for the purposes of section 122B(2) of the Environmental Planning and Assessment Act 1979. Section 122E provides that a person must not include false or misleading information (or provide information for inclusion in) an audit report produced to the Minister in

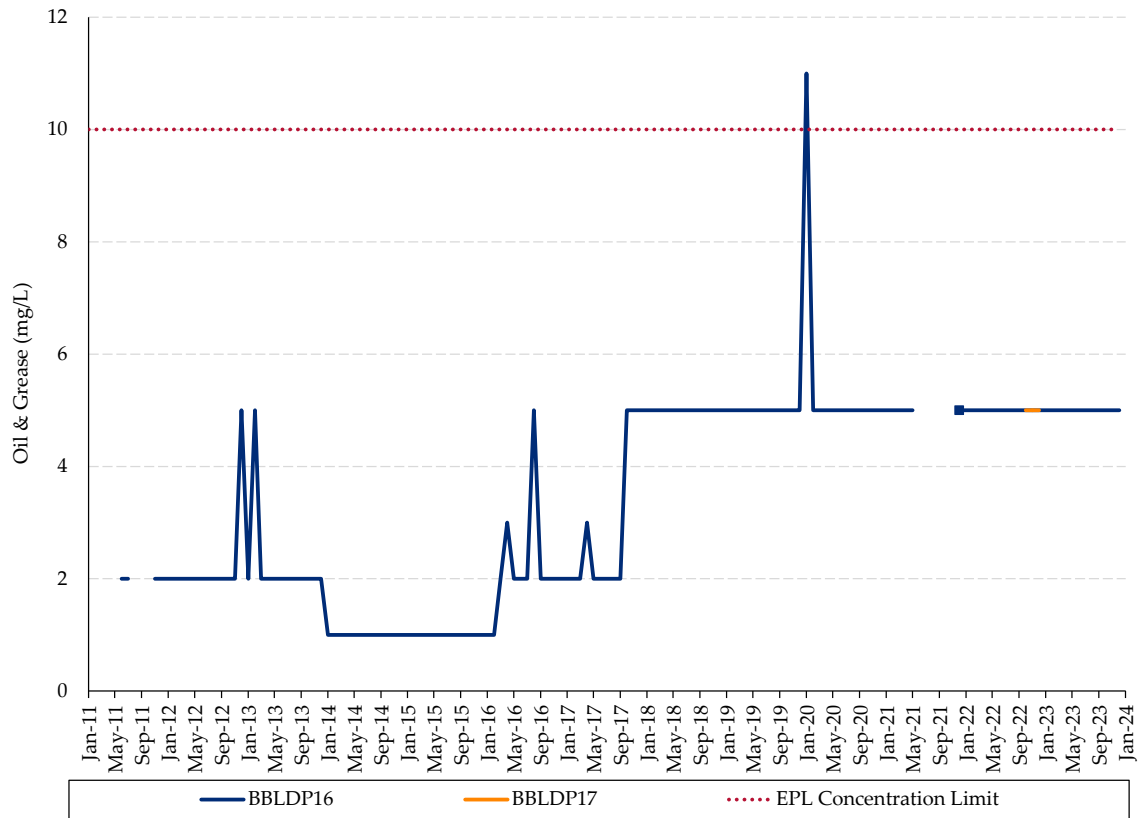
Figure 7.6: Oil and grease levels from 2011 to 2023

Figure 7.6 shows oil and grease levels for the period 2014-2023. All results are under the EPL concentration limit of 10mg/L with the exception of an oil and grease level sample from January 2020 with a result of 11 mg/L. An investigation was undertaken into this exceedance which found that potential contributors may have been the extended dry spell and recent rainfall, the bushfires moving through the area as well as vehicles and machinery on site. Refer to previous Annual Reviews for further information.

Note that prior to January 2014, the limit of reporting for oil and grease was < 2 mg/L. From January 2014, limit of reporting value became < 1 mg/L before increasing back to <2 mg/L in March 2016. From October 2017 the limit of reporting increased to <5 mg/L due to changing to ALS Group Environmental Division Lithgow to undertake the monthly monitoring and analysis. These changes in the limit of reporting account for the step change in reported oil and grease levels.

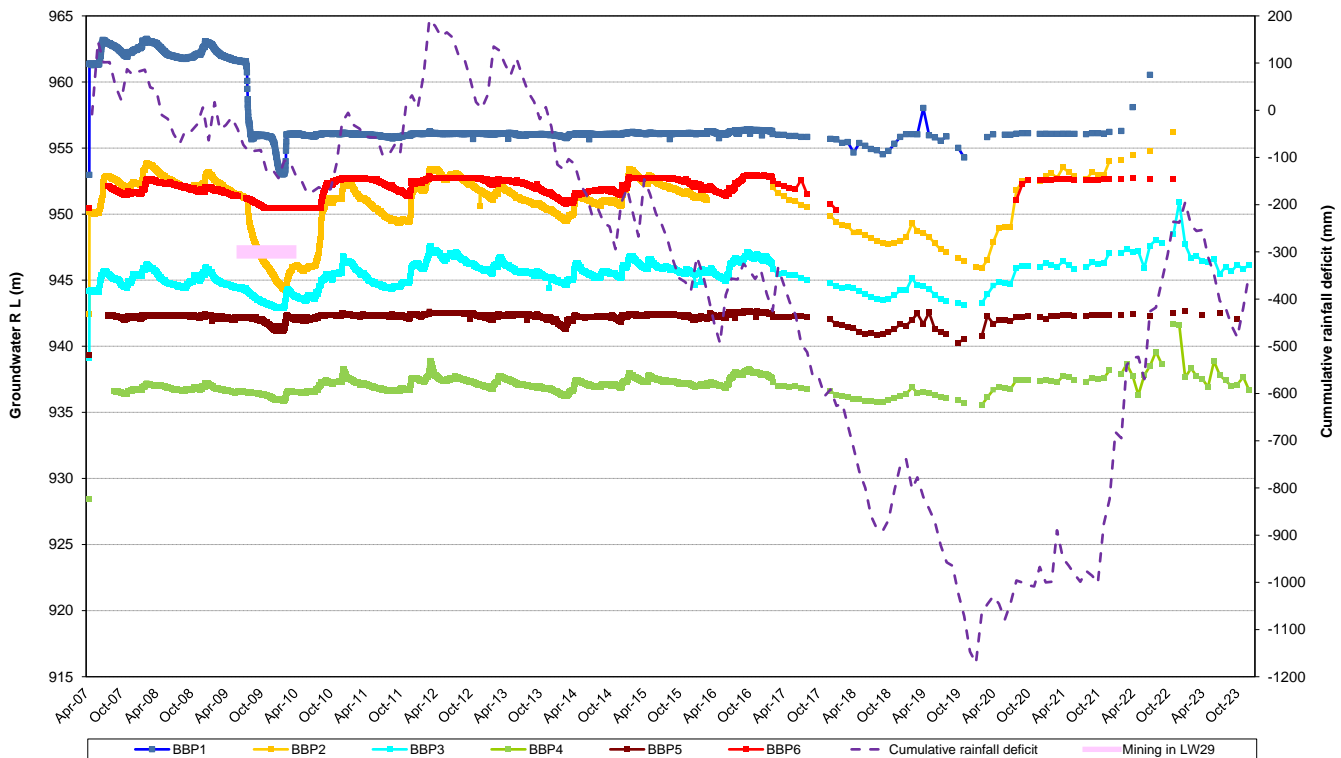
Figure 7.9: Coxs River Swamp groundwater levels and rainfall deficit

The water levels in bores BBPB3 and BBPB4 decreased during 2023, while water levels in BBPB5 remained stable. Due to poor road conditions in the now Gardens of Stone State Conservation Area, bores BBPB1-2 and BBPB6 were unable to be reached during 2023 for sampling or measurement of water heights. Extensive road repairs completed by NPWS during the end of 2023 has enabled sampling of all bores to recommence in January 2024.

Groundwater data are plotted on **Figure 7.9** and **Figure 7.10**. The north – to – south downstream groundwater gradient has been broadly maintained (highest level observed in BBPB1 and lowest level observed in BBPB4), indicating that overall flow has been maintained down through the swamp.

All groundwater levels appear to be approximately at pre-mining levels, with the only exception being at piezometer BBPB1, where a groundwater level re-stabilised at RL 956 m from 2009 to 2021 (approximately 5 m below pre-mining level). High rainfall during 2022 has seen the groundwater RL at BBPB1 increase to near pre-mining levels.

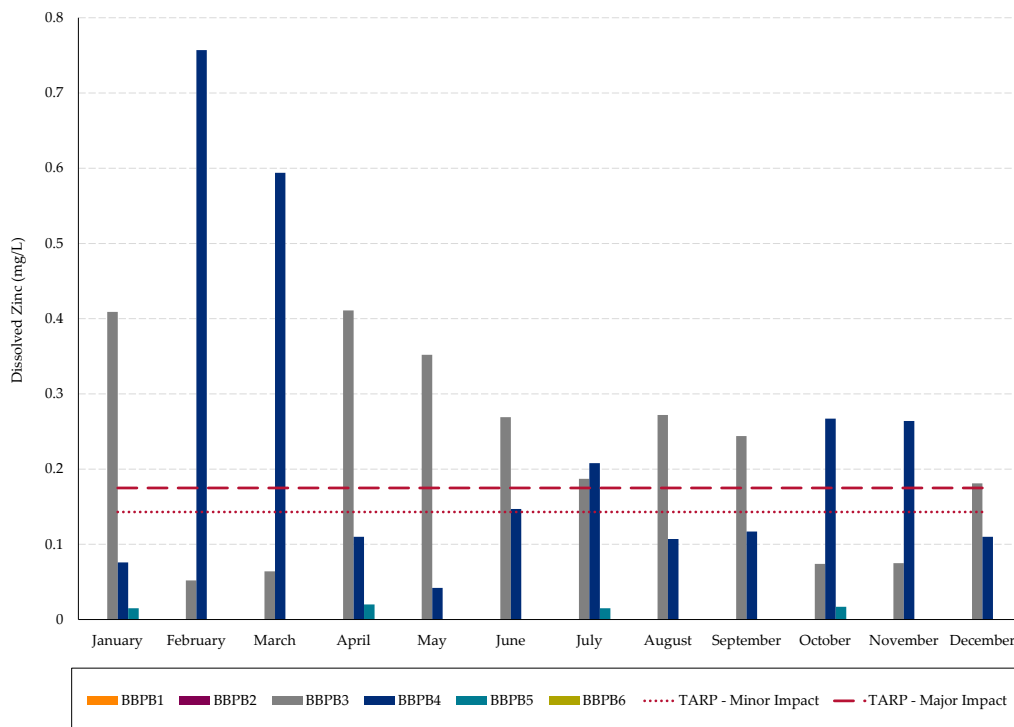
Figure 7.15: 2023 Groundwater Zinc Levels – background corrected (See Section 9.4.4.3 of the Consolidated Environmental Management Strategy for more information).

After background correction BBPB3 exceeded the major impact trigger levels in January, April, May, June, July, August, September and December 2023. The Loss of Water Quality TARP was therefore triggered twice in 2023. Investigations were carried out and notifications sent to DPIE on 3 July 2023 and 9 October 2023. These notifications also detailed the ongoing access issues at BBPB1, BBPB2 and BBPB6 during 2023 due to the deterioration of a number of trails in the Gardens of Stone SCA following prolonged wet weather.

As noted in **Section 7.2.4**, there were a number of major trigger level events during 2023 at BBPB3 for zinc. Both the 2012 Aurecon report and the 2020 Umwelt report on groundwater quality conclude that minor changes to groundwater quality can occur by chance in the variable conditions of rainfall and the resulting groundwater level changes.

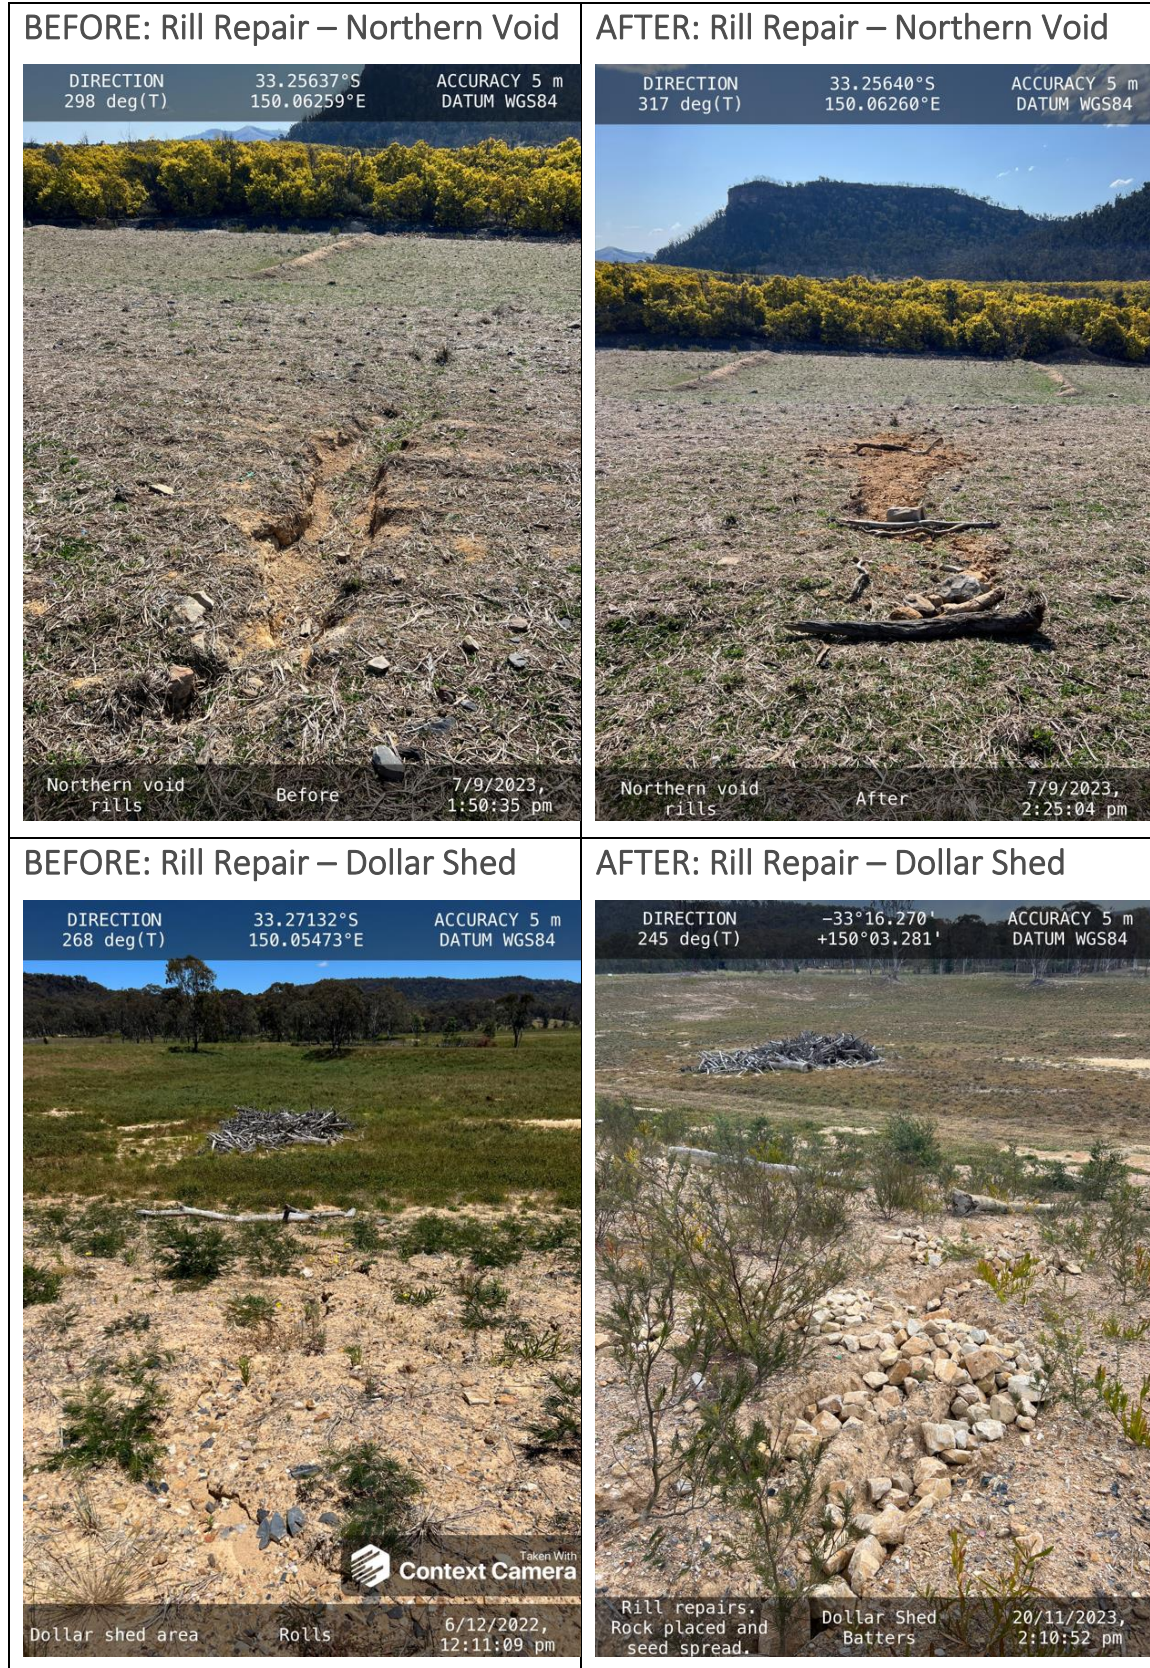
During 2023, rehabilitation works consisted of augmentation and repairs of existing rehabilitation, including erosion repairs and works to improve groundcover.

Plate 2 provides photos showing examples of rehabilitation works completed in 2023.
