BAAL BONE UNDERGROUND

Annual Review
2020

Name of Operation	Baal Bone Colliery
Name of Operator	Baal Bone Colliery
Project Approval Number	09_0178
Name of Holder of Project Approval	The Wallerawang Collieries Ltd
Mining Lease Number/s	CCL749, MPL261, CL391, ML1302, ML1389, ML1607
Name of Holder of Mining Lease/s	The Wallerawang Collieries Ltd
Water Licence Number/s	WAL27887, WAL34952, 80WA706034, 80WA706035, 80BL239077, 10BL601877, 10BL601816, 10BL601817, 10BL601970.
Name of Holder of Water Licence/s	The Wallerawang Collieries Ltd
MOP Start Date	20 th December 2019
MOP End Date	31 st December 2025
Annual Review Start Date	1 st January 2020
Annual Review End Date	31 st December 2020
<p>I, Elizabeth Fishpool, certify that this audit report is a true and accurate record of the compliance status of Baal Bone Colliery for the period 1st January 2020 to 31st December 2020 and that I am authorised to make this statement on behalf of Baal Bone Colliery.</p> <p><i>Note.</i></p> <p>a) <i>The Annual Review is an 'environmental audit' for the purposes of section 122B(2) of the Environmental Planning and Assessment Act 1979. Section 122E provides that a person must not include false or mislead

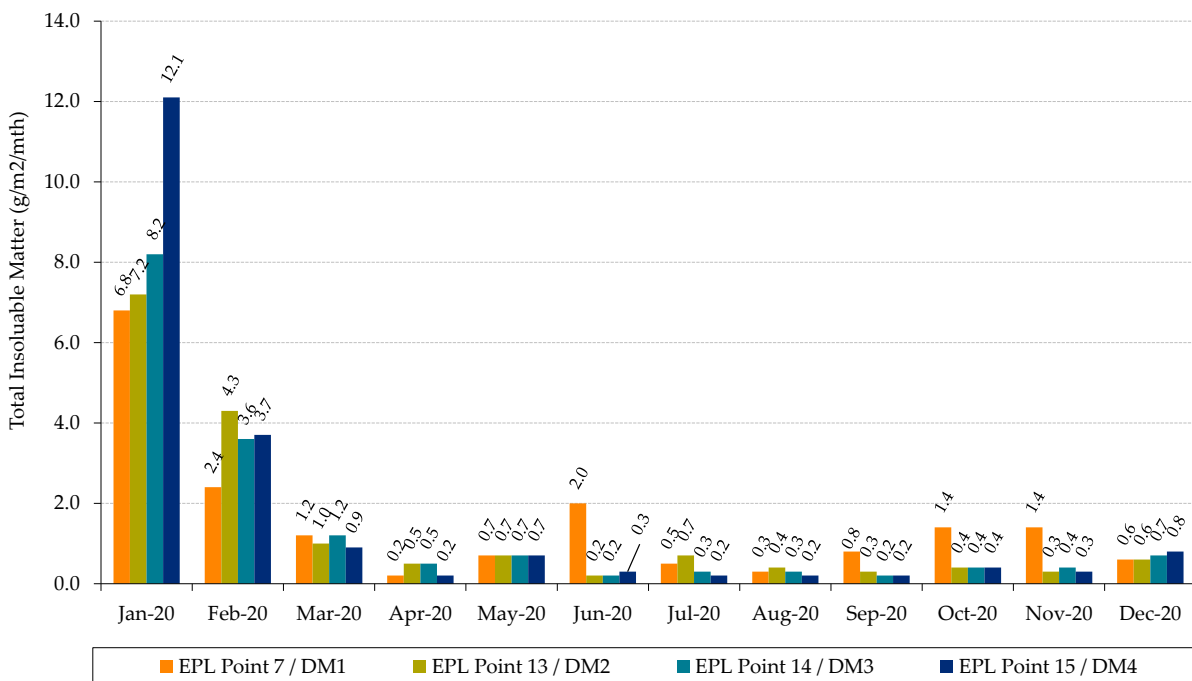
Figure 6.2: 2020 Deposited Dust Monthly Monitoring Results

³ High deposited dust results were recorded in all dust gauges in January/February 2020, predominantly due to the 2019-20 bushfires in the area (Gospers Mountain fire).

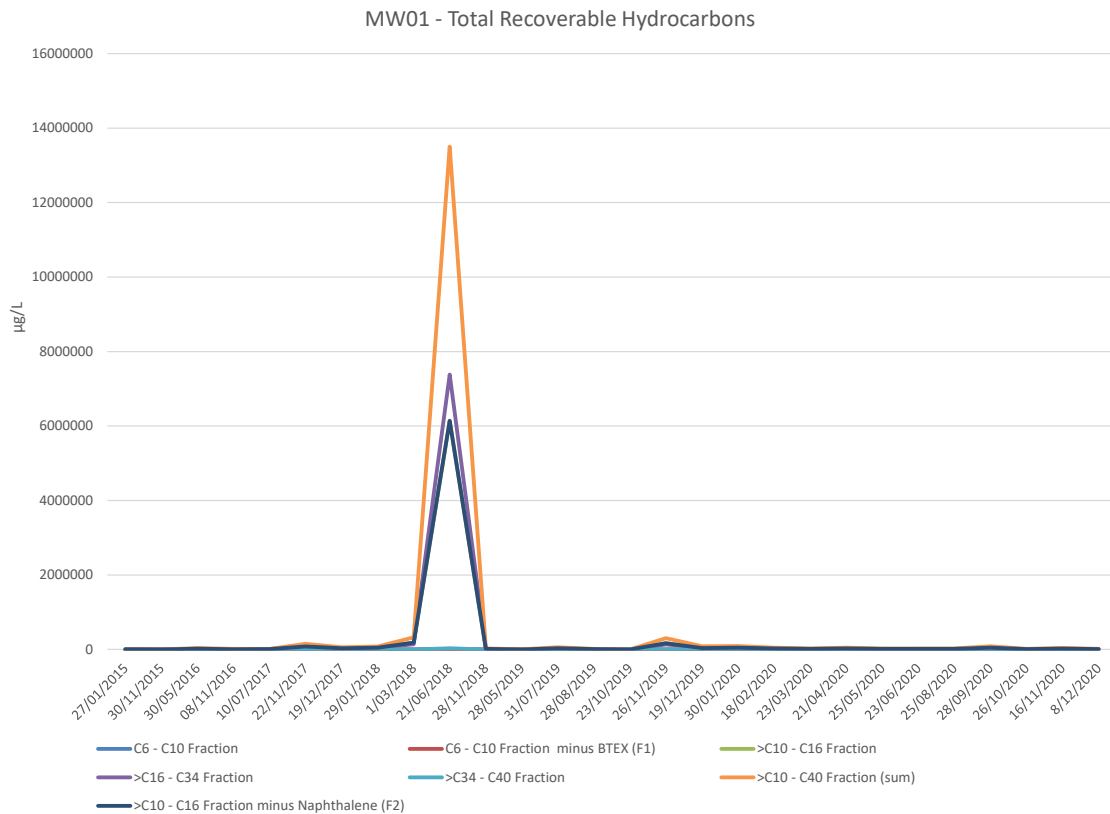
Figure 6.6: TRH results for MW01 (2015 to 2020)

Given the high concentrations of TRH at MW01, integrity testing of the 50,000L diesel UST and lines was conducted on 9 April 2018. The integrity test found no issues with the tank, however noted a small leak in a line and hand nozzle. A replacement line and hand nozzle was fitted the week following the integrity test. Further investigations on site detected a leak in a second fitting (banlaw fitting) – only evident when the line was pressurised. Subsequently, that line and banlaw fitting was removed.

Groundwater sampling of the monitoring wells in June 2018 sampling found that TRH levels at MW01 had increased significantly since the March 2018 sampling. MW03 and MW101 continued to return consistently low concentrations of TRH. Due to the continued increases of TRH at

Subsequently in May 2019, use of the diesel UST was recommenced due to mine closure works and increased diesel usage. Groundwater monitoring wells were sampled on an increased frequency during the remainder of 2019 and into 2020. Results show that MW03 has continued to return consistently low concentrations of TRH (MW101 has been unable to be sampled since mid-2019 due to damage to the well). MW01 TRH levels during 2019 and 2020 were broadly consistent with historical levels, with the exception of an increase noted in November 2019. Since November 2019 TRH levels at MW01 have steadily declined. Sampling will continue during 2021 at a reduced frequency of every six months. The UST will be removed as part of closure activities during 2021.

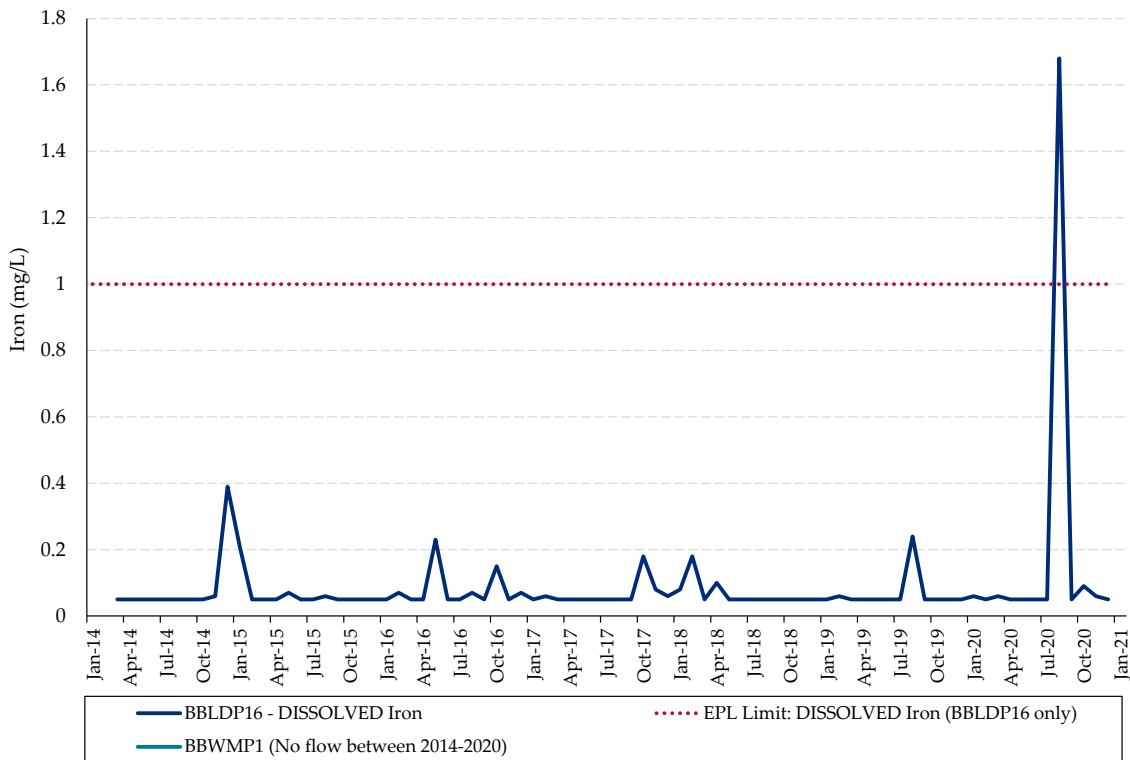
Figure 7.5: Iron – Total and Dissolved (2014 – 2020)

Figure 7.5 shows the iron level recorded at BBLDP16 from 2014 to 2020. From 1 August 2013 EPL 765 specified a *dissolved* iron concentration limit of 1 mg/L at BBLDP16. Prior to this time, the iron concentration limit at BBLDP16 was 1 mg/L of *total* iron. Between 2014 and 2020 there has been one exceedance of the EPL dissolved iron concentration limit, in August 2020, with a reading of 1.68 mg/L. An investigation which included follow up testing of BBLDP16 and examination of water transfers could find no definitive reason for the isolated spike in iron levels.

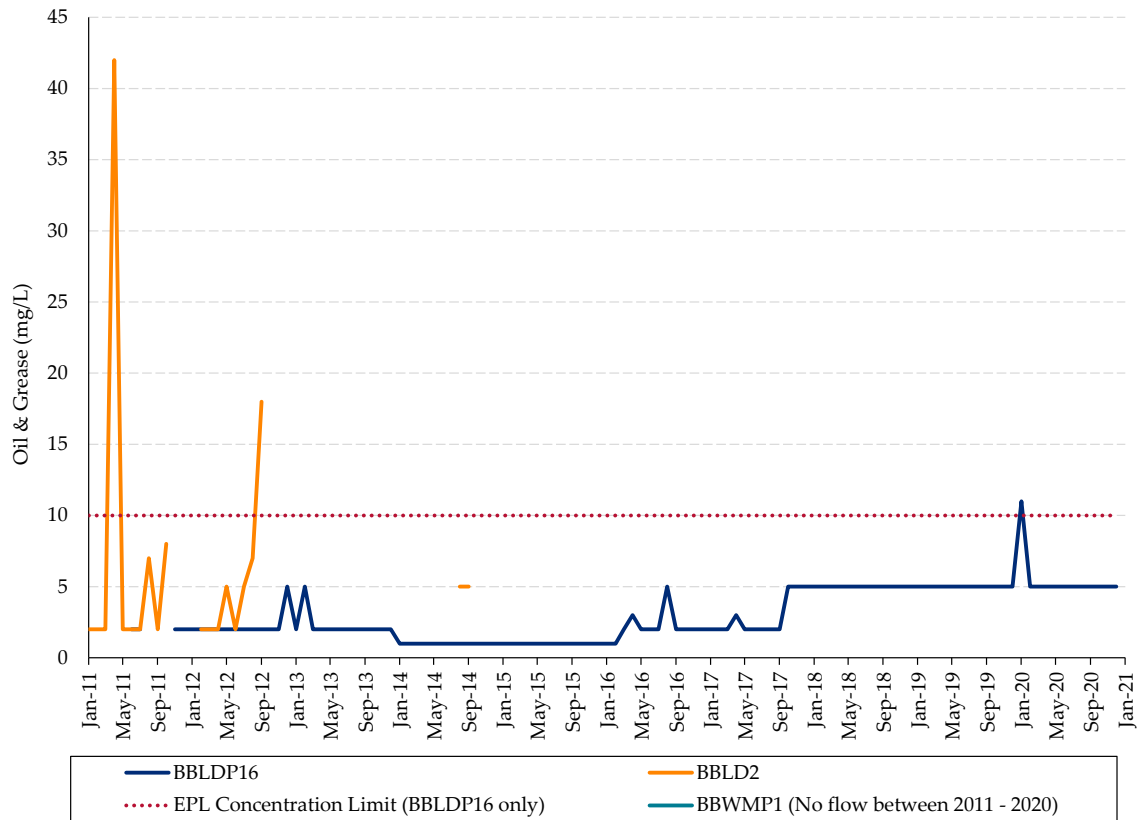
Figure 7.6: Oil and grease levels from 2011 to 2020

Figure 7.6 shows oil and grease levels from 2011 to 2020 at BBLD2 and BBLDP16. All oil and grease levels at BBLDP16 during 2011 – 2020 have remained well below the EPL limit of 10 mg/L, with the exception of January 2020.

Oil and grease levels in the sample taken on 22 January 2020 exceeded the EPL concentration limit of 10mg/L, with a result of 11 mg/L. An investigation was undertaken into this exceedance which found that potential contributors may have been the extended dry spell and recent rainfall, the bushfires moving through the area as well as vehicles and machinery on site. Refer to **Section 7.1.2** for further information.

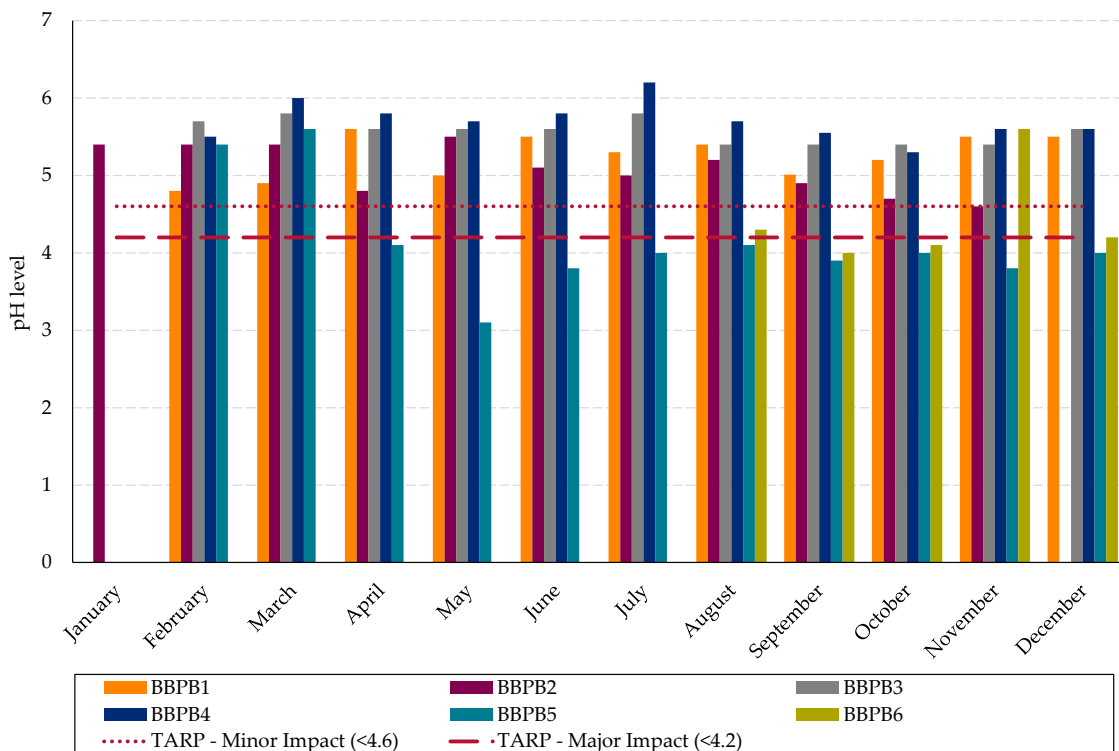
Figure 7.11: 2020 Groundwater pH levels.

As shown in **Figure 7.11** above, all pH levels for bores BBPB1 through 4 were within both the minor and major impact criteria for all groundwater monitoring bores during 2020. BBPB5 was outside either the major and/or minor impact trigger levels for 8 months from April 2020 to December 2020. BBPB6 also dropped below the major and/or minor impact trigger levels for August, September, October and December 2020. This major impact TARP event was investigated and notifications sent to DPIE on 1 March 2021.

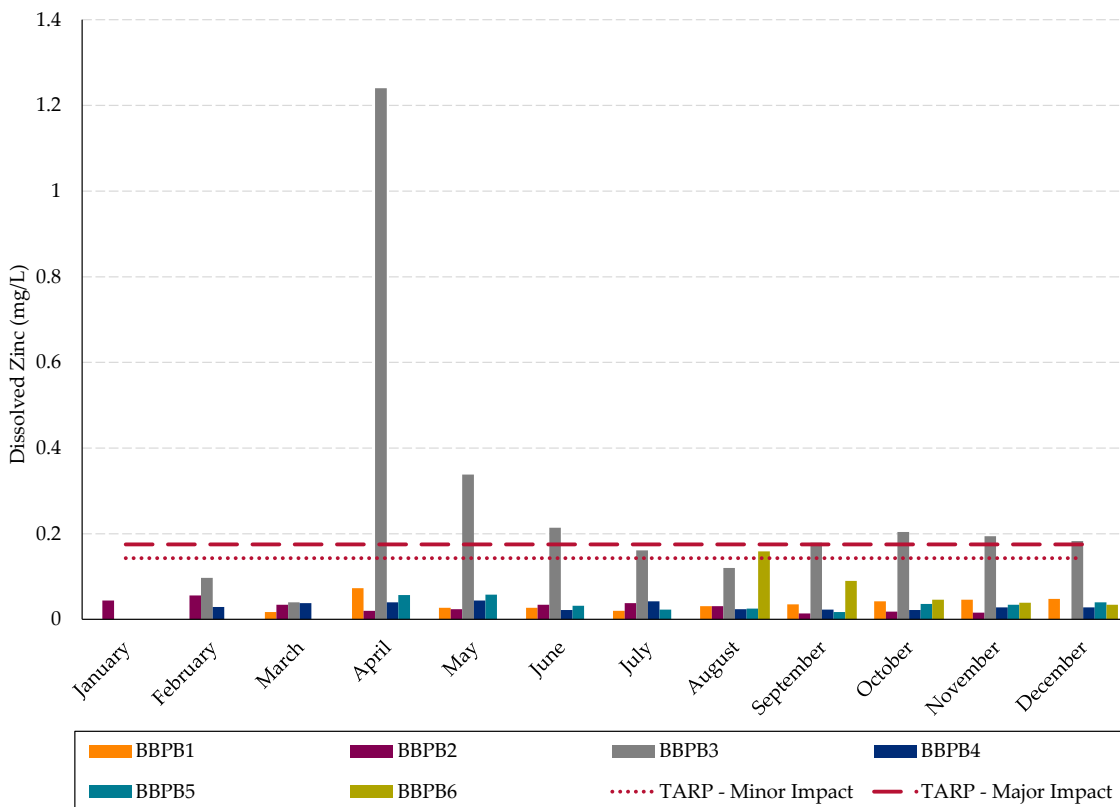
Figure 7.15: 2020 Groundwater Zinc Levels.

The 2019 Independent Environmental Audit (IEA) carried out by Hansen Bailey determined that the ongoing exceedance of Water Quality Trigger Levels for dissolved zinc at BBPB3 was a low risk non-compliance. The audit recommended that Baal Bone Colliery, "revisit the zinc trigger levels for BBP3 in consultation with DPIE for the closure stage".

criteria (trigger values) should be updated. In relation to zinc Umwelt found that “the peak concentrations during many of these events was recorded shortly after increased rainfall following a prolonged dry period. This suggests that rainfall-runoff infiltration has mobilised zinc from dry strata within the BBP3 catchment and that a wetting and drying process could be a significant contributor to groundwater zinc concentrations.” Also that “Elevated zinc concentrations were observed to occur pre-mining, during mining and post-mining. Elevated zinc concentrations at times followed a rise in groundwater level in BBP3”.

In the 2019 IEA Action Plan, Baal Bone Colliery committed that by 30 March 2021 a consultant will be engaged to further investigate the exceedance with consideration to be given to calibrating the groundwater triggers to site specific conditions if appropriate.
