BAAL BONE UNDERGROUND

Annual Review 2017

Name of Operation	Baal Bone Colliery
Name of Operator	Baal Bone Colliery
Project Approval Number	09_0178
Name of Holder of Project Approval	The Wallerawang Collieries Ltd
Mining Lease Number/s	CCL749, MPL261, CL391, ML1302, ML1389, ML1607
Name of Holder of Mining Lease/s	The Wallerawang Collieries Ltd
Water Licence Number/s	10BL601816, 10BL601817, 10BL601877, 10BL601970, 80BL236132, 80BL236134, WAL27887, WAL34952.
Name of Holder of Water Licence/s	The Wallerawang Collieries Ltd
MOP Start Date	29 th February 2016
MOP End Date	31 st December 2019
Annual Review Start Date	1 st January 2017
Annual Review End Date	31 st December 2017
<p>I, Elizabeth Fishpool, certify that this audit report is a true and accurate record of the compliance status of Baal Bone Colliery for the period 1st January 2017 to 31st December 2017 and that I am authorised to make this statement on behalf of Baal Bone Colliery.</p> <p><i>Note.</i></p> <p>a) <i>The Annual Review is an 'environmental audit' for the purposes of section 122B(2) of the Environmental Planning and Assessment Act 1979. Section 122E provides that a person must not include false or misleading informat

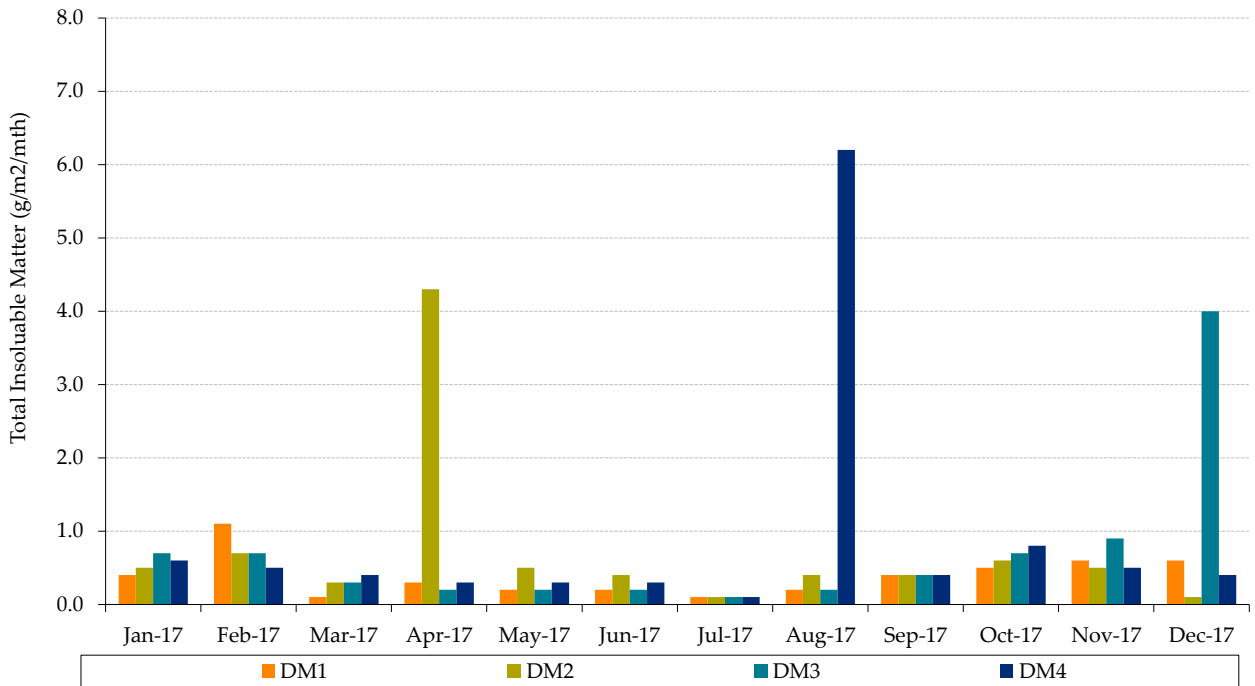
Figure 5.2: 2017 Deposited Dust Monthly Monitoring Results

* The April 2017 dust monitoring result for DM2 recorded an abnormally high result of 4.3 g/m²/month. A characterisation of particulates was carried out and found that the sample comprised approximately 45% organic matter.

** The August 2017 dust monitoring result for DM4 recorded an abnormally high result of 6.2 g/m²/month. A characterisation of particulates was carried out and found that the sample comprised approximately 45% organic matter.

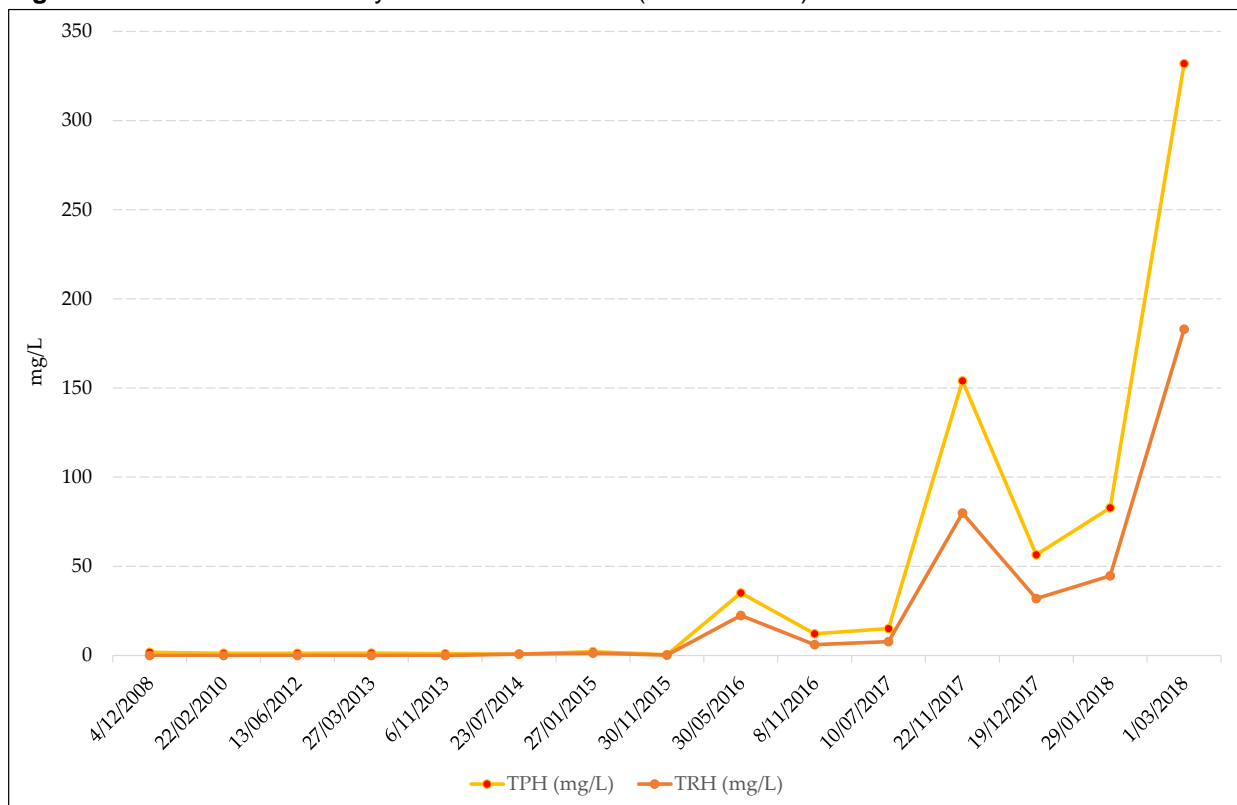
Figure 5.6: TPH and TRH analysis results for MW01 (2008 to 2018)

At the time of the May 2017 sampling, it was noted that the bore hole cap at MW01 had been left off, and that was potentially the reason for the high result for petroleum hydrocarbon fractions. MW01 was retested on 10 July 2017 and the petroleum hydrocarbon fractions returned a considerably lower result, in line with historic results. MW03 and MW101 are downstream from MW01 and did not return high readings for petroleum hydrocarbon fractions, therefore the contamination was localised around MW01. Integrity testing of the underground diesel tank and lines, located adjacent to MW01, was also conducted in July 2017 with no issues found.

Given the recent results of high concentrations of TRH and TPH at MW01, integrity testing of the 50,000L underground diesel tank and lines will be conducted in March/April 2018. Six monthly hydrocarbon testing will continue in 2018 with a focus on MW01.

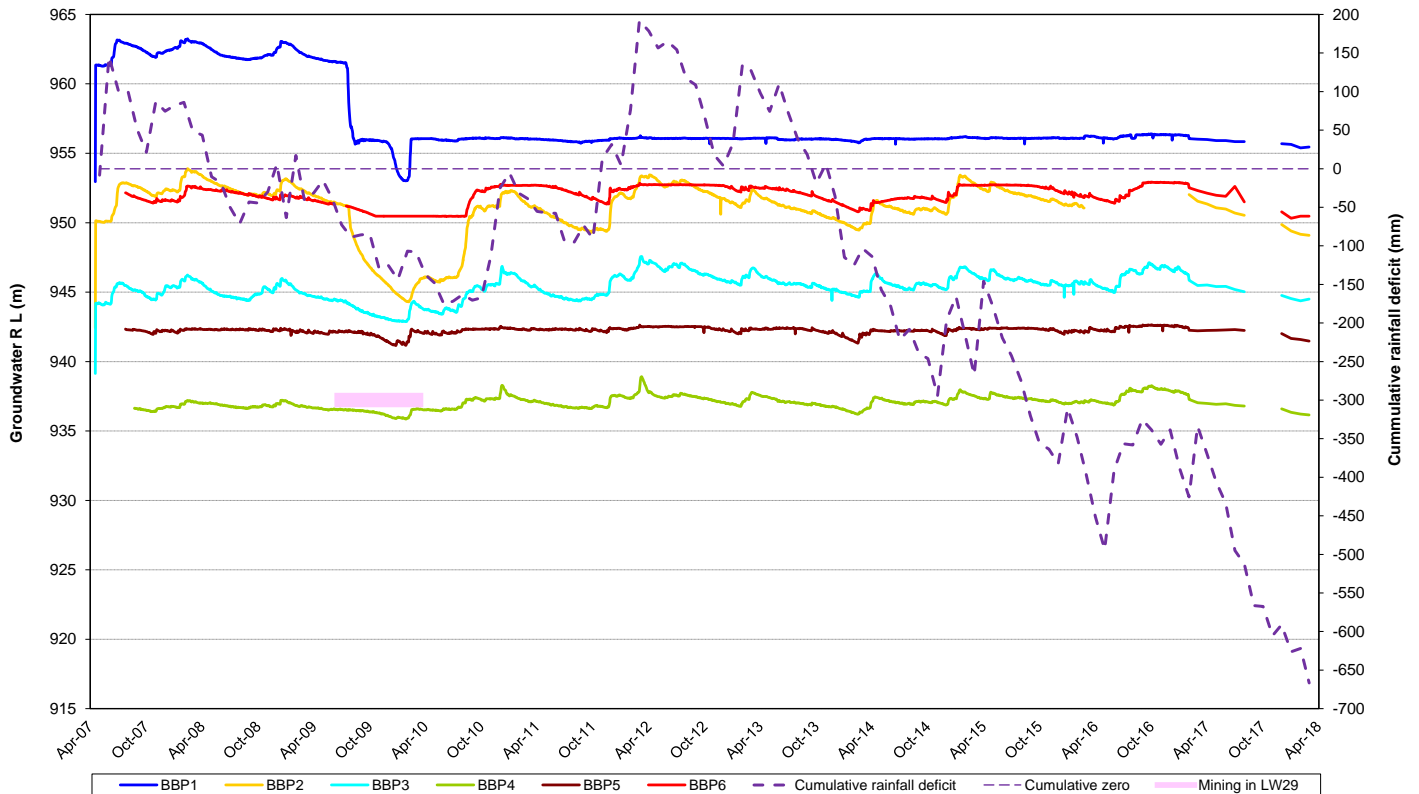
Figure 6.9: Coxs River Swamp groundwater levels and rainfall deficit

BBPB6 groundwater levels have also dropped throughout 2017 in response to the dry conditions, and in February 2018 the piezometer has been recorded as dry.

Note: The approved Groundwater Monitoring Plan requires groundwater levels in the Cox's River Swamp piezometers be recorded every two months. Groundwater levels in the Cox's River Swamp were not recorded in September 2017 as the sampler (ALS Mudgee) did not have the necessary equipment available on the selected sampling day. In October 2017 Baal Bone Colliery personnel commenced sampling all surface and groundwaters across the site. Unfortunately groundwater levels were also not recorded in October and November 2017 as the Colliery was awaiting the delivery of the necessary equipment.

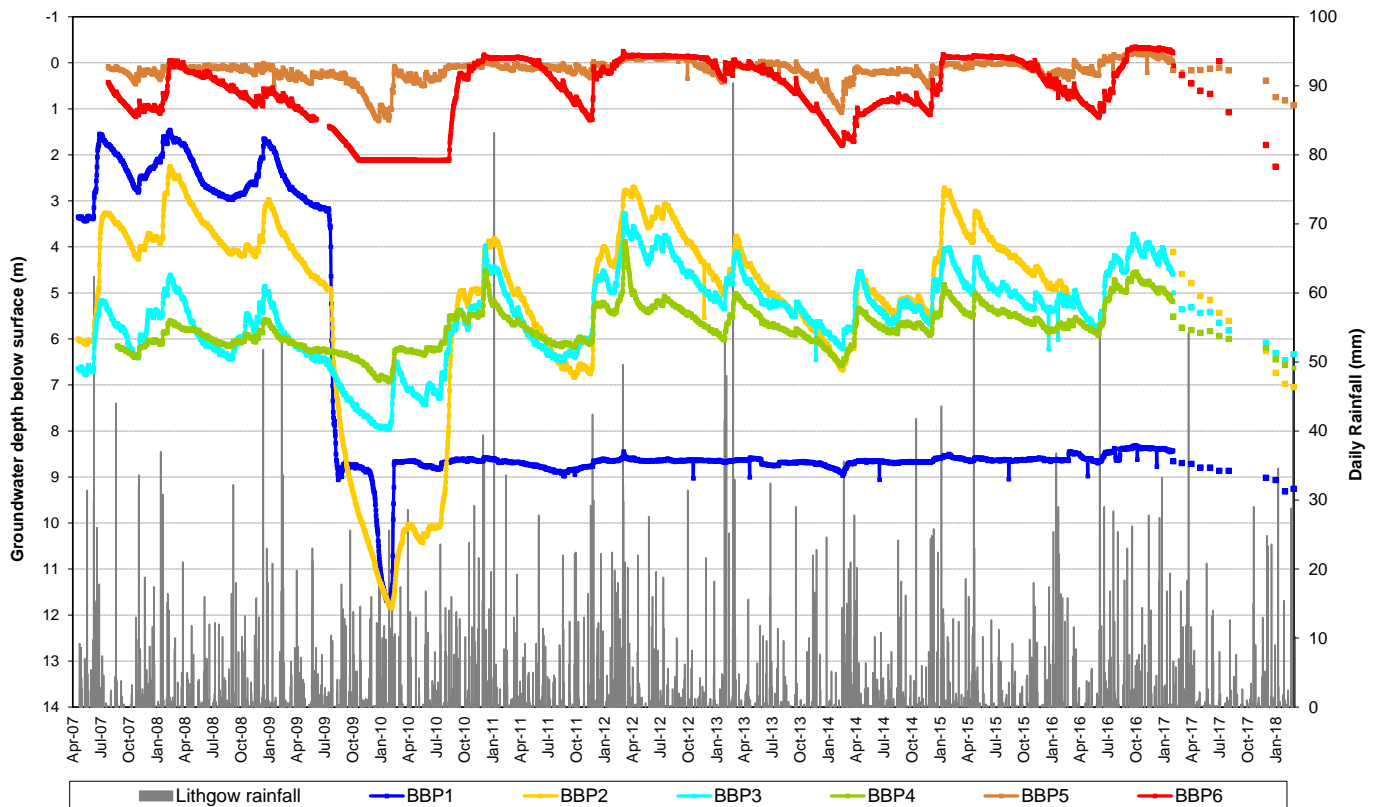
Figure 6.10: Longterm groundwater trends

Groundwater data are plotted on Figure 6.9 and Figure 6.10. The north – to – south downstream groundwater gradient has been broadly maintained (highest level observed in BBP1 and lowest level observed in BBP4), indicating that overall flow has been maintained down through the swamp.

All groundwater levels appear to be approximately at pre-mining levels, with the only exception being at piezometer BBP1, where a groundwater level has re-stabilised at RL 956 m (approximately 5 m below pre-mining level).

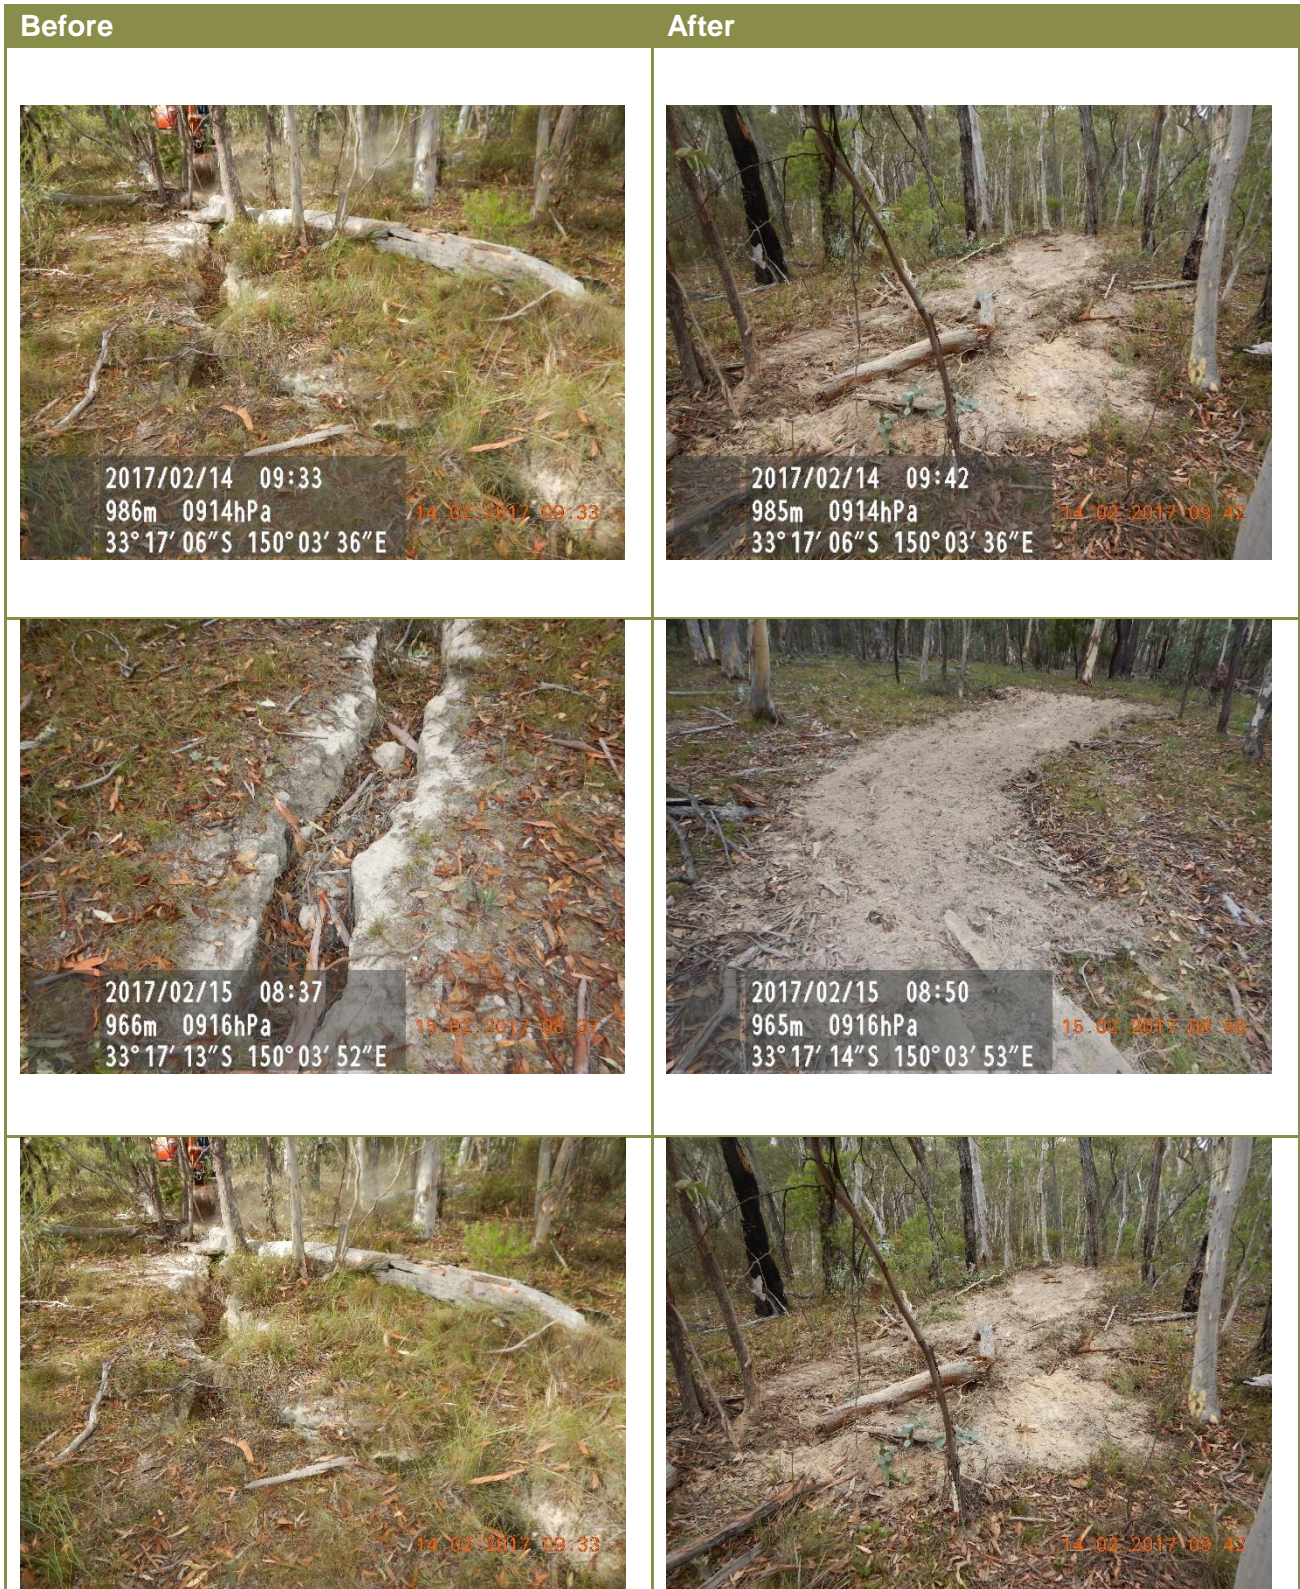
Plate 1: Before and after photos of shallow cover subsidence repairs in February 2017.

The high risk subsidence cracks identified during the steep slope survey (April 2015) were progressively remediated during the second half of 2015. In February 2017 Baal Bone Colliery remediated a number of subsidence cracks in the shallow cover area over Longwalls 16 to 18a within Consolidated Coal Lease 749 (refer to **Plate 1**).
