BAAL BONE UNDERGROUND

Annual Review
2021

Name of Operation	Baal Bone Colliery
Name of Operator	Baal Bone Colliery
Project Approval Number	09_0178
Name of Holder of Project Approval	The Wallerawang Collieries Ltd
Mining Lease Number/s	CCL749, MPL261, CL391, ML1302, ML1389, ML1607
Name of Holder of Mining Lease/s	The Wallerawang Collieries Ltd
Water Licence Number/s	WAL27887, WAL34952, 80WA706034, 80WA706035
Name of Holder of Water Licence/s	The Wallerawang Collieries Ltd
MOP Start Date	20 th December 2019
MOP End Date	31 st December 2025
Annual Review Start Date	1 st January 2021
Annual Review End Date	31 st December 2021
<p>I, Elizabeth Fishpool, certify that this audit report is a true and accurate record of the compliance status of Baal Bone Colliery for the period 1st January 2020 to 31st December 2020 and that I am authorised to make this statement on behalf of Baal Bone Colliery.</p> <p><i>Note.</i></p> <p>a) <i>The Annual Review is an 'environmental audit' for the purposes of section 122B(2) of the Environmental Planning and Assessment Act 1979. Section 122E provides that a person must not include false or misleading information (or provide information for inclusion in) an

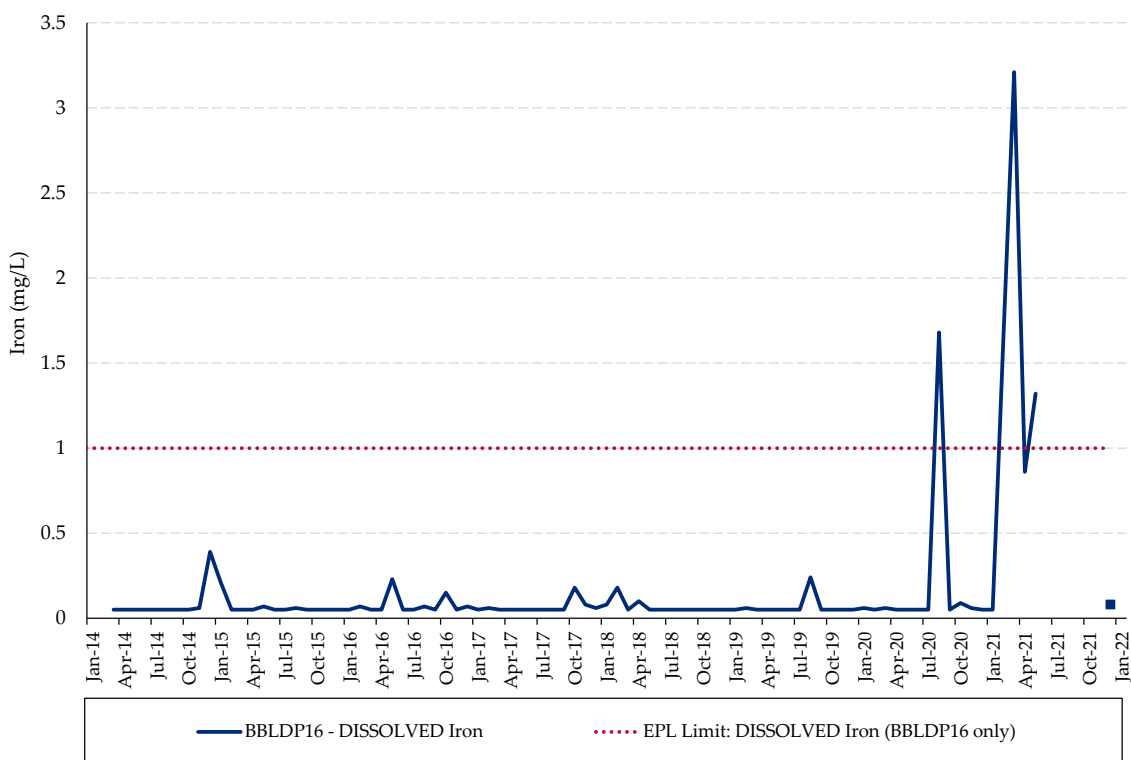
Figure 7.5: Iron Dissolved (2014 – 2021)

Figure 7.5 shows the iron level recorded at BBLDP16 from 2014 to 2021. From 1 August 2013 EPL 765 specified a *dissolved* iron concentration limit of 1 mg/L at BBLDP16. Prior to this time, the iron concentration limit at BBLDP16 was 1 mg/L of *total* iron. Between 2014 and 2020 there has been one exceedance of the EPL dissolved iron concentration limit, in August 2020, with a reading of 1.68 mg/L. An investigation which included follow up testing of BBLDP16 and examination of water transfers could find no definitive reason for the isolated spike in iron levels.

During 2021 there were three exceedances of the dissolved iron EPL limit of 1mg/L. Refer to **Section 7.1.2** for further detail on 2021 exceedances and management actions.

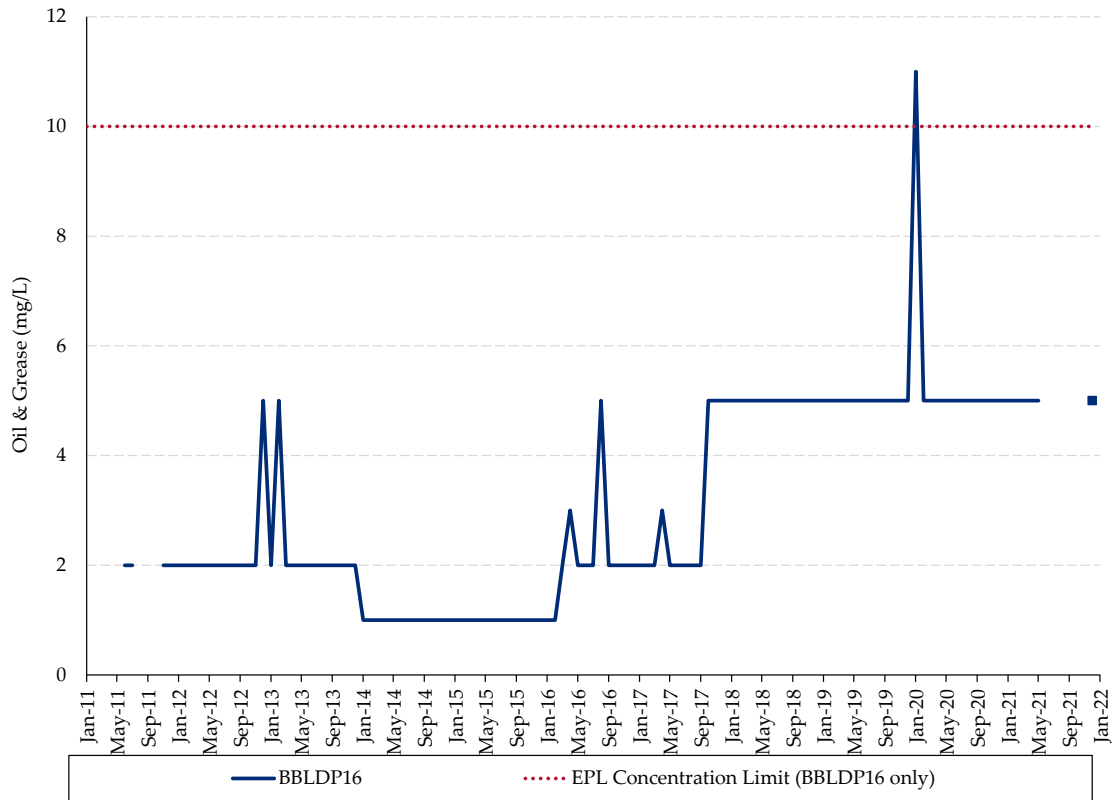
Figure 7.6: Oil and grease levels from 2011 to 2021

Oil and grease levels in the sample taken on 22 January 2020 exceeded the EPL concentration limit of 10mg/L, with a result of 11 mg/L. An investigation was undertaken into this exceedance which found that potential contributors may have been the extended dry spell and recent rainfall, the bushfires moving through the area as well as vehicles and machinery on site. Refer to **Section 7.1.2** for further information.

Prior to January 2014, the limit of reporting for oil and grease was < 2 mg/L. From January 2014, limit of reporting value became < 1 mg/L before increasing back to <2 mg/L in March 2016. From October 2017 the limit of reporting increased to <5 mg/L due to changing to ALS Group Environmental Division Lithgow to undertake the monthly monitoring and analysis. These changes in the limit of reporting account for the step change in reported oil and grease levels.

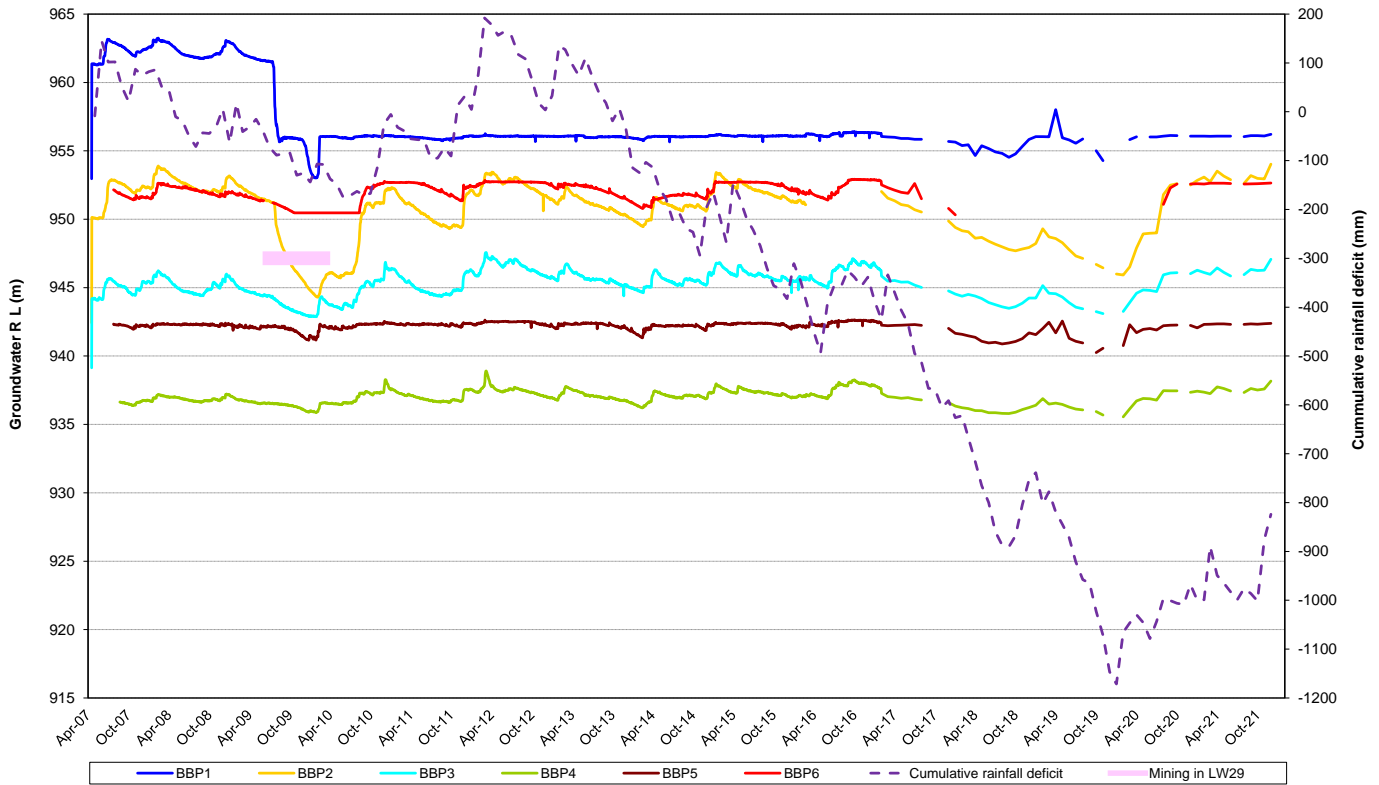
Figure 7.9: Coxs River Swamp groundwater levels and rainfall deficit

The water levels in all the bores (BBPB1 – BBPB5) have remained relatively stable during 2021, which is interpreted to be due to wetter conditions compared to previous years.

BBPB6 was recorded as dry from February 2018 until groundwater levels dropped throughout 2017 in response to the dry conditions, and in February 2018 the piezometer has been recorded as dry. BBPB6 has remained dry from February 2018 until July 2020. From August 2020 until Oct 2020 water levels in BBPB6 have increased. Throughout 2021 the water levels in BBPB5 and BBPB6 were stable, with water at ground level for the entire year at these bores within the swamp.

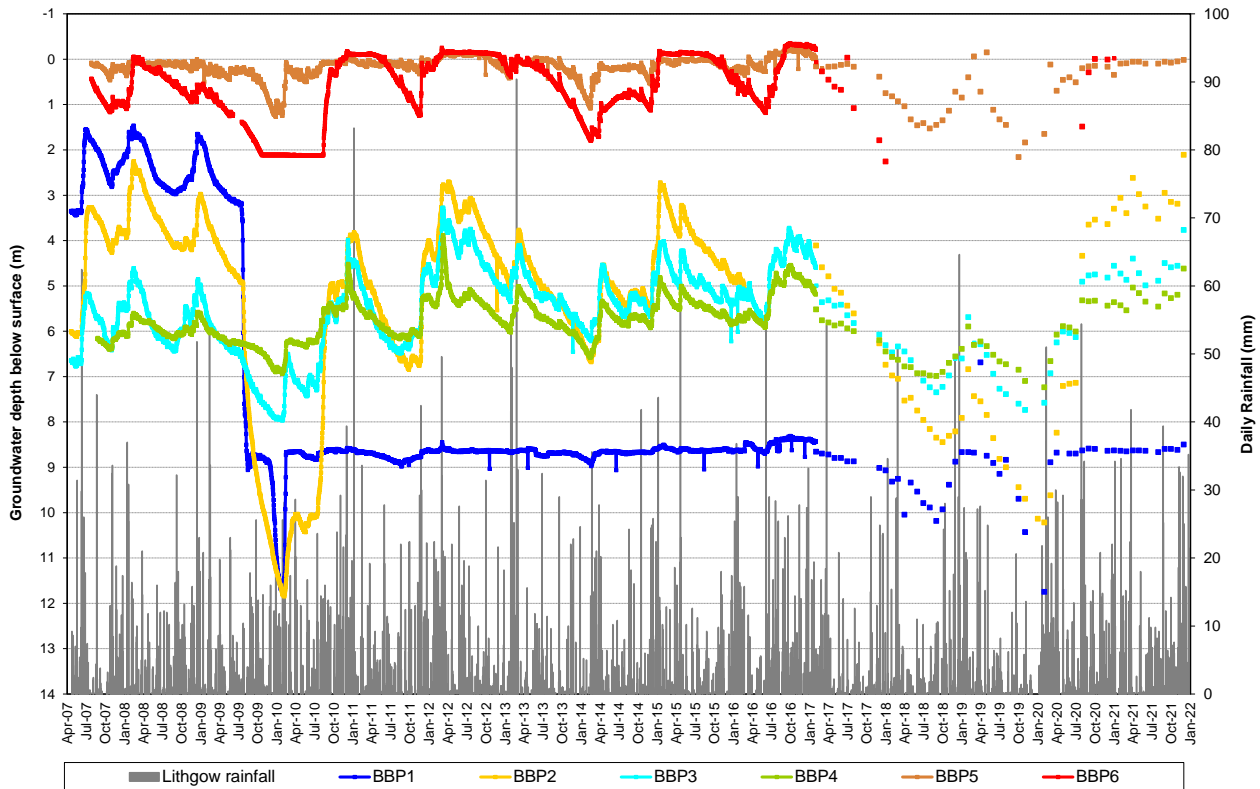
Figure 7.10: Longterm groundwater trends

Groundwater data are plotted on **Figure 7.9** and **Figure 7.10**. The north – to – south downstream groundwater gradient has been broadly maintained (highest level observed in BBP1 and lowest level observed in BBP4), indicating that overall flow has been maintained down through the swamp.

All groundwater levels appear to be approximately at pre-mining levels, with the only exception being at piezometer BBP1, where a groundwater level has re-stabilised at RL 956 m (approximately 5 m below pre-mining level).

All bores saw a decrease in groundwater RL corresponding to the prolonged drought period and rainfall deficit from early 2017 until end 2019. During 2020 the higher volume of rainfall received comparative to previous years, corresponded with an increase in groundwater RLs in all bores. Water levels in all bores have remained relatively stable during 2021.

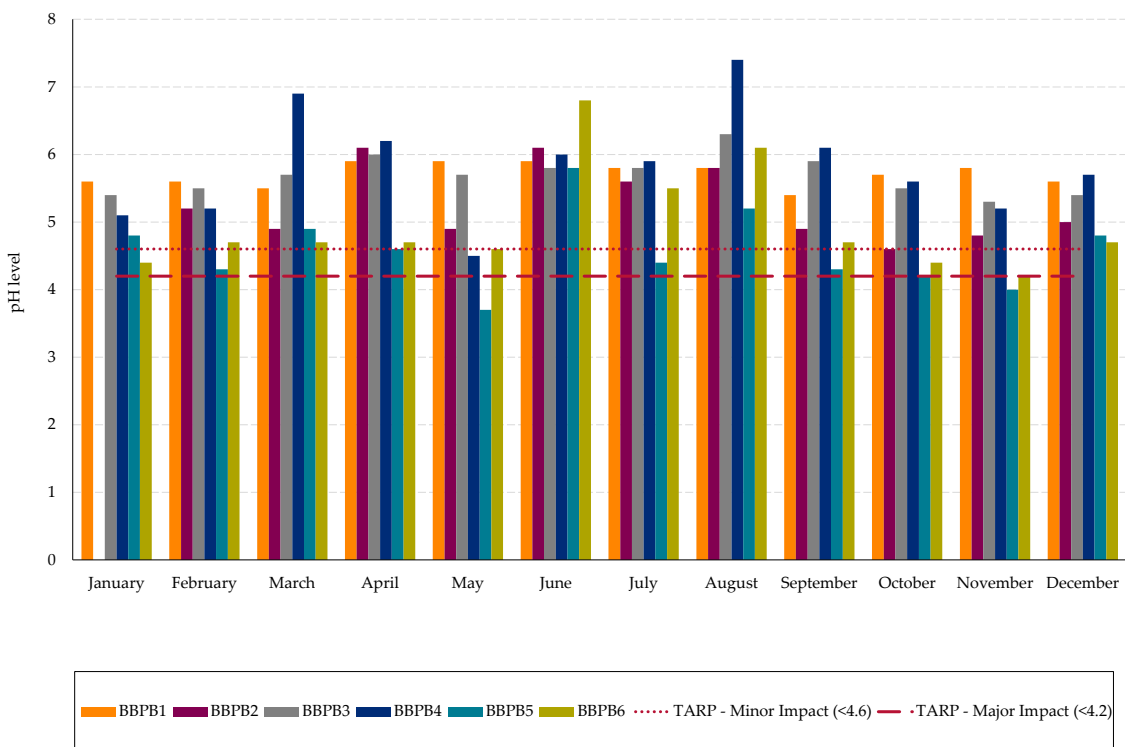
Figure 7.11: 2021 Groundwater pH levels.

As shown in **Figure 7.11** above, all pH levels for bores BBPB1 through 3 were within both the minor and major impact criteria during 2021. BBPB4 was below the minor trigger level for one month in May 2021. BBPB5 was outside either the major and/or minor impact trigger levels for 6 months within 2021, including a three-month consecutive period from September until November. BBPB6 also dropped below the minor impact trigger levels for January, October and November 2021.

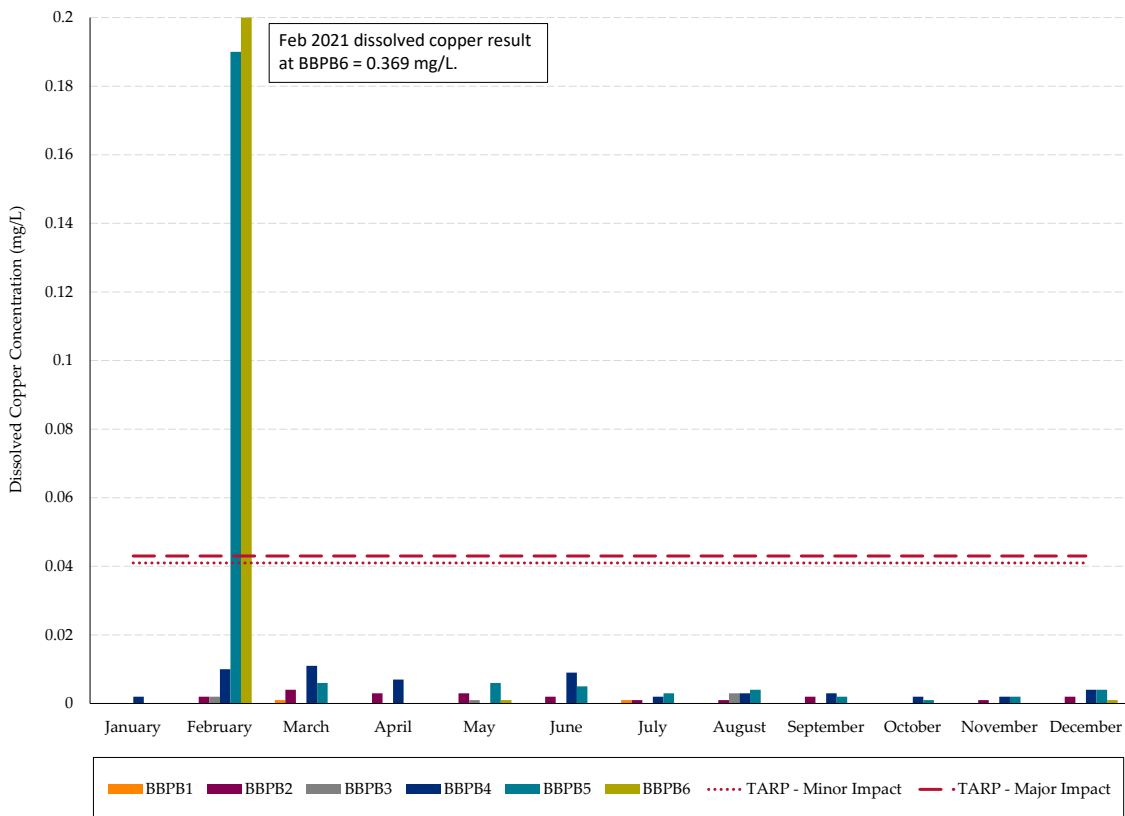
Figure 7.13: 2021 Groundwater Copper levels.

As shown in **Figure 7.13**, copper levels were also within impact criteria for all groundwater monitoring bores during 2021, except at BBPB5 and BBPB6 in February 2021. The spike in copper levels was isolated to BBPB5 and BBPB6 for February 2021. Copper results returned to historical levels for the remainder of 2021, and no obvious cause for the spike was determined.

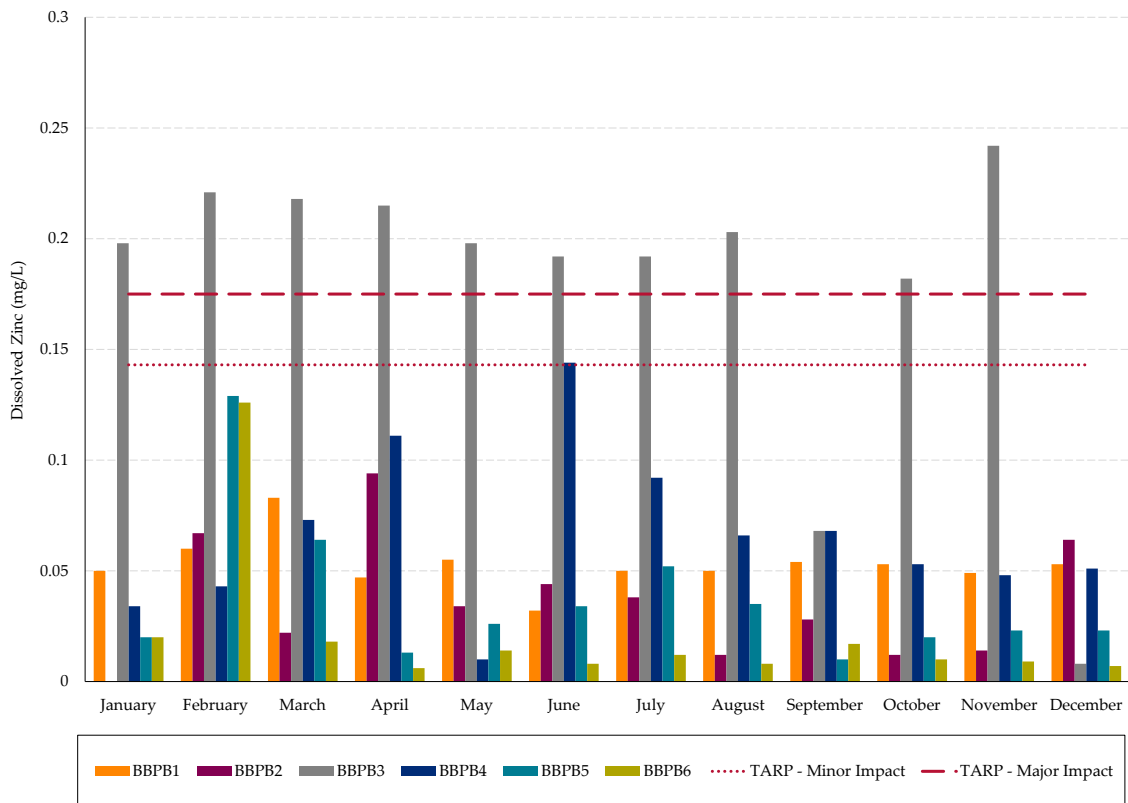
Figure 7.15: 2021 Groundwater Zinc Levels.

The 2019 Independent Environmental Audit (IEA) carried out by Hansen Bailey determined that the ongoing exceedance of Water Quality Trigger Levels for dissolved zinc at BBPB3 was a low risk non-compliance. The audit recommended that Baal Bone Colliery, "revisit the zinc trigger levels for BBP3 in consultation with DPIE for the closure stage".

In 2020, Umwelt were engaged in part to determine the potential causes of elevated zinc concentrations at BBP3 and identify whether the existing groundwater minor and major change criteria (trigger values) should be updated. In relation to zinc Umwelt found that "the peak

concentrations during many of these events was recorded shortly after increased rainfall following a prolonged dry period. This suggests that rainfall-runoff infiltration has mobilised zinc from dry strata within the BBP3 catchment and that a wetting and drying process could be a significant contributor to groundwater zinc concentrations.” Also that “Elevated zinc concentrations were observed to occur pre-mining, during mining and post-mining. Elevated zinc concentrations at times followed a rise in groundwater level in BBP3”.

In the 2019 IEA Action Plan, Baal Bone Colliery committed that by 30 March 2021 a consultant will be engaged to further investigate the exceedance with consideration to be given to calibrating the groundwater triggers to site specific conditions if appropriate.
