BAAL BONE COLLIERY

ANNUAL ENVIRONMENT REVIEW

1st January 2014 – 31st December 2014

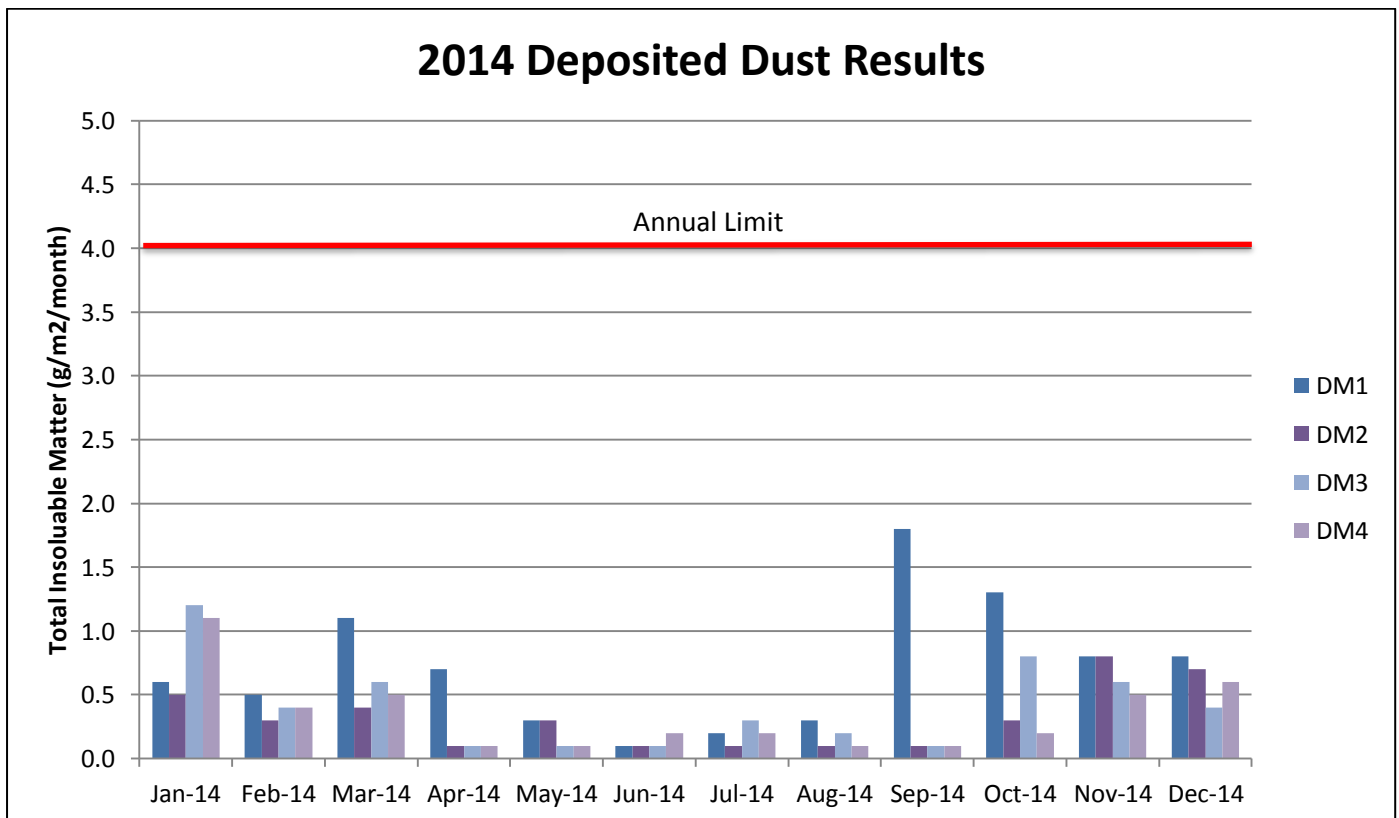
Figure 2: 2014 Deposition Dust Monitoring Results

All levels of deposited dust were below the 4 g/m²/month criterion (annual averaging period). The highest result during 2014 was at DM1 in September with a result of 1.8/m².

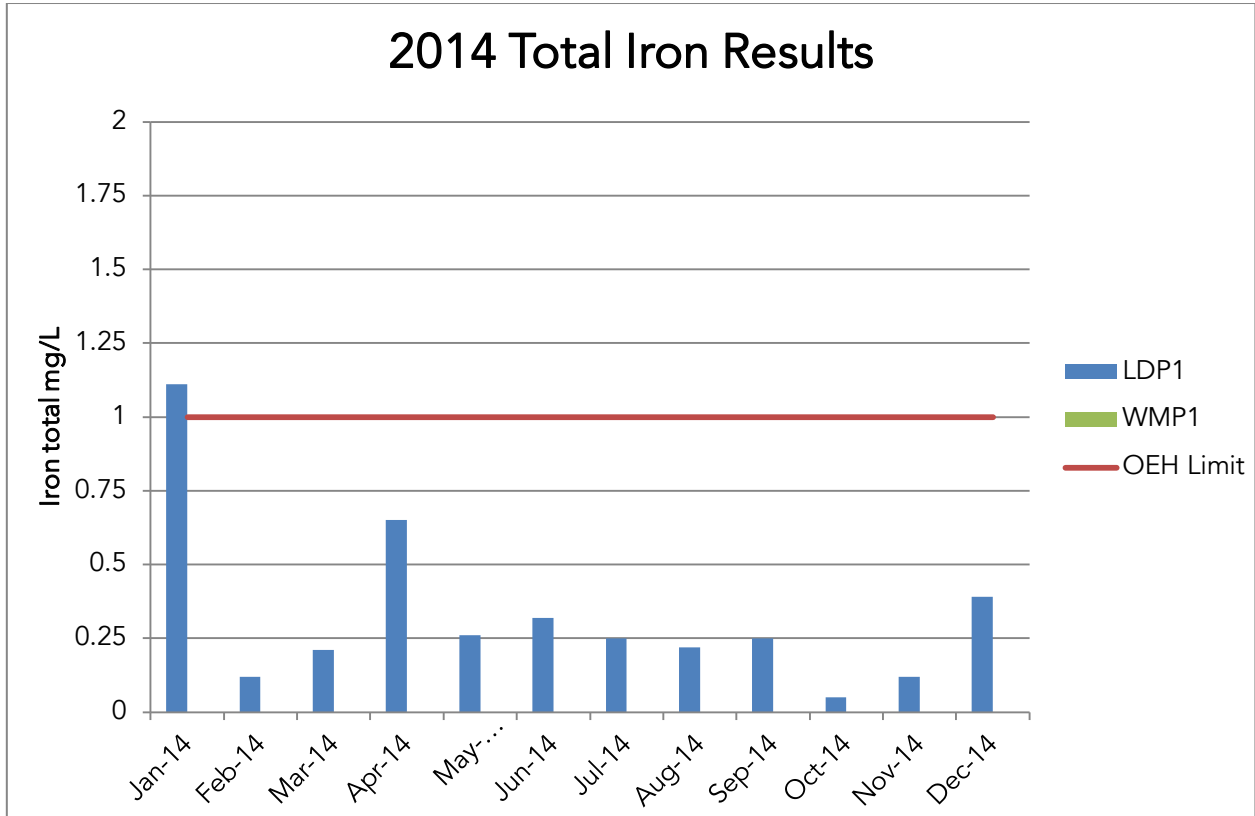
Figure 4: Total Iron

All samples recorded were within EPL concentration limits during the 2014 reporting period, with the exception of Total Iron exceedances at LDP1 during January. Initial analysis suggested that the elevated Total Iron levels were the result of reduced dilution of mine water as a result of below average rainfall over

Based on the investigation, the cause was identified as incorrect sampling being carried out on the samples taken on 13 January.

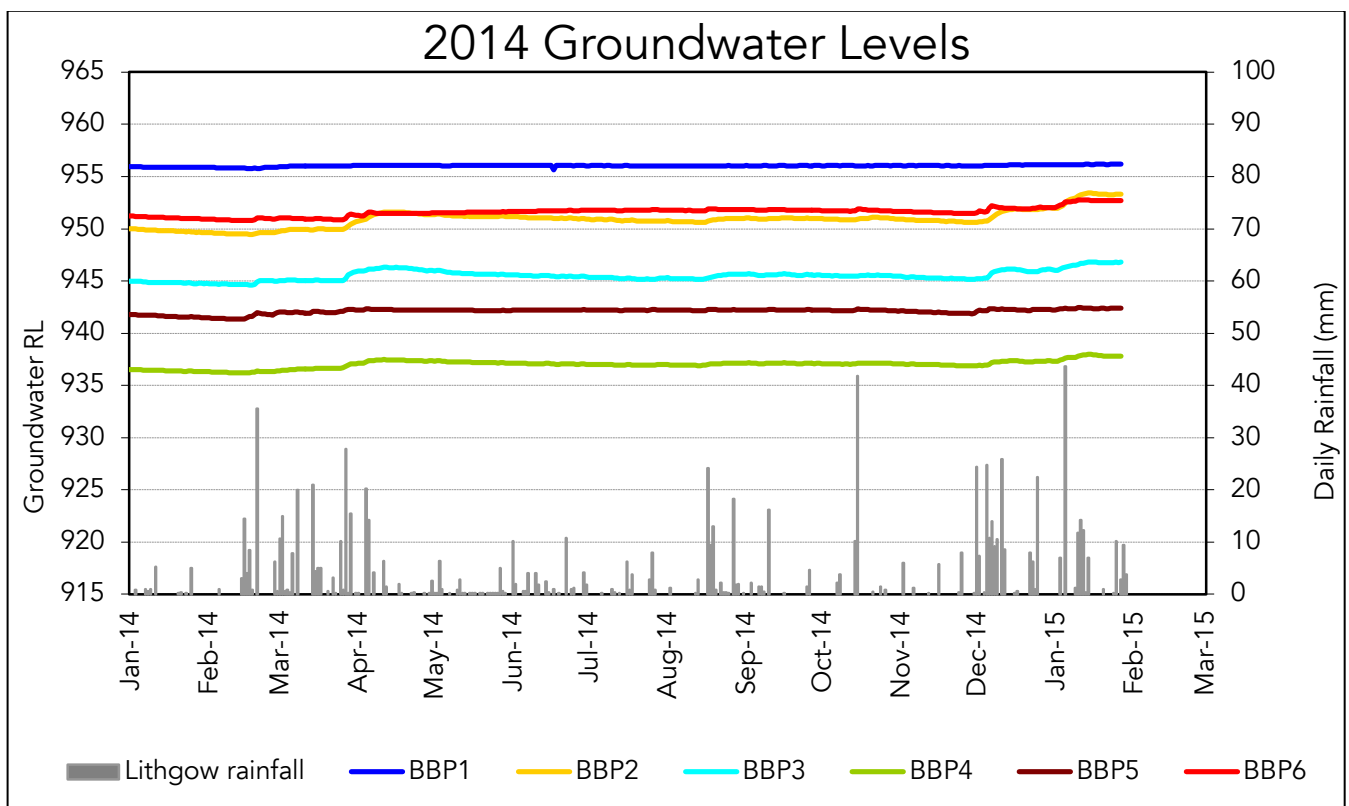
Figure 8: Groundwater levels 2014

Most groundwater levels appear to be approximately at or above pre-mining levels. The only exception is at piezometer P1, where groundwater level has stabilised at RL 956 m (approximately 5 m below pre-mining level).

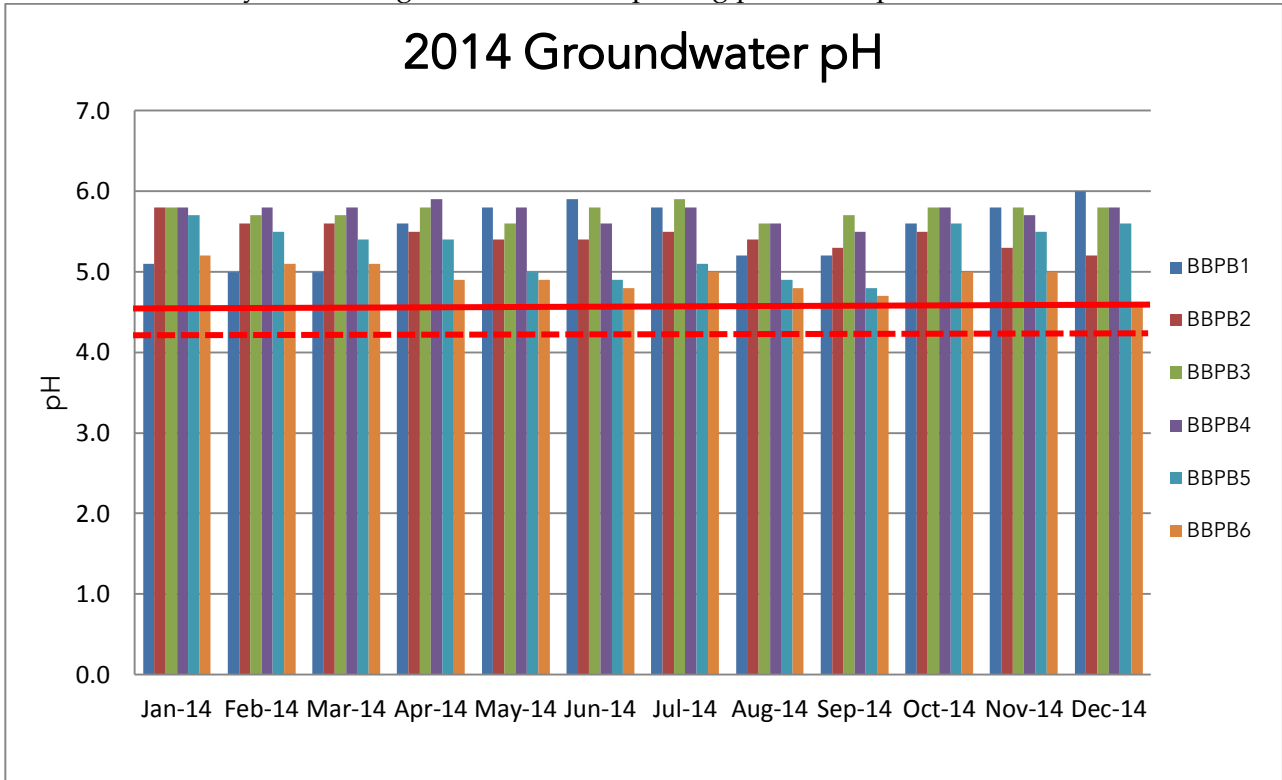
Figure 10: 2014 Groundwater pH levels.

As shown, pH levels for all piezometers were above the minor and major impact trigger levels for 2014.

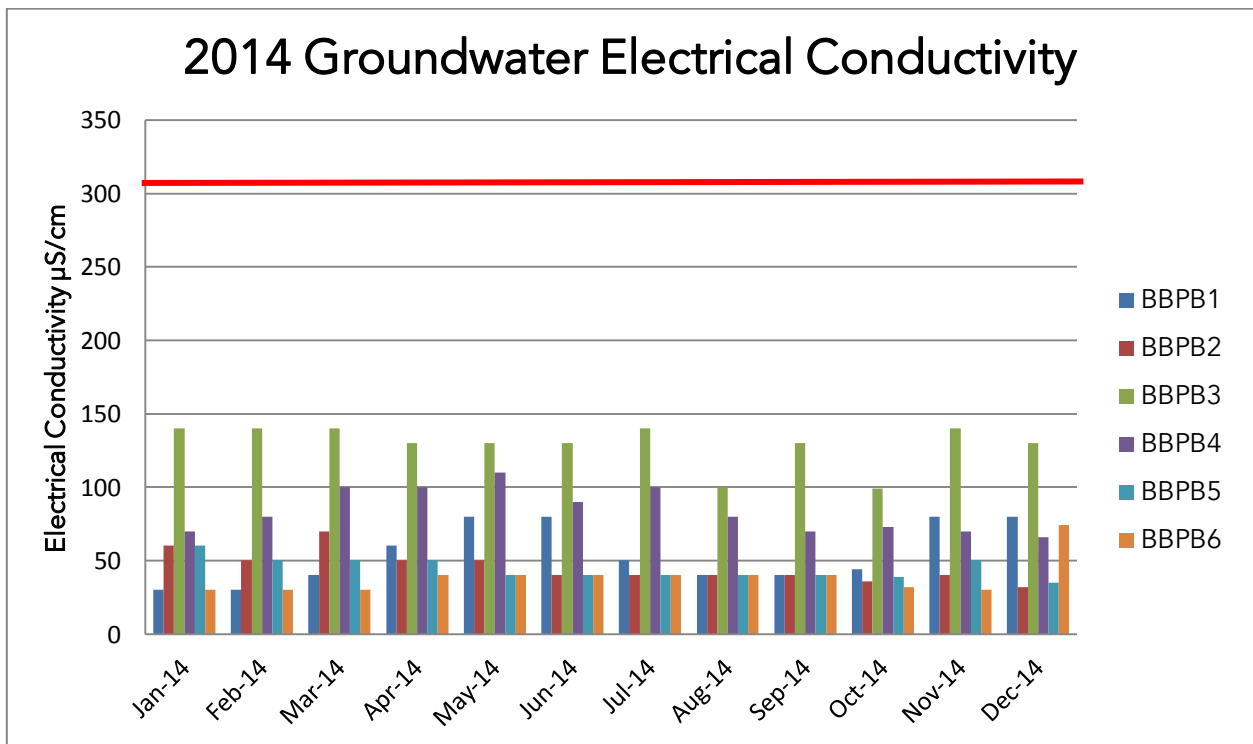
Figure 11: 2014 Groundwater Electrical Conductivity.

As shown above, electrical conductivity levels at all piezometers were below the TARP trigger levels during the reporting period.

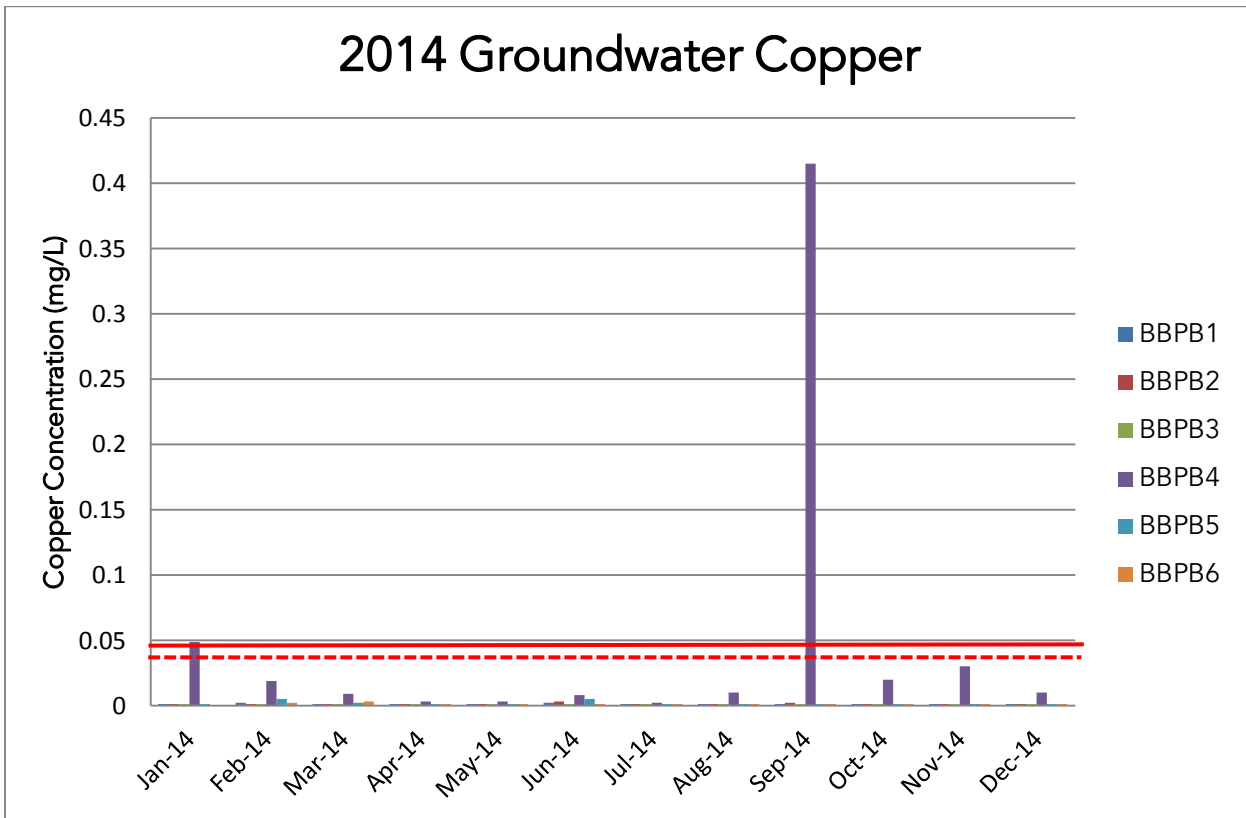
Figure 12: 2014 Groundwater copper levels.

As shown above, copper levels at BBPB4 in 2014 exceeded the major impact trigger level in September. It should be noted that BBPB4 is a background bore and its purpose is to provide a benchmark for comparison with the other potentially affected monitoring bores. BBPB4 is an aquifer groundwater bore and is not located within the Cox’s River Swamp. BBPB4 is located approximately 70 metres to the west of the wetland in an area where no subsidence was expected to occur.

The Aurecon report found that copper levels increased during spring each year, suggesting a biological process. Aurecon stated that:

“The release of trace metals from wetland soils to the local groundwater is known to occur as a result of biological degradation of organic matter. The decaying organic matter releases carbon dioxide, which forms carbonic acid in the groundwater. The acid conditions reduce the alkalinity such that the water is poorly buffered and the trace metals are released (Schaller et.al. 2011 and Maltby 2009).”

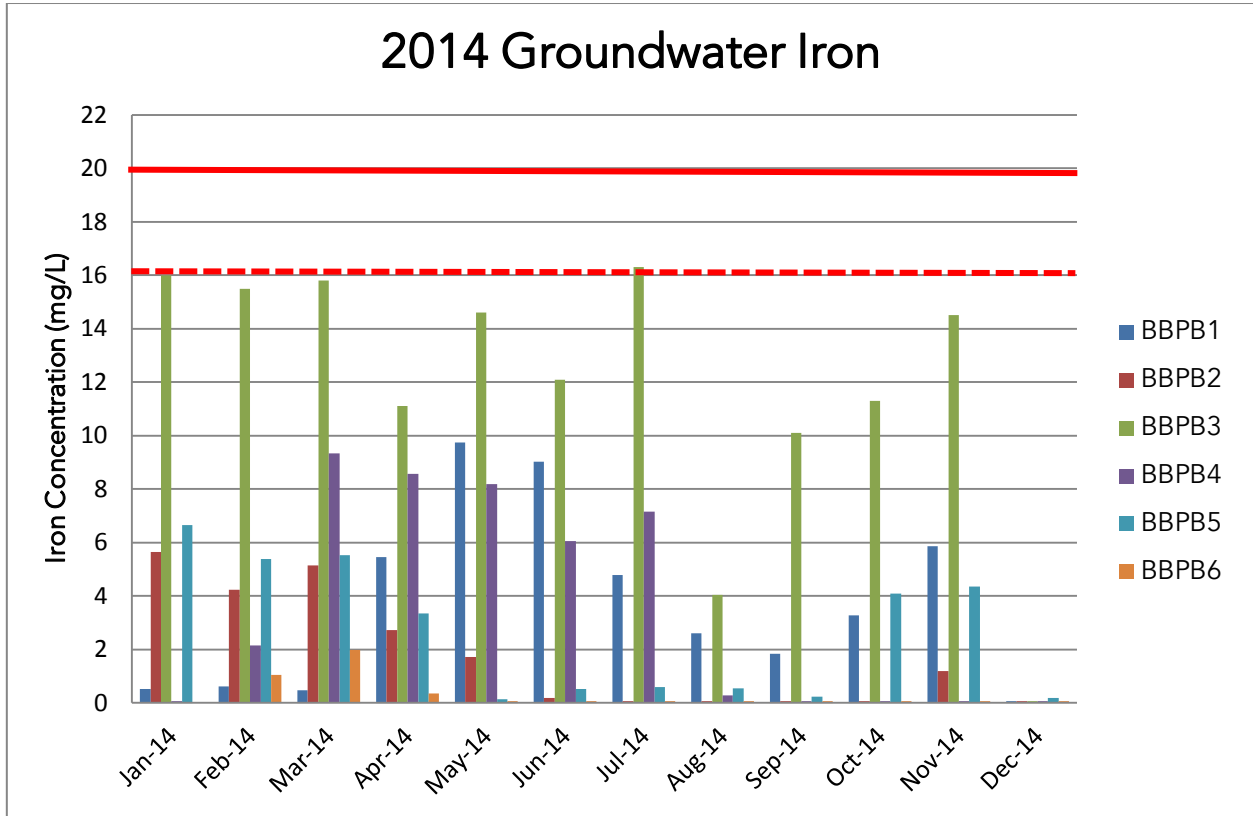
Figure 13: 2014 Groundwater Iron levels.

As shown above, all iron levels were below the minor impact trigger level with the exception of BBPB3. In July, BBPB3 marginally exceeded the minor impact trigger level for only one month.

“Iron is abundant in the groundwater in the area, as indicated by the pre-mining 80th percentile baseline of 12 mg/L for all the bores. The water level changes, caused by drought conditions just before and during mining, did not occur during the pre-mining period of 2008/09, which was used to establish the baseline conditions and the trigger levels. The bore BBP3 exceedance of even the major level of 24.27 mg/L by the increase to 36 mg/L, during the change from dry to wet conditions, shows the naturally abundant level of iron in the area.”

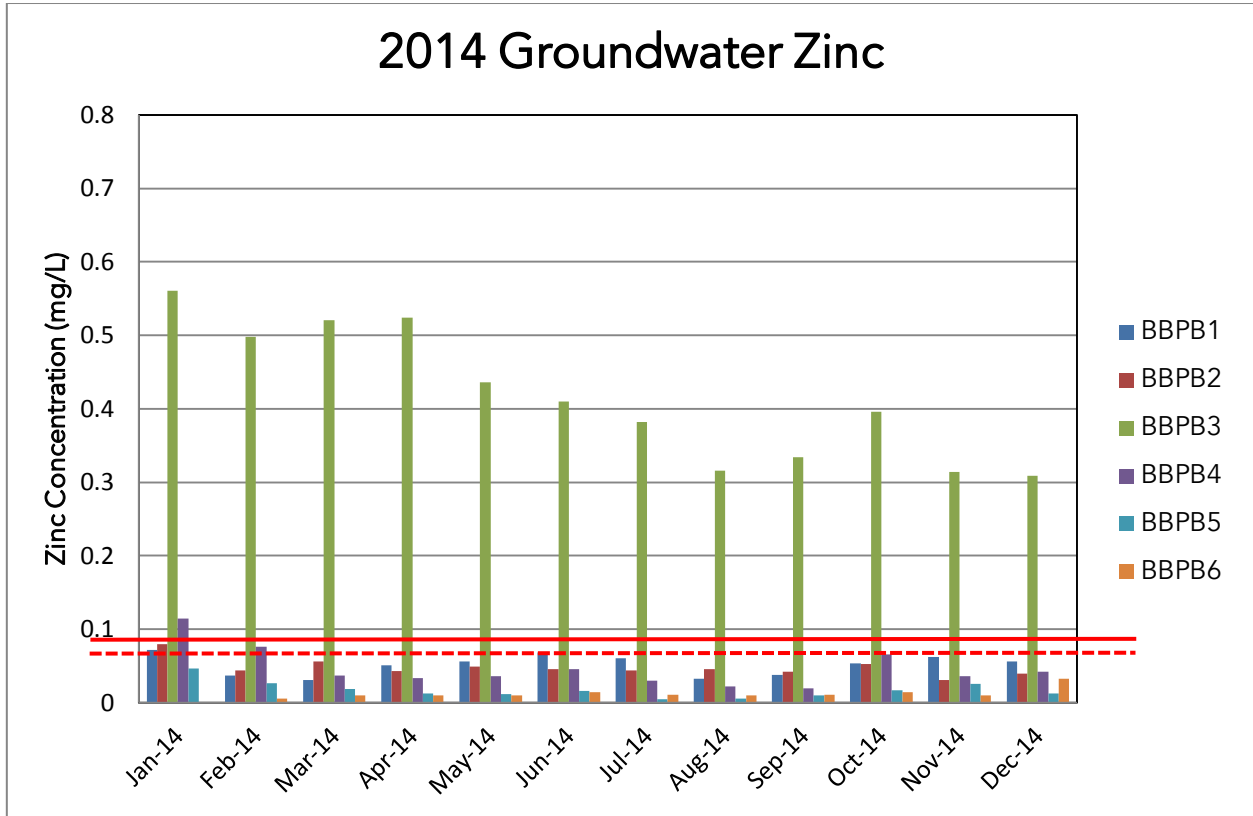
Figure 14: 2014 Groundwater Zinc Levels.

As shown above, zinc levels at BBPB3 exceeded the minor and major impact TARP trigger levels during all months in 2014. This major impact TARP event has continued since August 2012.
