BAAL BONE UNDERGROUND

Annual Review 2018

Name of Operation	Baal Bone Colliery
Name of Operator	Baal Bone Colliery
Project Approval Number	09_0178
Name of Holder of Project Approval	The Wallerawang Collieries Ltd
Mining Lease Number/s	CCL749, MPL261, CL391, ML1302, ML1389, ML1607
Name of Holder of Mining Lease/s	The Wallerawang Collieries Ltd
Water Licence Number/s	10BL601816, 10BL601817, 10BL601877, 10BL601970, 80BL236132, 80BL236134, WAL27887, WAL34952.
Name of Holder of Water Licence/s	The Wallerawang Collieries Ltd
MOP Start Date	29 th February 2016
MOP End Date	31 st December 2019
Annual Review Start Date	1 st January 2018
Annual Review End Date	31 st December 2018
<p>I, Elizabeth Fishpool, certify that this audit report is a true and accurate record of the compliance status of Baal Bone Colliery for the period 1st January 2018 to 31st December 2018 and that I am authorised to make this statement on behalf of Baal Bone Colliery.</p> <p><i>Note.</i></p> <p>a) <i>The Annual Review is an 'environmental audit' for the purposes of section 122B(2) of the Environmental Planning and Assessment Act 1979. Section 122E provides that a person must not include false or misleading informat

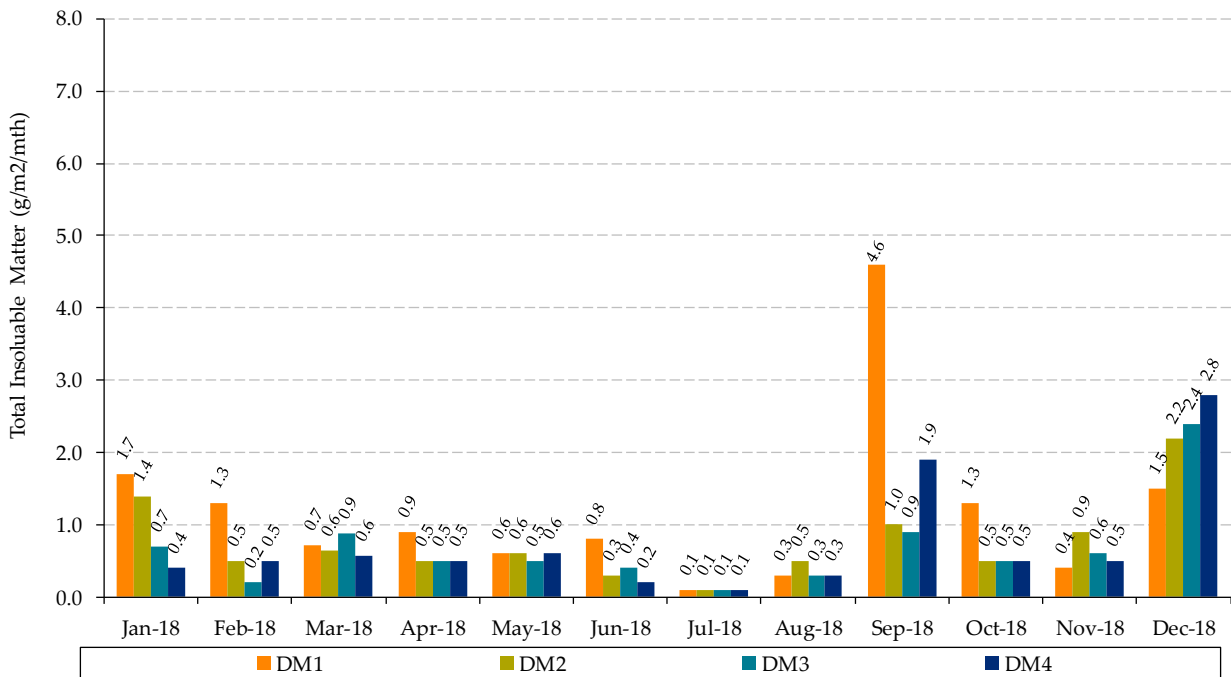
Figure 5.2: 2018 Deposited Dust Monthly Monitoring Results

*EPL Monitoring Point 7 (DM1) result for September 2018 is above the monthly maximum total deposited dust level of 4g/m²/month however when the annual average is applied the result is well within Project Approval limits – refer to Figure 5.3 for 12 month rolling average.

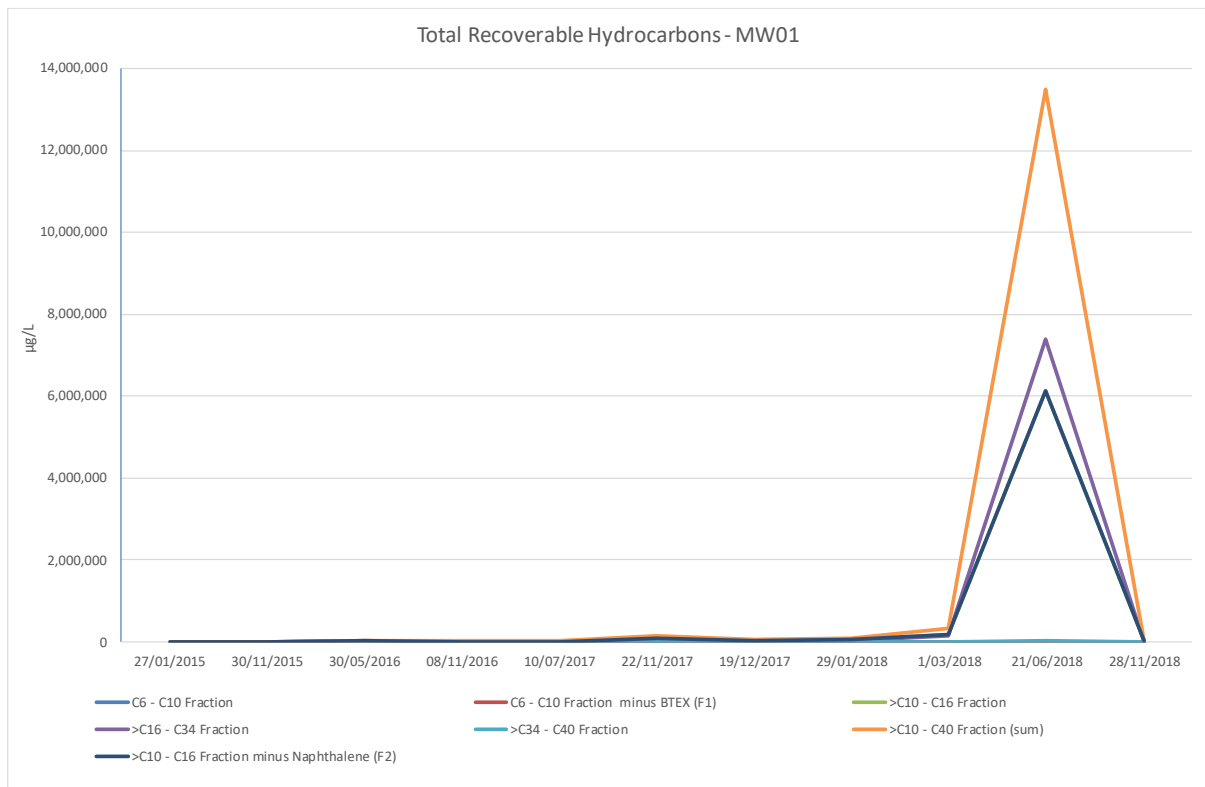
Figure 5.6: TRH results for MW01 (2015 to 2018)

Given the high concentrations of TRH at MW01, integrity testing of the 50,000L diesel UST and lines was conducted on 9 April 2018. The integrity test found no issues with the tank, however noted a small leak in a line and hand nozzle. A replacement line and hand nozzle was fitted the week following the integrity test. Further investigations on site detected a leak in a second fitting (banlaw fitting) – only evident when the line was pressurised. Subsequently, the line and banlaw fitting was removed.

Groundwater monitoring wells were sampled again in June 2018. The June 2018 sampling found that TRH levels at MW01 had increased significantly since the March 2018 sampling. MW03 and MW101 continued to return consistently low concentrations of TRH. Due to the continued increases of TRH at MW01, use of the underground diesel storage tank was discontinued.

The detection of elevated TRH in groundwater at MW01 suggests there has been impact to

groundwater from the diesel UST. It is expected that levels of contaminants in groundwater will continue to attenuate over time with the planned mine closure, removal of the UST and remediation of the surrounding soils.

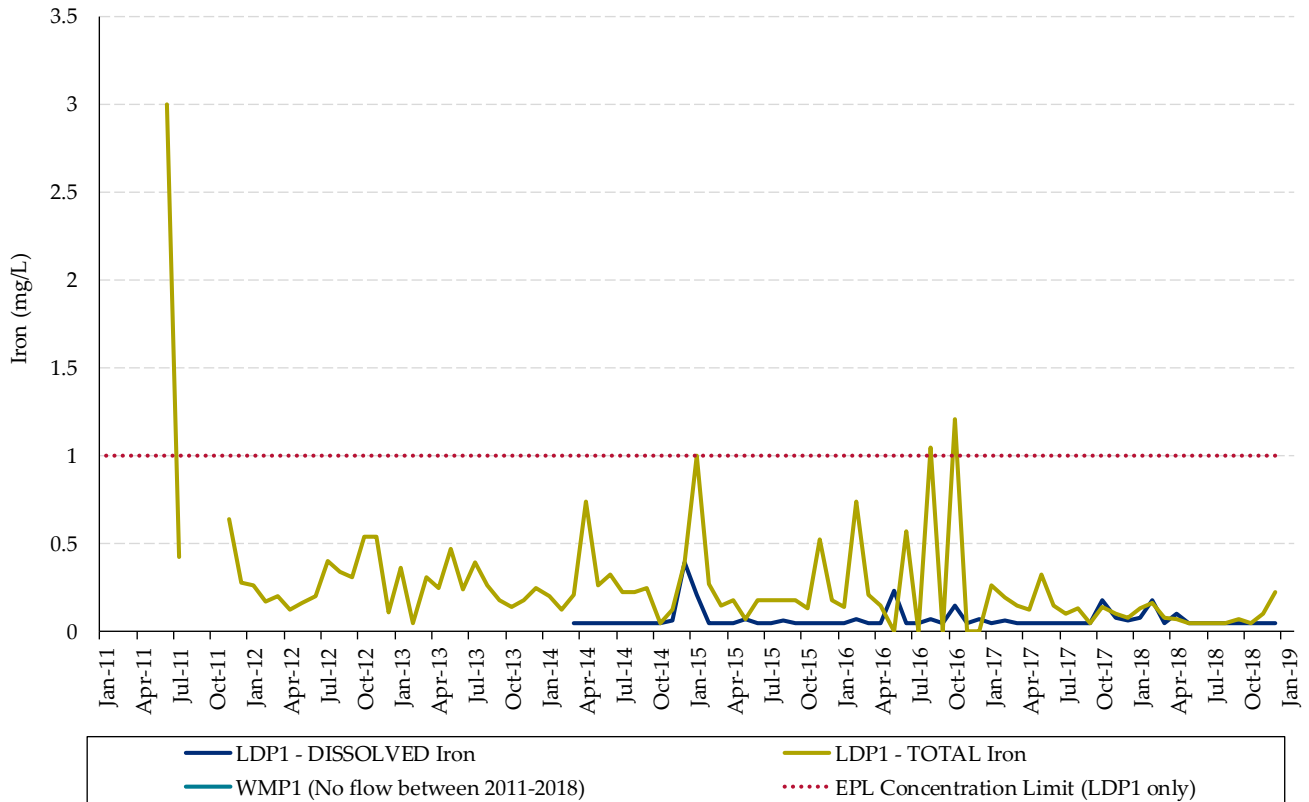
Figure 6.5: Iron – Total and Dissolved (2011 – 2018)

Figure 6.5 shows the iron level recorded at LDP1 from 2011 to 2018. From 1 August 2013 EPL 765 specifies a *dissolved* iron concentration limit of 1 mg/L at LDP1. Prior to this time, the iron concentration limit at LDP1 was 1 mg/L of *total* iron. Between 2011 and 2018 there has been one exceedance of the EPL iron concentration limit, in June 2011, with a reading of 3 mg/L. An investigation which included follow up testing of LDP1 and examination of water transfers could find no definitive reason for the isolated spike in iron levels.

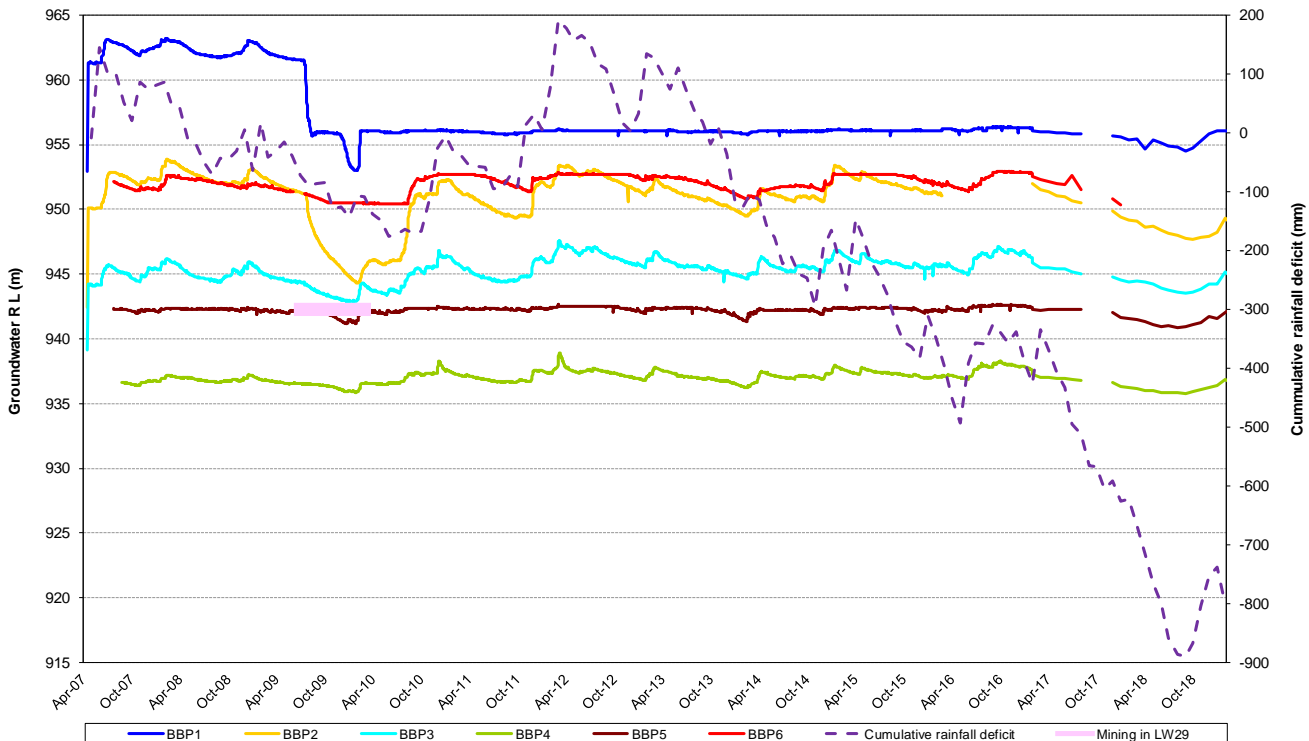
Figure 6.9: Coxs River Swamp groundwater levels and rainfall deficit

BBPB6 groundwater levels have also dropped throughout 2017 in response to the dry conditions, and in February 2018 the piezometer has been recorded as dry.

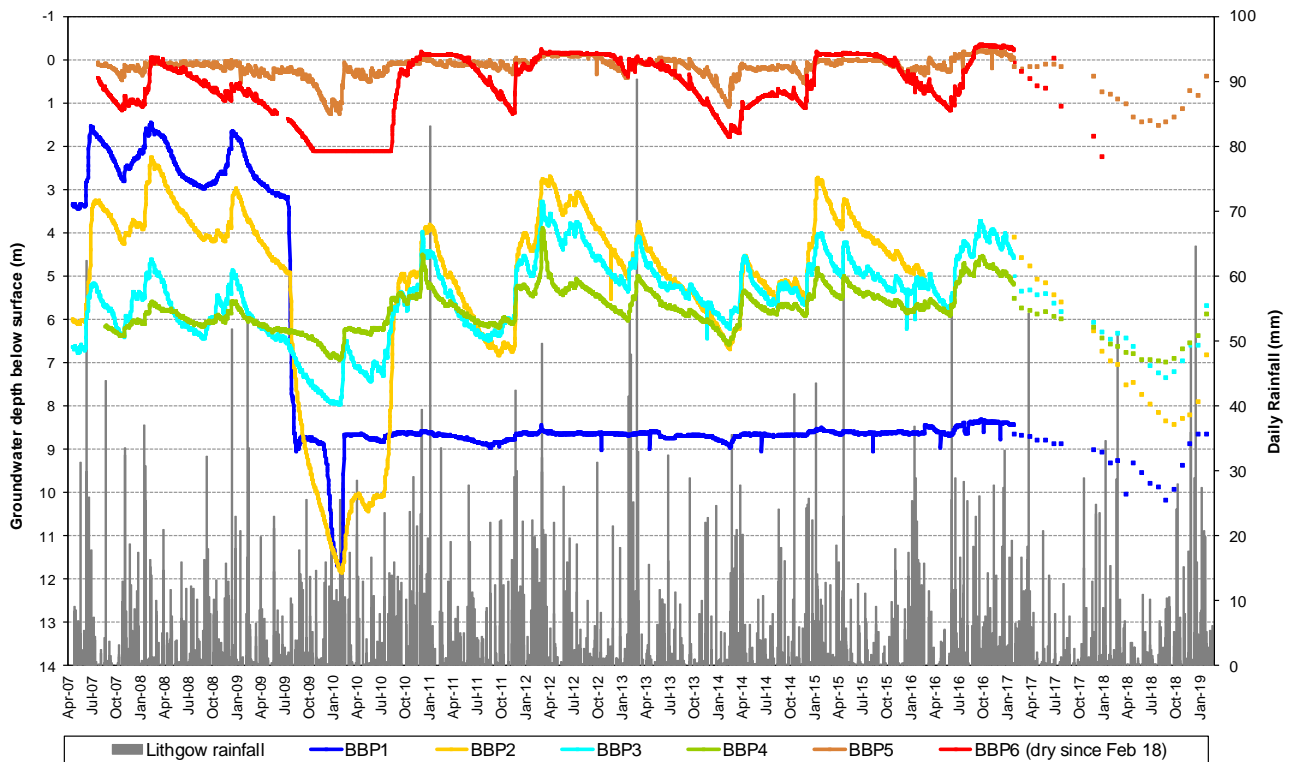
Figure 6.10: Longterm groundwater trends

Groundwater data are plotted on Figure 6.9 and Figure 6.10. The north – to – south downstream groundwater gradient has been broadly maintained (highest level observed in BBPB1 and lowest level observed in BBPB4), indicating that overall flow has been maintained down through the swamp.

All groundwater levels appear to be approximately at pre-mining levels, with the only exception being at piezometer BBPB1, where a groundwater level has re-stabilised at RL 956 m (approximately 5 m below pre-mining level).

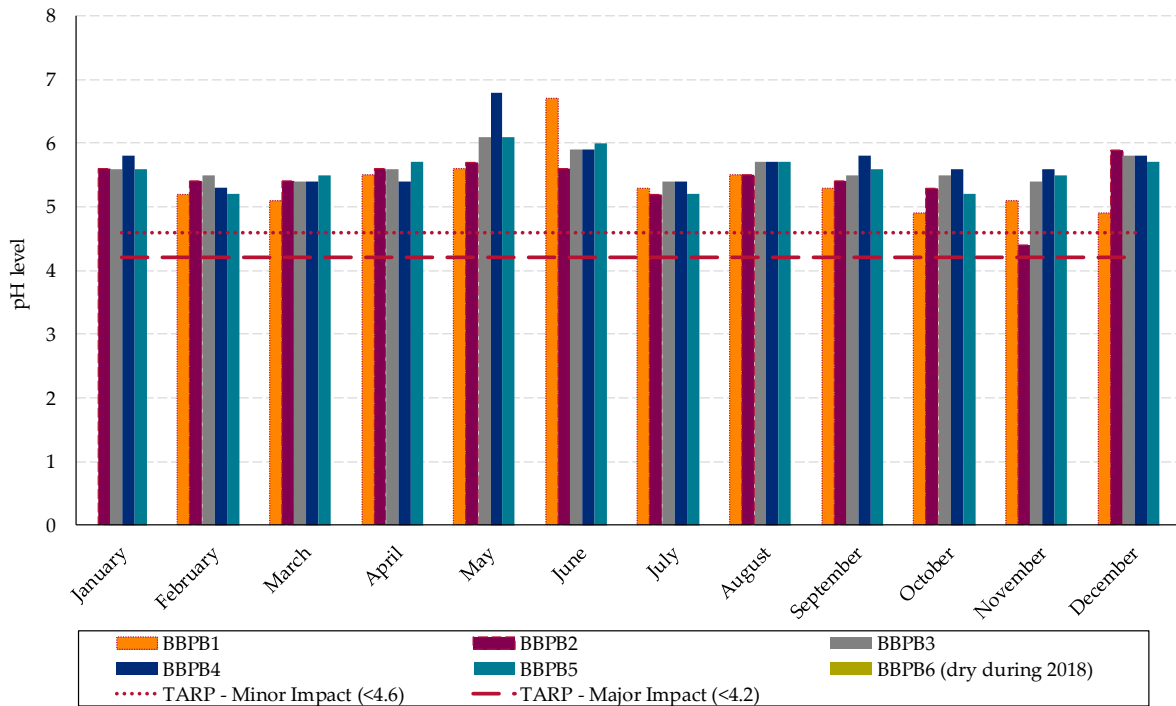
Figure 6.11: 2018 Groundwater pH levels.

As shown in **Figure 6.11** above, all pH levels were within both the minor and major impact criteria for all groundwater monitoring bores during 2018, with the exception of BBPB2 in November 2018. A reading of 4.4 was returned for pH at BBPB2 in November 2018, which exceeded the minor impact threshold. As this was a minor exceedance for only one month, no further action was undertaken.

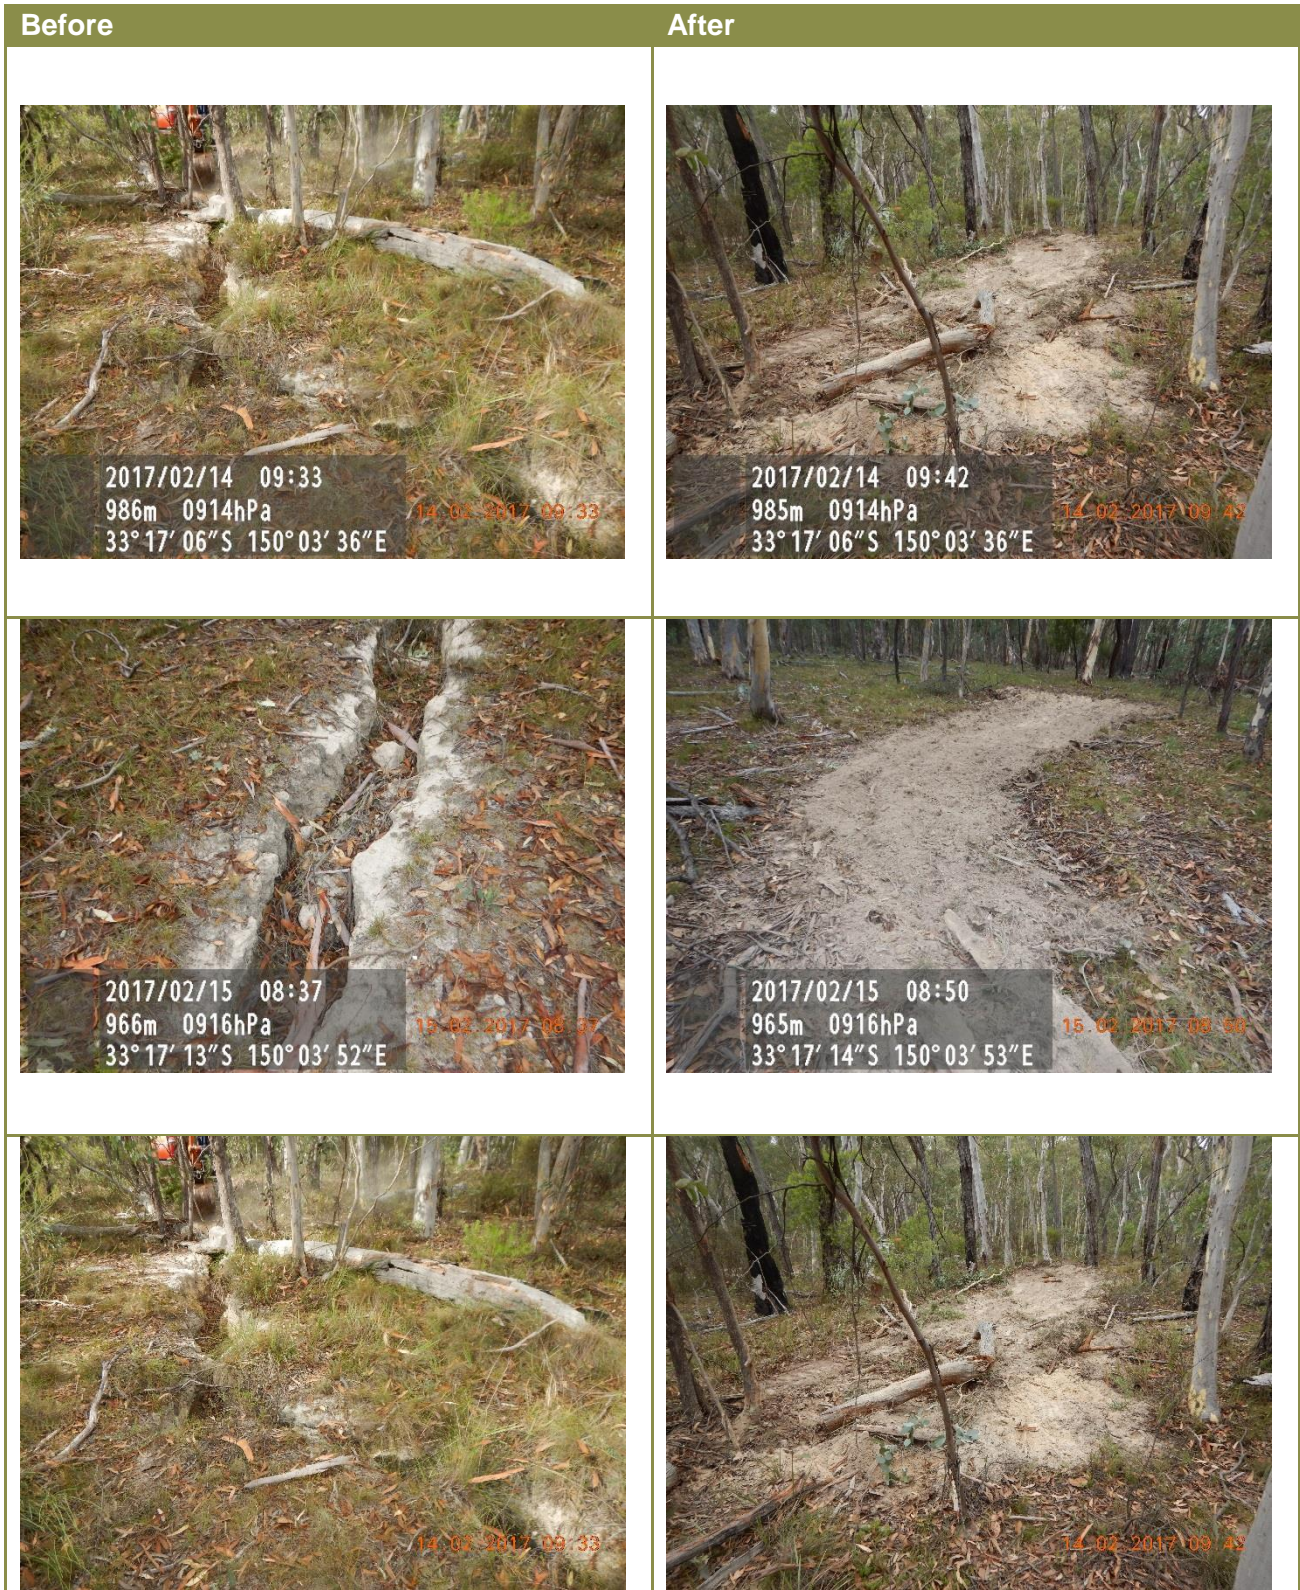
Plate 1: Before and after photos of shallow cover subsidence repairs in February 2017.

The high risk subsidence cracks identified during the steep slope survey (April 2015) were progressively remediated during the second half of 2015. In February 2017 Baal Bone Colliery remediated a number of subsidence cracks in the shallow cover area over LW16-18a within CCL 749 (refer to **Plate 1**).
