Liddell Coal Annual  
Environmental  
Management  
Report

# Liddell Coal Annual Environmental Management Report – Revision 1

January - December 2013

Liddell Coal Operations Pty Ltd

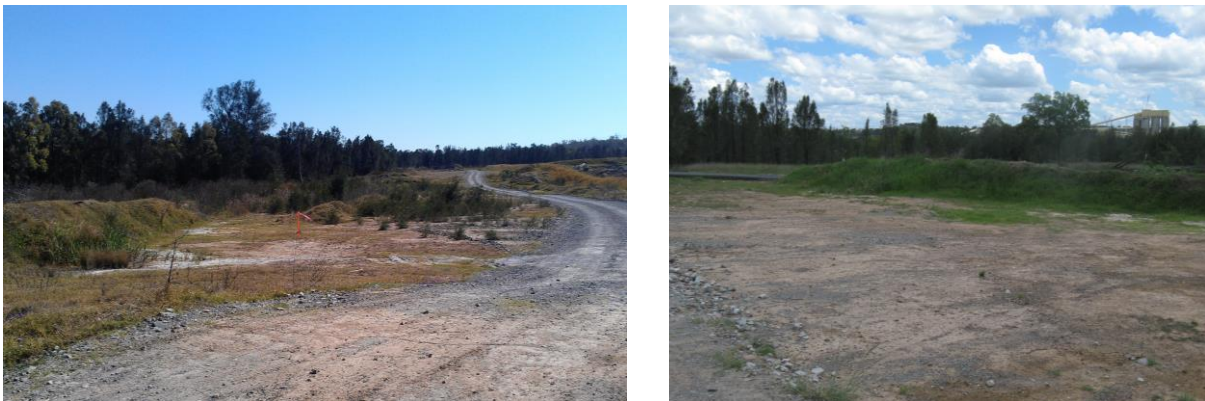
Figure 4 Image of drill site FYC1261 prior to drilling works (left) and immediately after drilling operations (right)

Rehabilitation works were completed including seeding of cleared areas. See Figures 4 and 5 for pre and post drilling site photos.

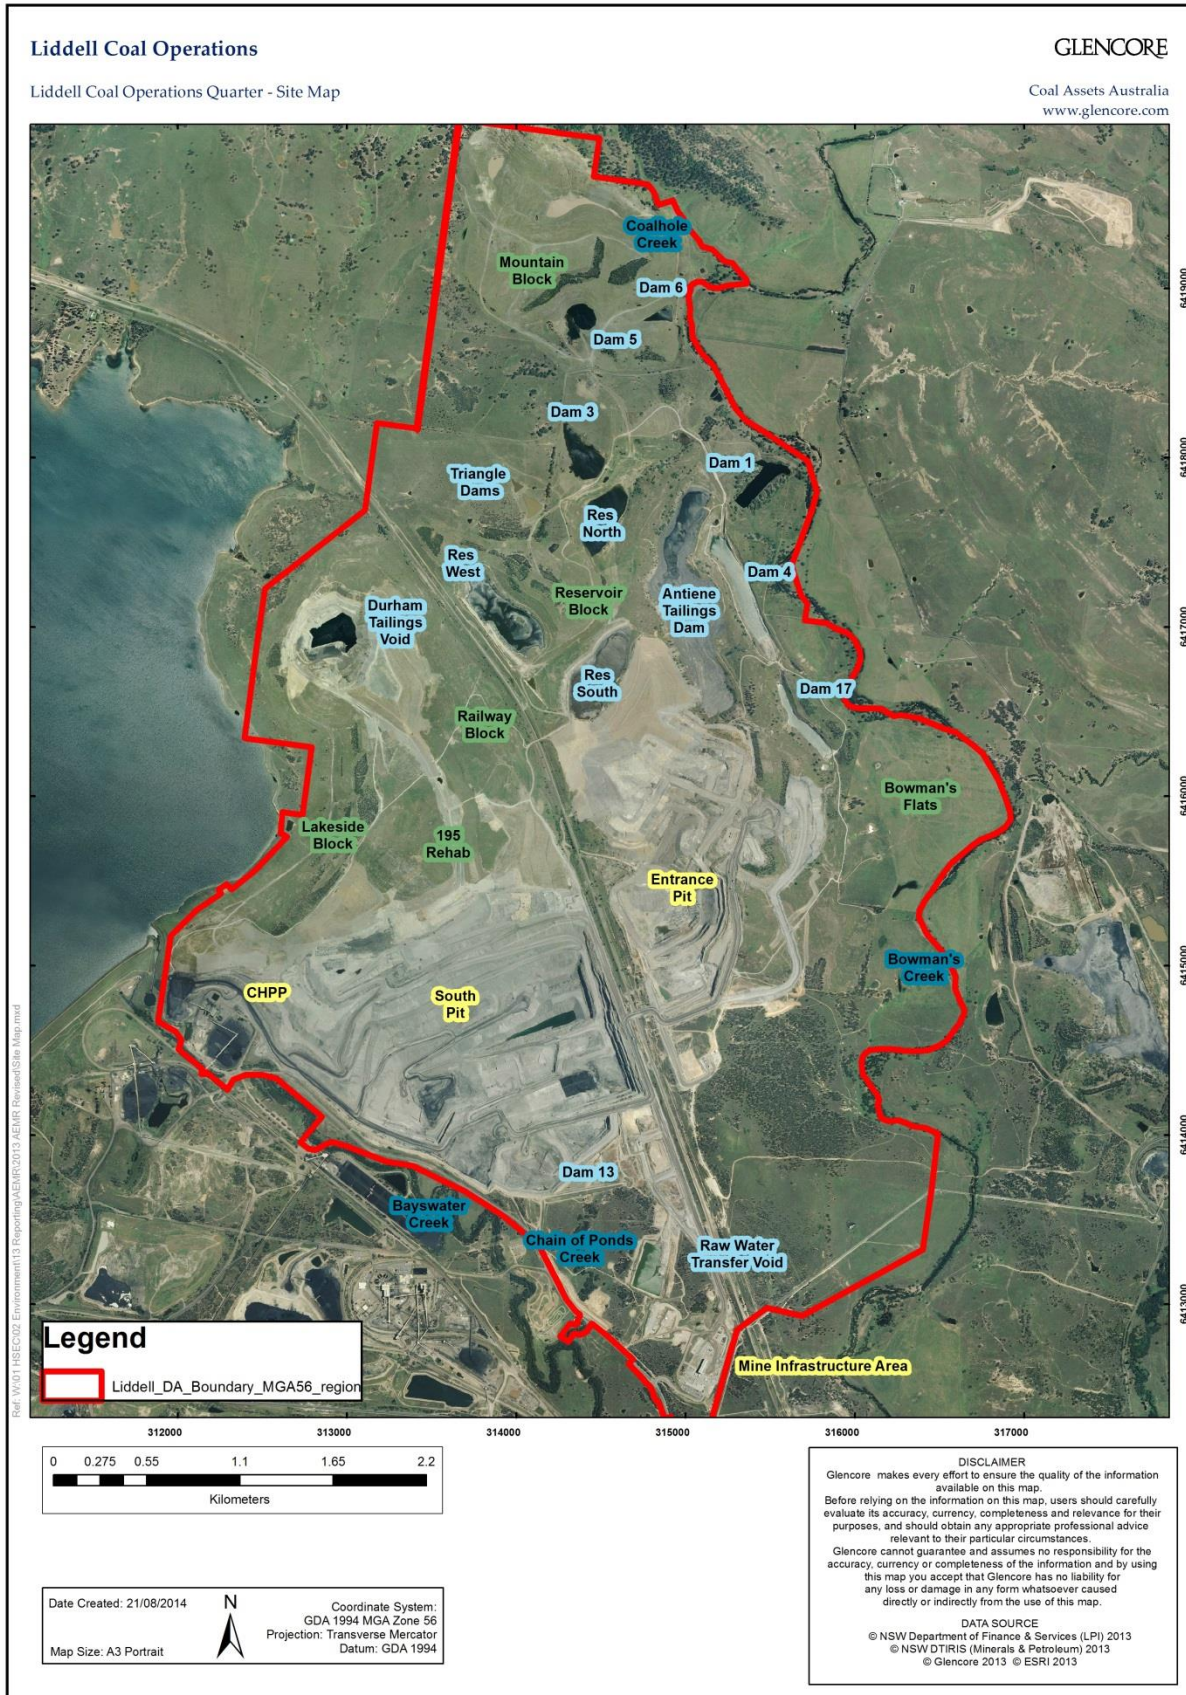
Figure 6 Map of key site features

Mining activities were carried out generally in accordance with the Liddell Coal MOP. During the reporting period active mining areas included South Pit and the Entrance Pit. During 2013, the Durham Pit was being converted to a tailings emplacement area. Figure 6 identifies the key site features including operational area, infrastructure and other notable features.

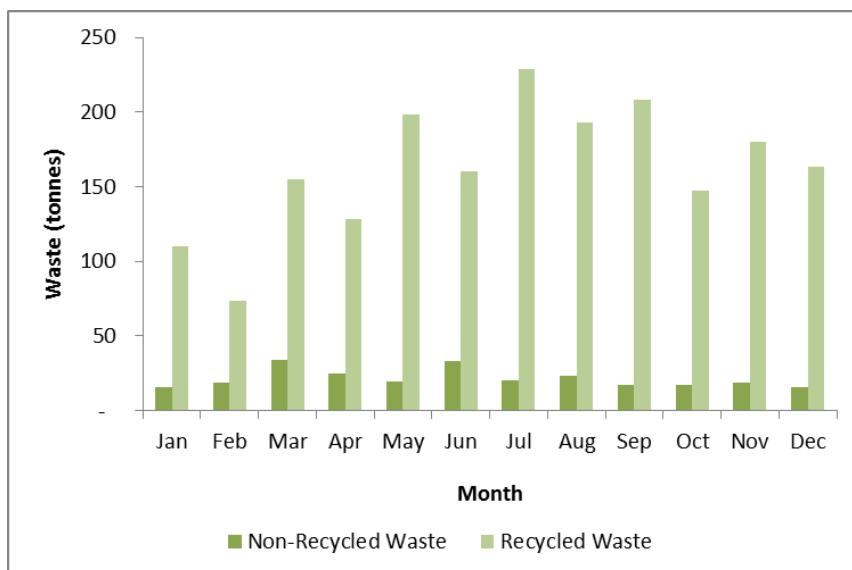
**Figure 7 Total monthly non-recycled waste vs recycled waste 2013**

All waste generated by LCO is stored onsite and removed for recycling or disposal by licensed contractors. During the reporting period, LCO sent 250 tonnes of non-recyclable waste to landfill and recycled 1,946 tonnes of waste Figure 7 shows non-recycled waste versus recycled waste during 2013.

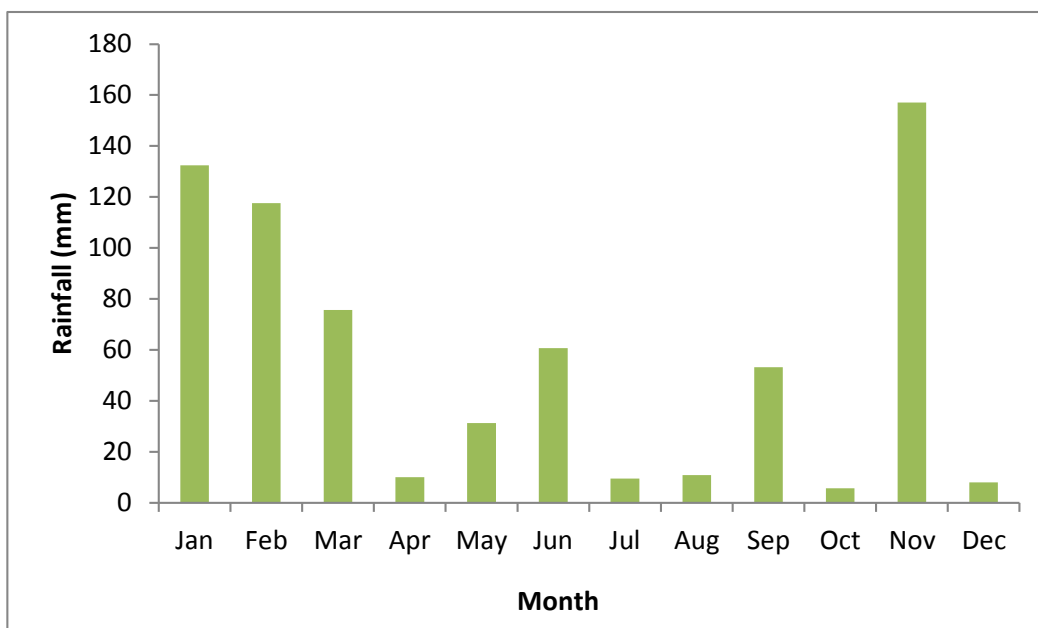
Figure 9 Total monthly rainfall January – December 2013

Total annual rainfall for the reporting period was 671.4mm. The highest daily rainfall of 71mm was recorded in November 2013. The wettest month was November, with 157mm of rainfall recorded, while the driest month was October, recording only 5.6mm of rainfall. The total monthly rainfall data for the monitoring period is shown on Figure 9.

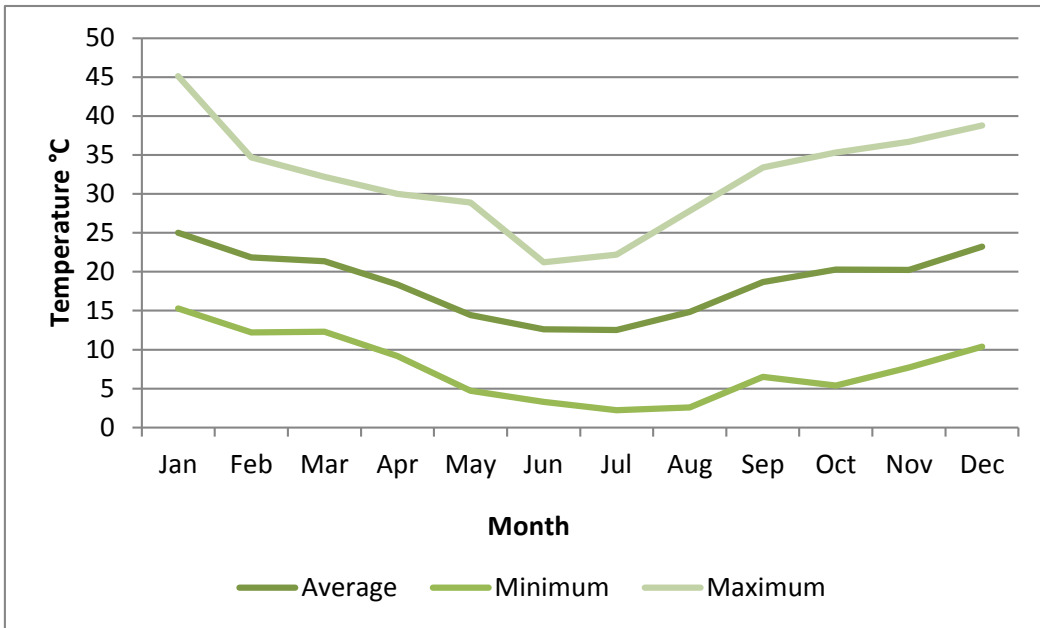
Figure 10 Minimum, average and maximum monthly temperatures January – December 2013

The average daily temperature recorded at the meteorological station varied from 12.5°C to 25.0°C during the reporting period. On average, July 2013 was the coolest month, and January 2013 was the warmest month. The temperature data was consistent with standard seasonal patterns.

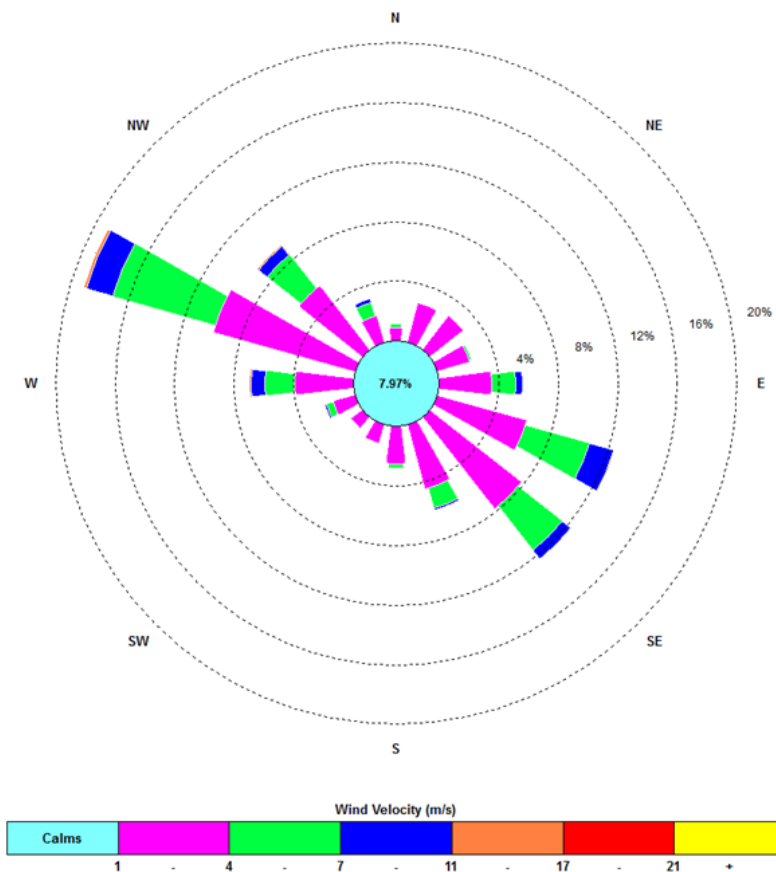
Figure 11 Annual Wind Rose 2013

Seasonal patterns for wind direction are evident at LCO. During the summer and autumn months (November to April) wind direction is predominantly south east. In comparison, during the winter and spring months (May to September) the prevailing wind direction is north-west. Wind directions are referenced to magnetic north.

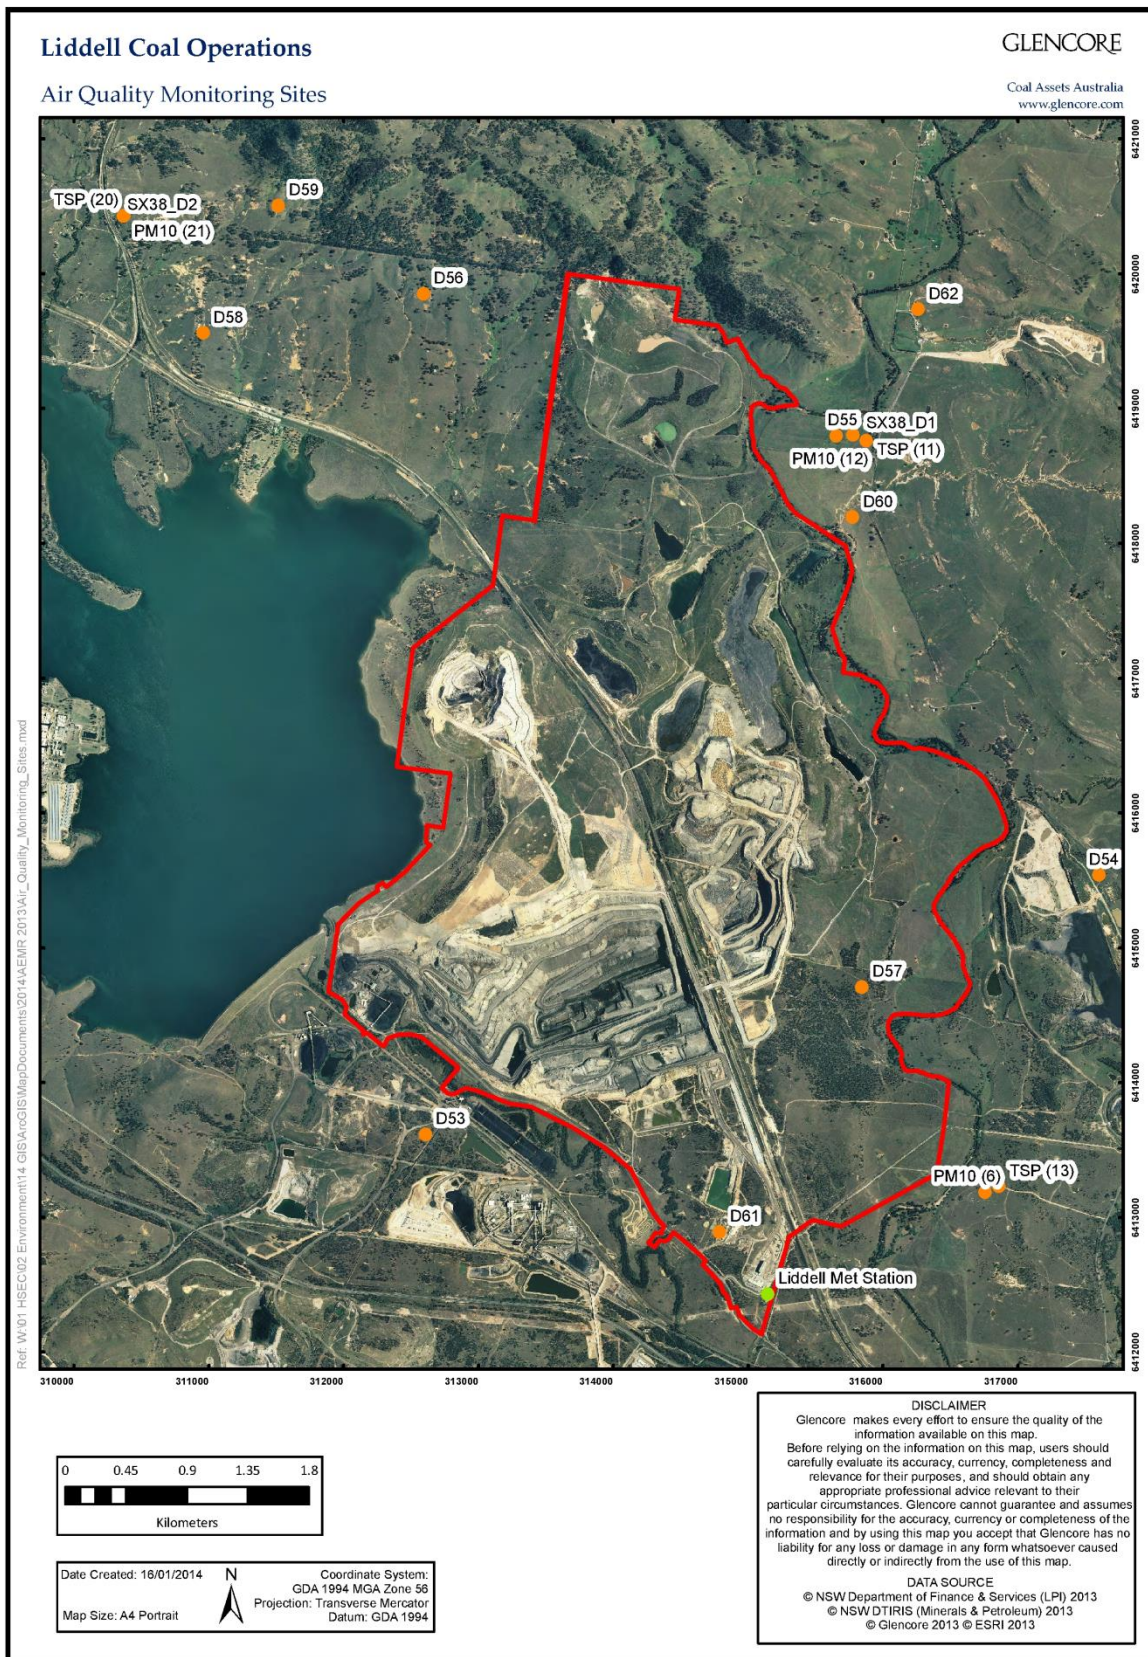
Figure 12 LCO Air Quality Monitoring Sites

The LCO air quality monitoring network is shown in Figure 12. The LCO air quality monitoring network comprises ten deposited dust gauges and six high volume air samplers (HVAS).

The location of LCO’s deposited dust gauges are shown on Figure 12.

LCO operates three High Volume Air Samplers (HVAS) which sample Total Suspended Particulates (TSP), as shown in Figure 12. In accordance with the Air Quality Monitoring Program and EPL requirements, TSP is measured by the samplers every six days.

LCO operates three HVAS which sample fine particulates with an aerodynamic diameter of less than 10 microns (PM<sub>10</sub>), as shown in Figure 12. In accordance with the Air Quality Monitoring Program and EPL requirements, PM<sub>10</sub> is measured by the samplers every six days.

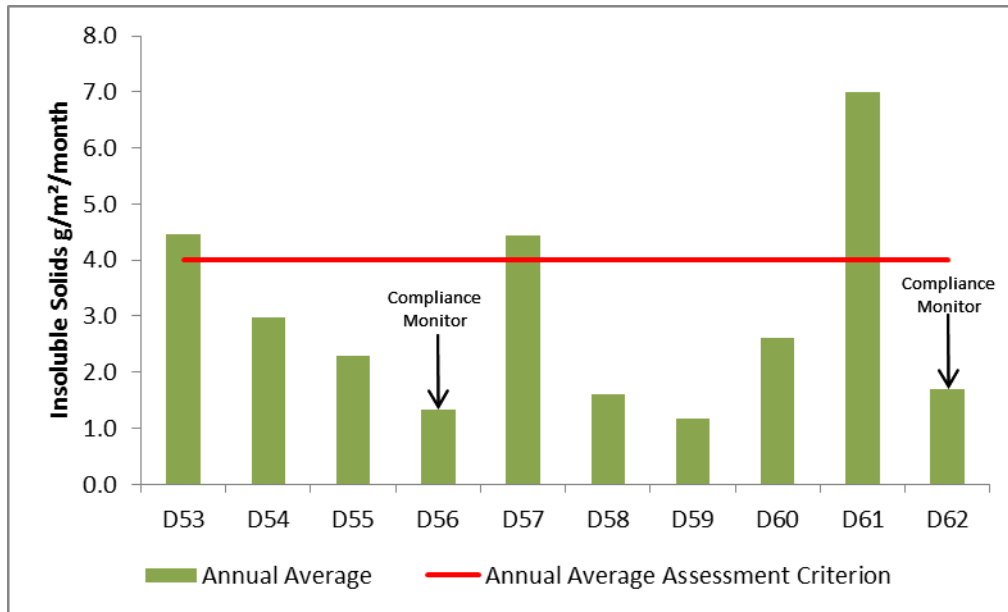
Figure 13 Deposited Dust - Annual Average Insoluble Matter

Two dust gauges maintained by LCO are representative of private residences (D56, and D62). During the reporting period both monitoring sites met the annual average criteria. The remaining eight dust gauges are representative of mine owned residences and are used for internal management purposes.

Data recovery for the ten dust deposition gauges varied between 16% and 100%. Gauges that had high levels of contamination throughout the reporting period included D57 and D60. Gauges can become contaminated with organic material such as bird droppings, insects, vegetation or algae growth and the contamination of gauges is determined on the basis of field observations and laboratory analysis. The contaminated results were not included when calculating the annual average results.

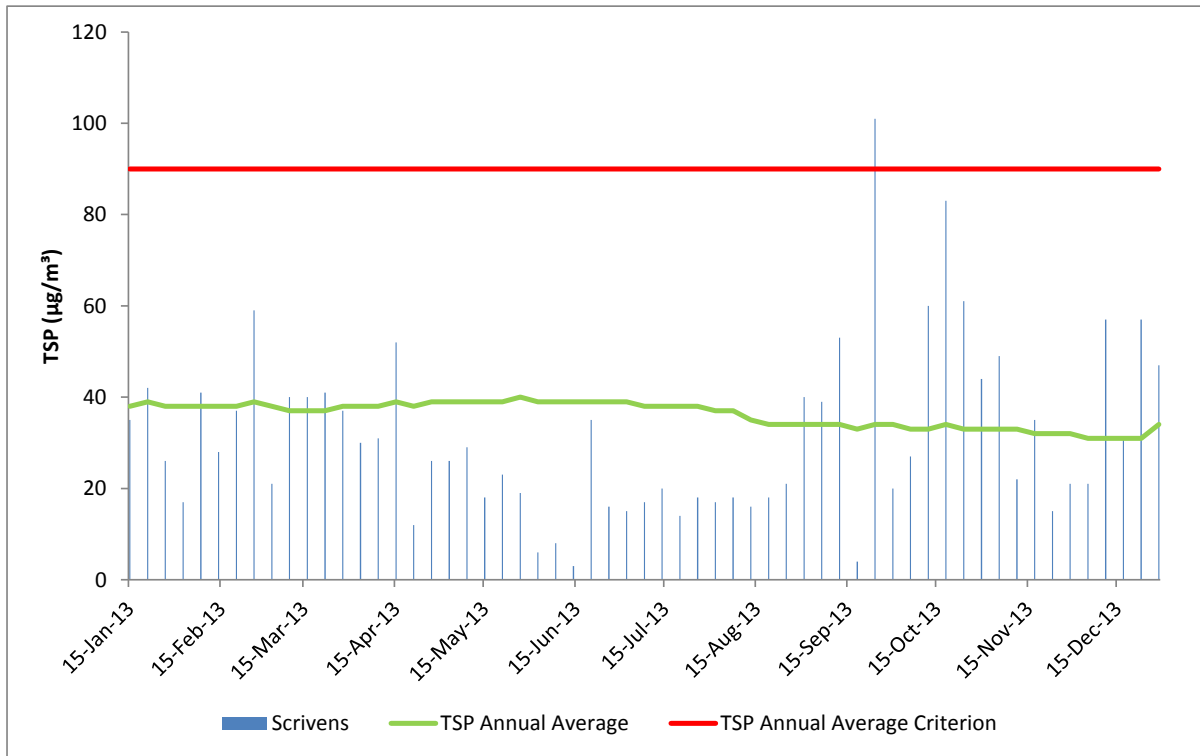
Figure 14 Annual Average HVA5 TSP Results – Scrivens (HVA511)

During the reporting period LCO complied with the TSP annual average goal ( $90\mu\text{g}/\text{m}^3$ ) at the Scrivens property (HVAS 11) and Antienne (HVAS20). The Scrivens property is privately owned land. The annual average TSP at HVAS 11 was  $34\mu\text{g}/\text{m}^3$  with a maximum concentration of  $101\mu\text{g}/\text{m}^3$  (recorded on 24 September 2013). HVAS20 (owned by LCO) was commissioned in May 2010. The annual average TSP at HVAS 20 was  $50\mu\text{g}/\text{m}^3$  with a maximum concentration of  $110\mu\text{g}/\text{m}^3$  (recorded on 31 August 2013).

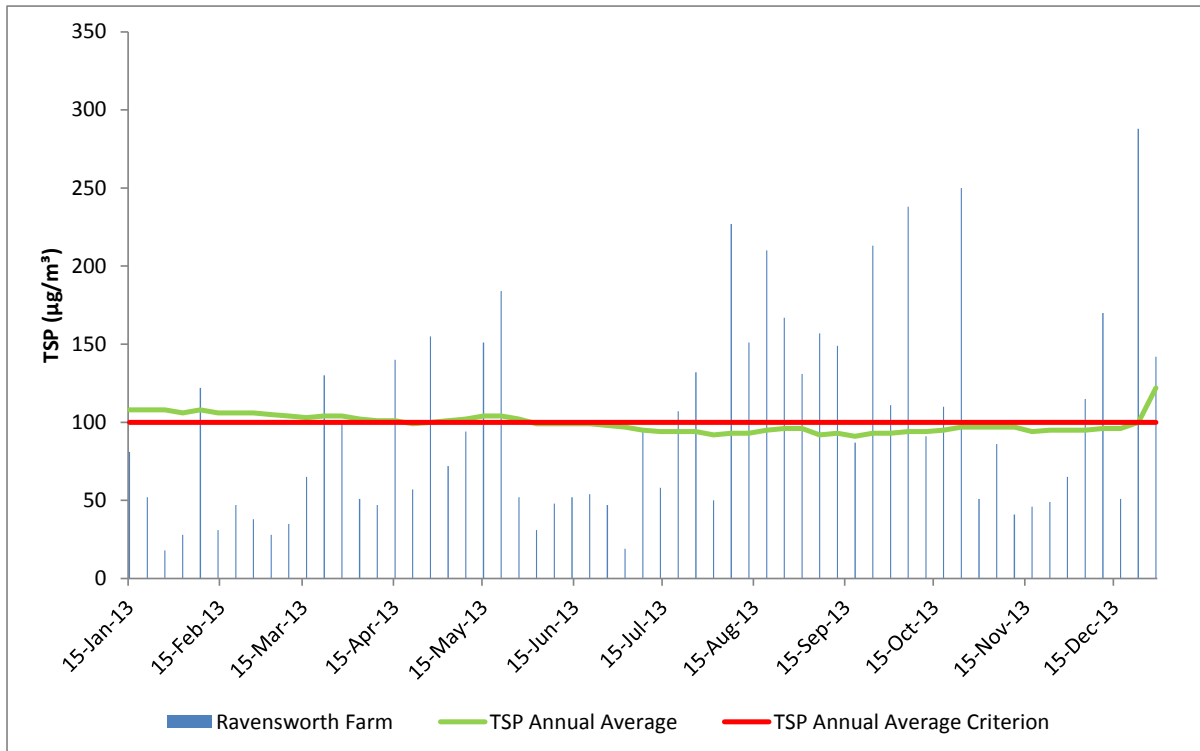
Figure 15 Annual Average HVA5 TSP Results – Ravensworth Farm (HVA513)

Ravensworth Farm, located on mine owned land (HVAS 13) is not a compliance monitor and is used for on-site management purposes only. To date, there has been a private Licence Agreement with the tenant to allow an alternative air quality criterion of  $100\mu\text{g}/\text{m}^3$ . This criterion was exceeded during the 2012 reporting period, with an annual average of  $120\mu\text{g}/\text{m}^3$  being recorded. As a result of ongoing monitoring indicating that dust levels were approaching agreed trigger levels, the rental agreement was terminated during 2012 and the property is now vacant. The maximum TSP concentration recorded at HVAS 13 during the reporting period was  $288\mu\text{g}/\text{m}^3$  on 23 December 2013. This result is likely to have been due to a regional scale air quality event as the Upper Hunter Air Quality Monitoring Network (UHAQMN) monitors at Camberwell, Maison Dieu, Singleton and Mt Thorley also showed elevated results on this day.

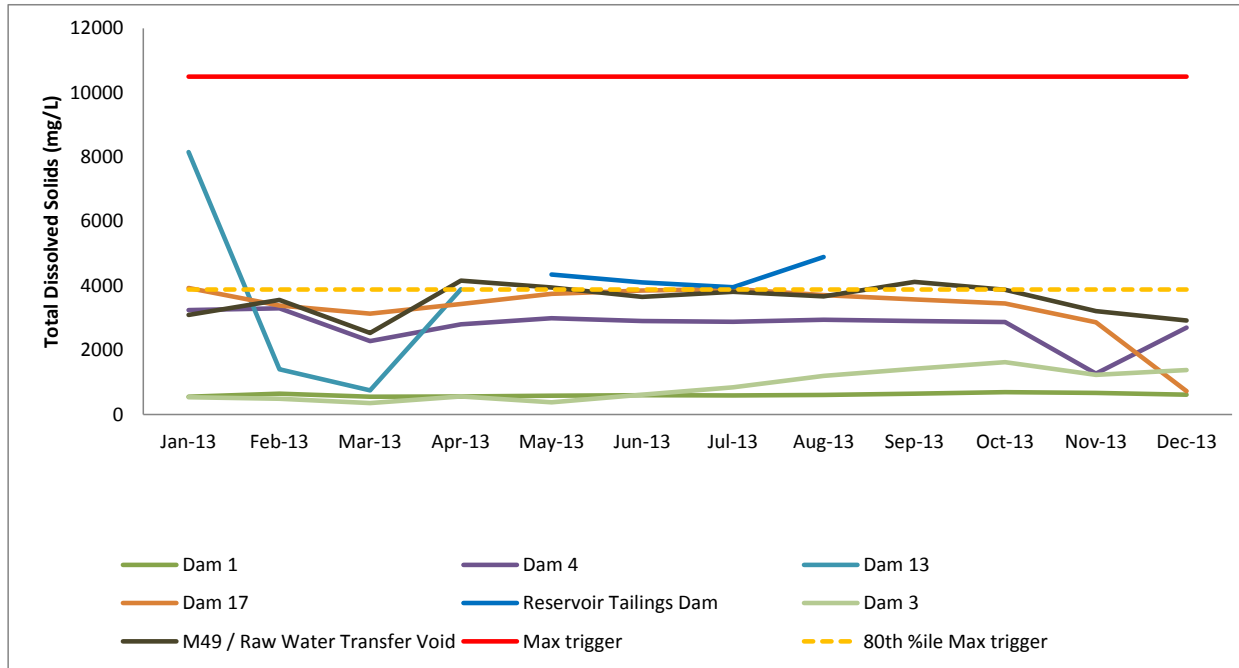
**Figure 355 On Site Dams Surface Water TDS 2013**

The monitoring results for TDS for On Site Dams are shown on Figure 35.

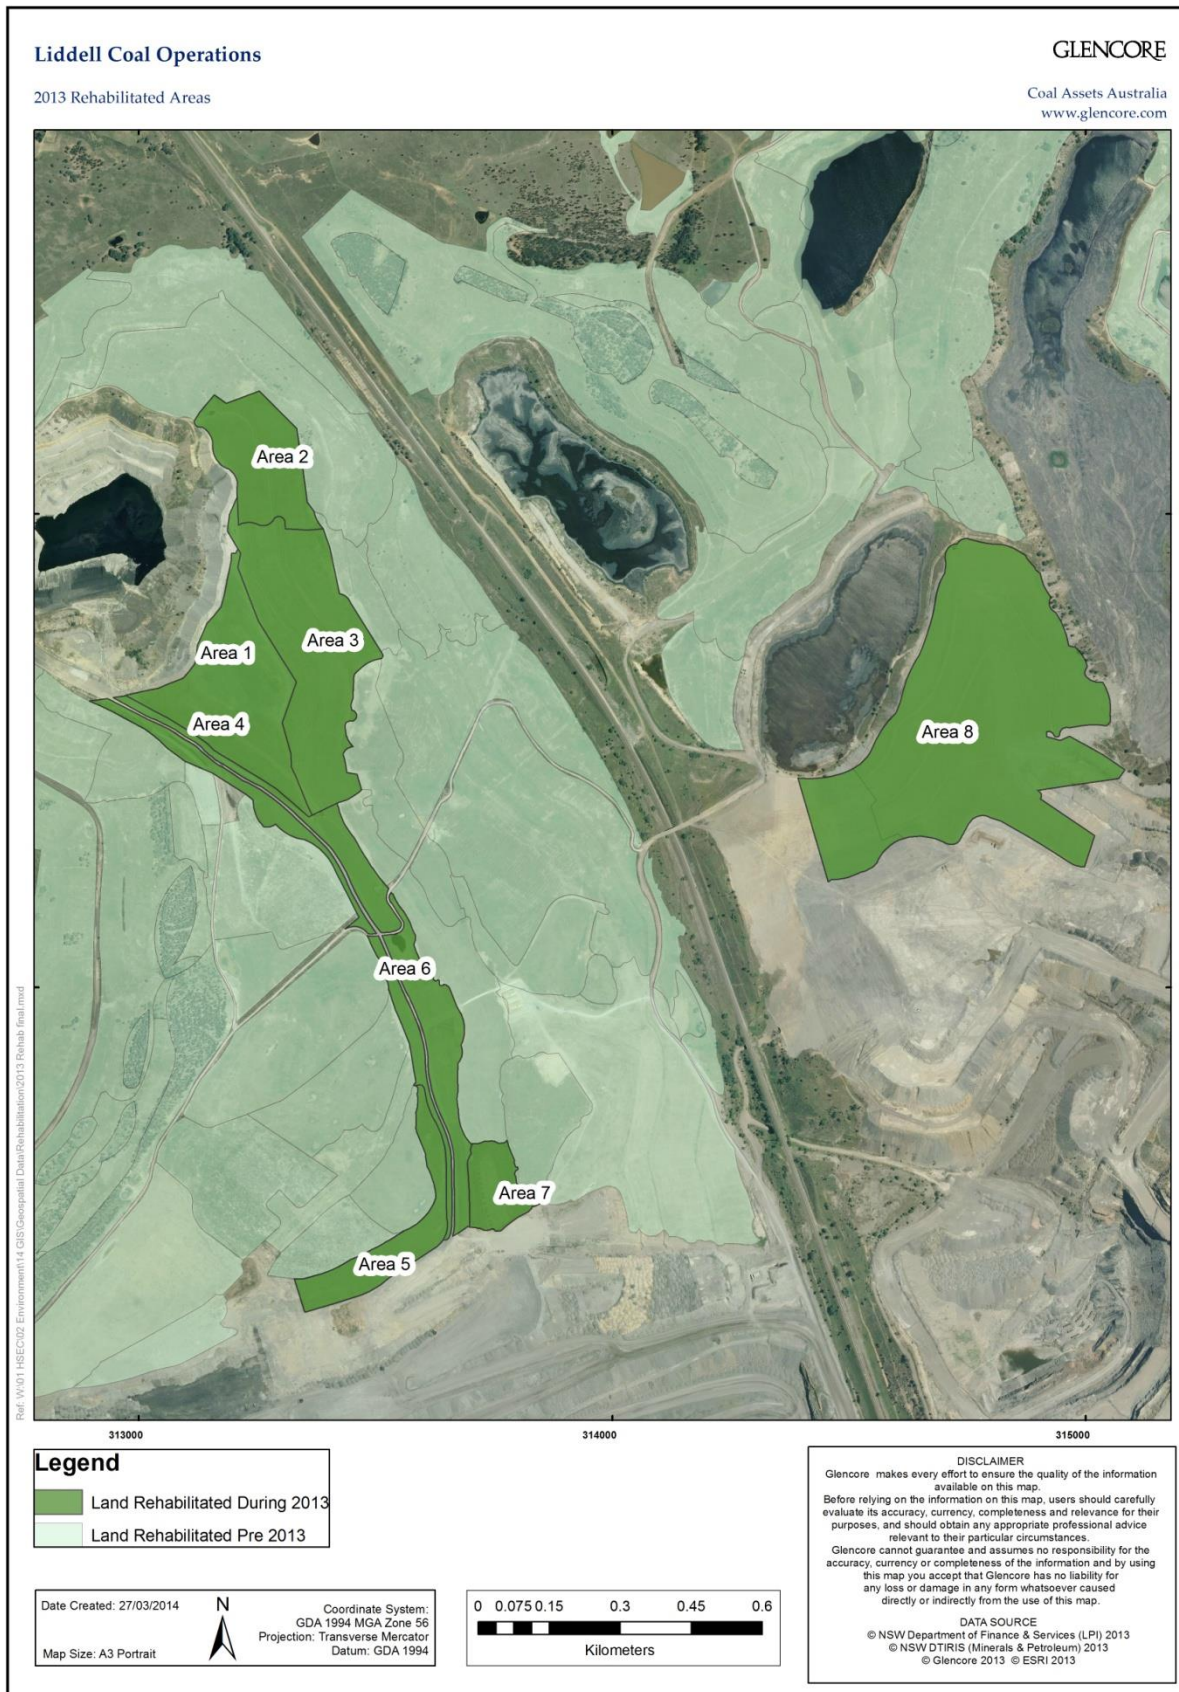
Figure 52 2013 Rehabilitated Areas

Domain	D6	Reveg Date:	9 Aug. 2013	Area:	25.2ha
<p><b>Name:</b> Entrance Northern Slope 160-192RL  <b>Land Use:</b> Temporary Rehabilitation  <b>Seed/Plant Mix:</b> Liddell summer pasture seed mix</p> <p>It is anticipated that this rehabilitation will be largely re-disturbed during capping operations of the final Antiene and Reservoir tailings emplacement to the North. Landform shaping completed in Quarter 2 2013 comprising of stable north facing slope from RL160 level (adjacent two tailings emplacements) to RL192. Contour banks were constructed to control surface water drainage and will connect with a proposed drop structure to the west once landform shaping in that area is complete. Substrate consists of typical rocky overburden. Area rock raked with local topsoil spread at 100mm thick. The area was ripped to 400mm then shallow contour ripped to 150mm prior to seeding which was undertaken immediately following site preparation. Liddell summer pasture seed mix applied using locally sourced seed (see Table 5.1 for details) with Granulock 15 fertilizer applied at 360kg/ha.</p> <p><b>Status/Progress:</b> Good strike rate and germination of cover crops with rain late November 2013. No significant erosion evident. Continue monitor and apply maintenance measures as necessary.</p>
