Compliance Lighting Audit

Prepared for Liddell Coal Operations Pty Ltd | 10 June 2015

Report J15042RP1 | Prepared for Liddell Coal Operations Pty Ltd | 10 June 2015

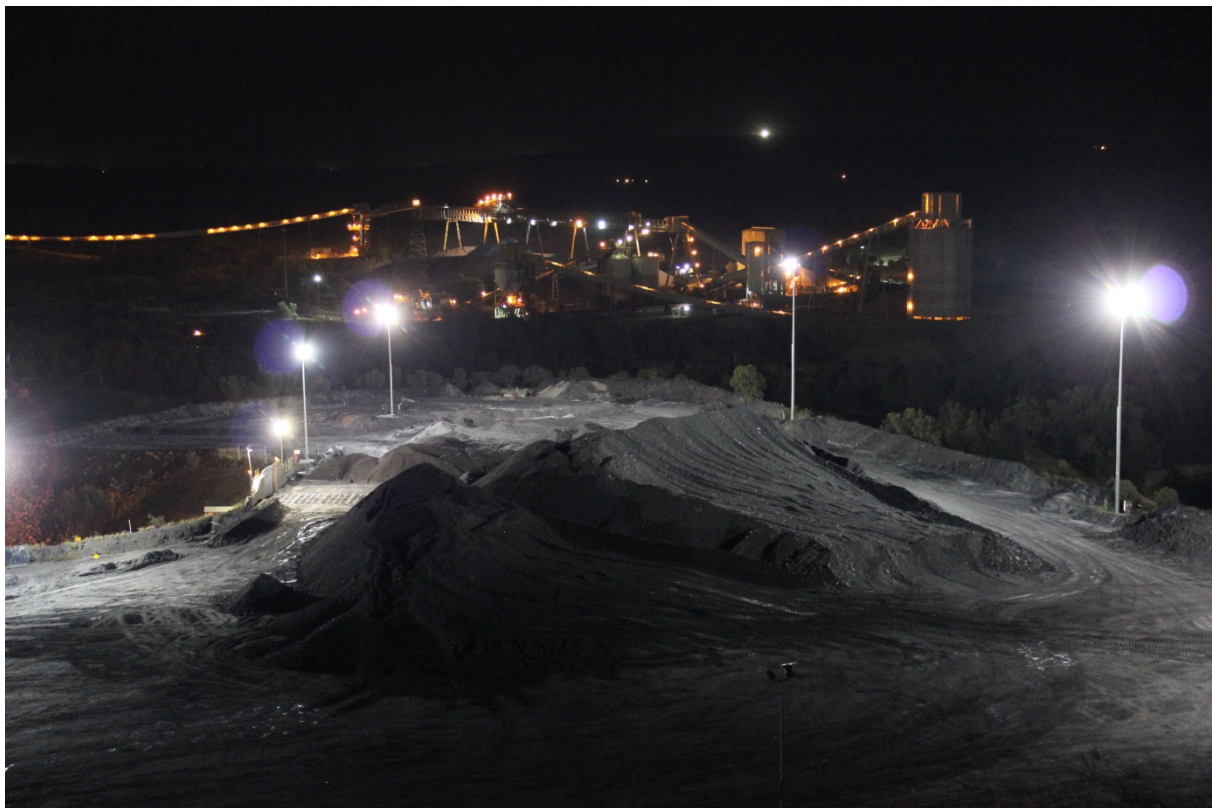
Free-standing light structures are common in operational areas such as the ROM and product stockpile areas, as the height of towers allows significant areas to be illuminated with minimal fittings. These types of structures, however, if not positioned correctly can result in significant light spill. Examples of the light towers are shown around the product stockpile in Photograph 3.1.

Photograph 3.1 Large free-standing lighting structures to product stockpiles

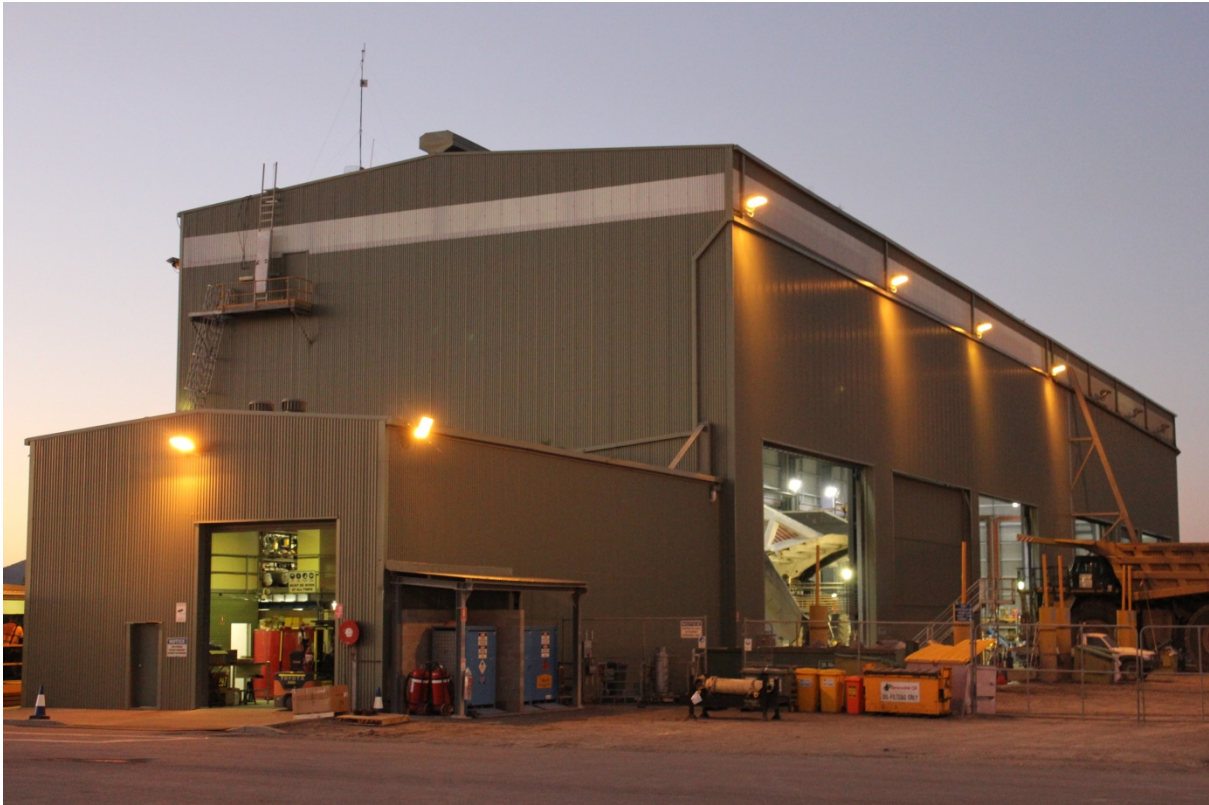
Fixed lighting structures are common around the workshops and infrastructure areas and provide lighting for safe movement of vehicles and personnel. Fittings of this type are for the most part shrouded similarly to the fitting seen attached to the workshop in Photograph 3.2, to ensure the beam is directed downward to light only the area below.

Photograph 3.2 Fixed lighting structures

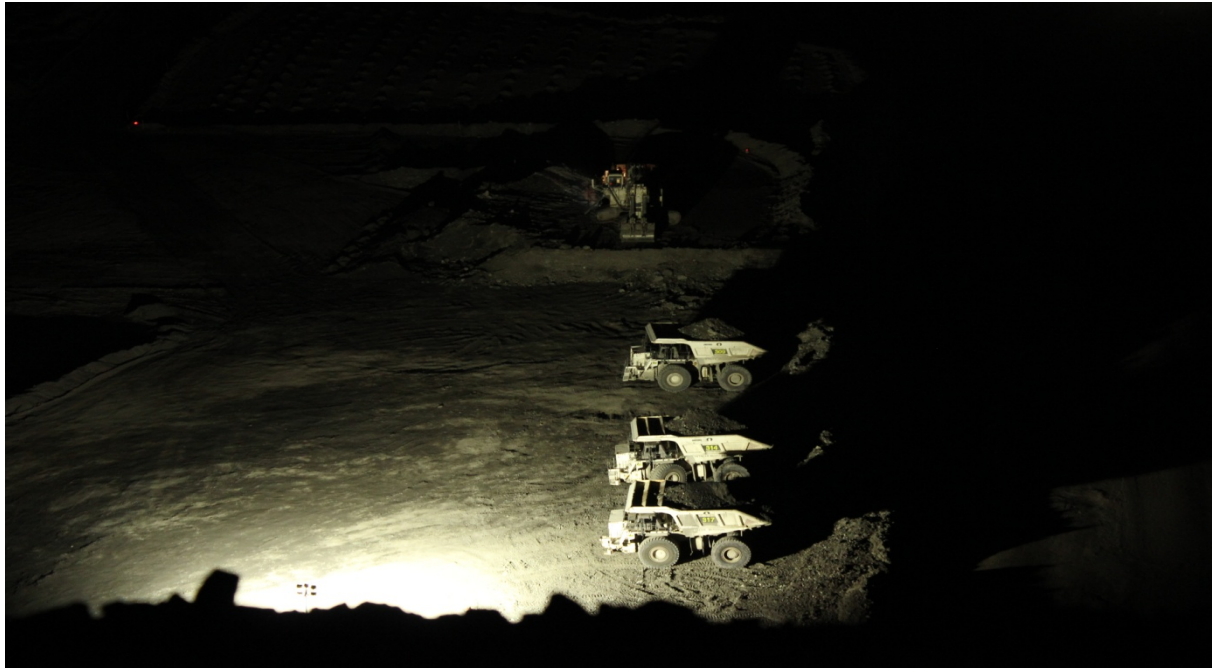
Temporary lighting plants are used around the mine to provide targeted light to operational areas with the benefit that they can be relocated and repositioned according to need. Temporary lighting plants, such as the type shown in Photograph 3.3 can, if positioned correctly, offer effective light without unwanted light spill to external receptors.

Photograph 3.3 Temporary lighting plant used to illuminate work area in the pit and overburden dumps

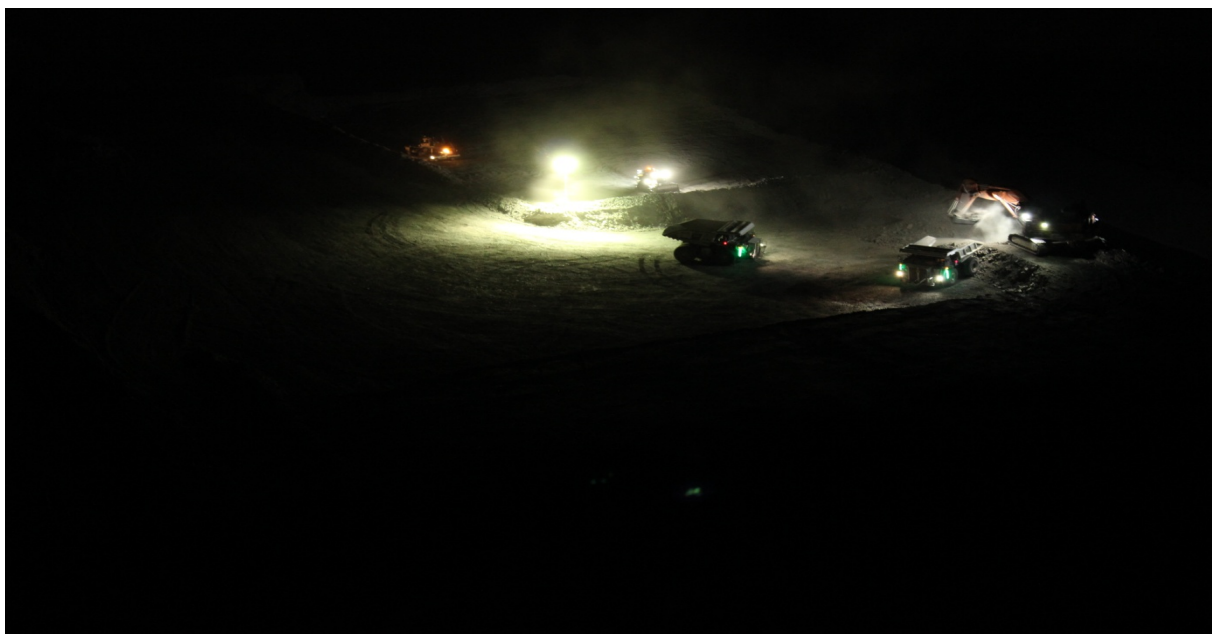
Lighting incorporated in to machinery such as excavators, haul trucks and loaders provided direct lighting on the workspace and reduce the need for additional lighting. LED lighting, such as the type fitted to the haul truck shown in Photograph 3.4, provide targeted lighting that eliminates light spill from the work area. Light to haul trucks further reduces the need for lighting along haul road which would create the potential for further contributions to skyglow.

Photograph 3.4 Lighting on excavators and haul trucks reduce need for additional lighting

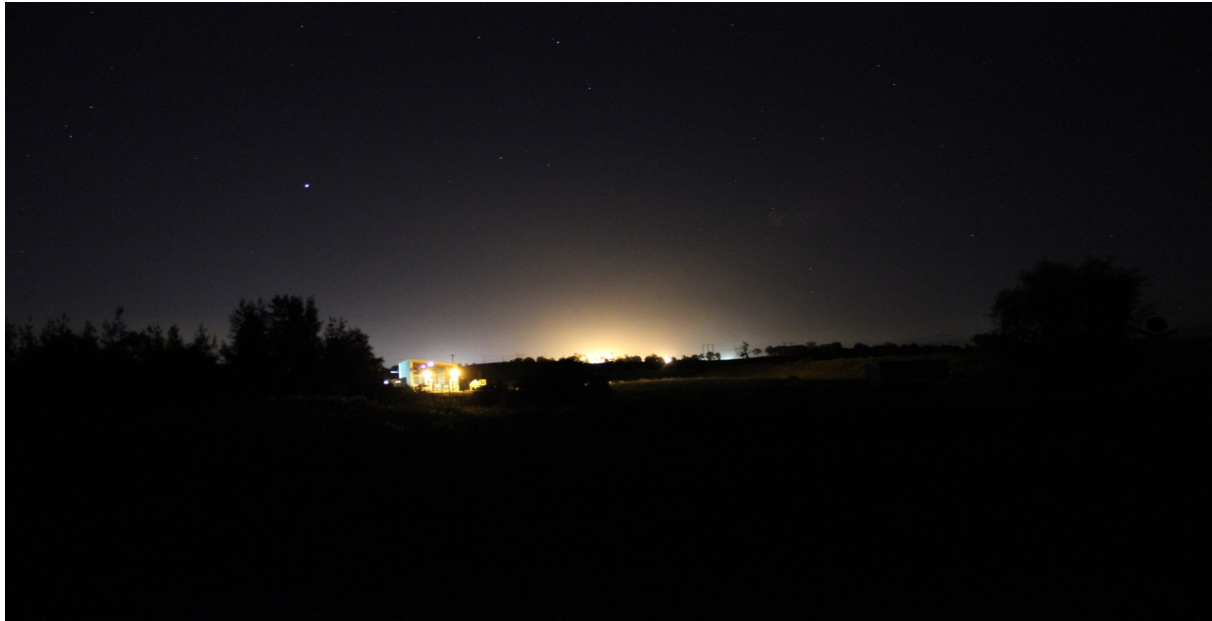
At a distance of approximately 1.8 km from the maintenance area and sheds, VP1 is a representative receptor for the New England Highway. From this location, lighting associated with the maintenance area and sheds is evident but unobtrusive. The light fittings associated with these are predominantly of the HPS type that emits a soft light. The number of light fittings associated with the mine infrastructure area and workshops, results in a large soft band of orange illumination in the viewscape from VP1 at night.

The most prominent lighting evident from this viewpoint is skyglow. It is noted that the inspection was undertaken on a night with clear skies. Skyglow is more prevalent when cloud cover is present.

Photograph 4.1 View taken from external viewpoint 1 facing north-west towards the maintenance area and sheds

During times when maintenance is not occurring or the workshop is shutdown, Liddell Coal could review the necessary lighting in order to reduce the amount of light spill from this area.

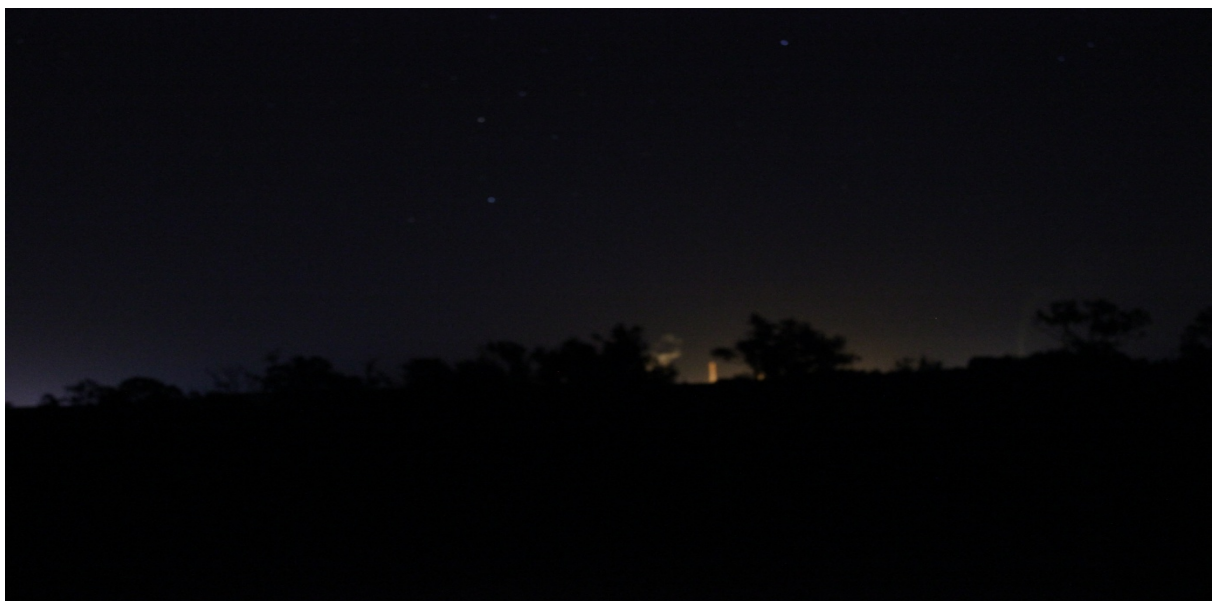
At a distance of approximately 4.6 km to the nearest lighting source, any direct views of lighting structures are obscured by the presence of a ridge which sits between the mine and this viewpoint. This viewpoint represents the closest residential receptor to the mine.

A negligible level of skyglow was present at this location at the time of inspection. No improvements are currently required to address lighting impacts from the viewpoint.

Photograph 4.2 View taken from external viewpoint 2 facing south-west towards the Entrance Block pit

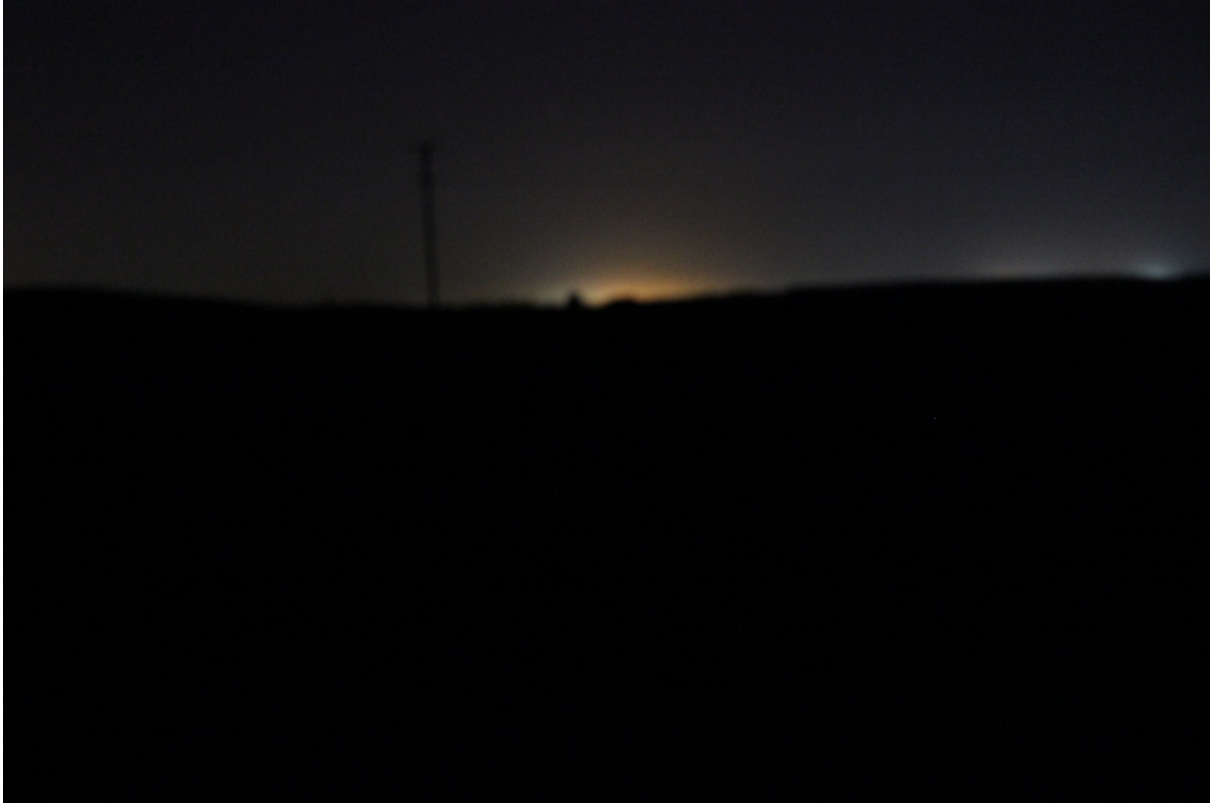
At a distance of approximately 6.5 km, this viewpoint represents the highest residential receptor in Hebden and to the north-east of the mine. As can be seen in Photograph 4.3, no lighting structures are visible from the mine and skyglow is negligible.

Photograph 4.3 View taken from external viewpoint 3 facing south-west towards the Entrance Block pit

No improvements are currently required to address lighting impacts from the viewpoint.

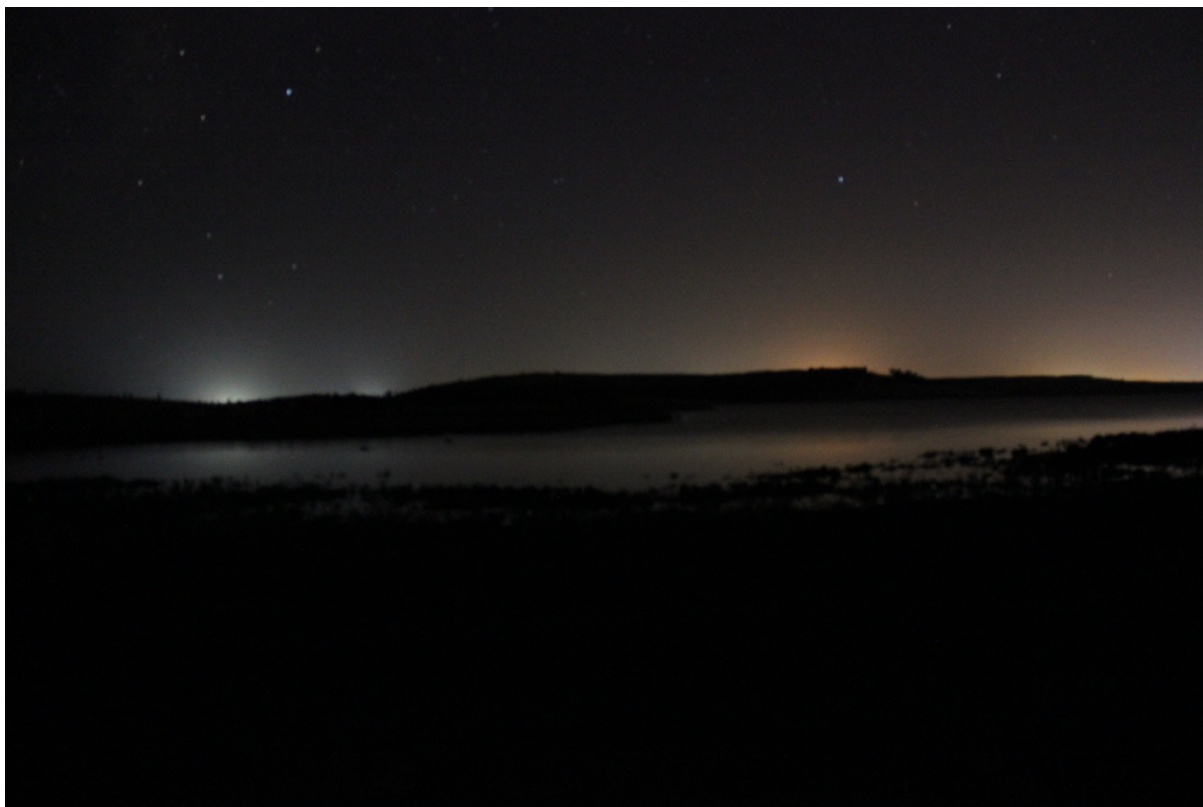
At a distance of approximately 4.1 km the nearest lighting source to the Lake Liddell recreational area is the CHPP and South Cut pit. Photograph 4.4 shows HPS skyglow emitted from lighting at the CHPP and metal halide skyglow from operations in the Entrance and South Cut pits.

It is noted that the inspection was undertaken on a night with clear skies and skyglow is more prevalent when cloud cover is present however the reflection from Lake Liddell also contributes to the overall affect. Nevertheless, results for this location from the Lux meter show compliance with the relevant criteria.

Photograph 4.4 View taken from external viewpoint 4 facing south-east towards the Entrance Block pit

No improvements are currently required to address lighting impacts from the viewpoint.

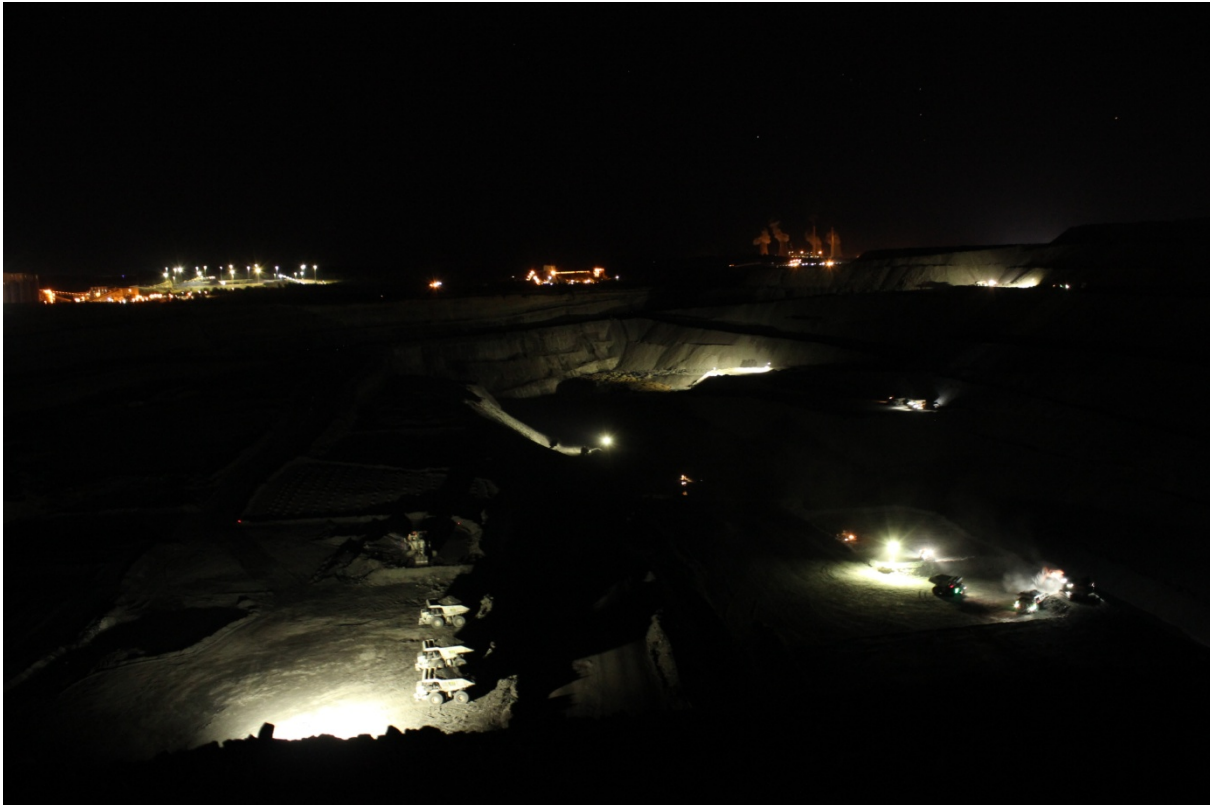
The most significant light contributor identified from this location was the maintenance area and sheds. It was also evident from this location that other mining operations and the Bayswater and Liddell Power Stations contribute to skyglow in the immediate area.

Photograph 4.5 **South Cut pit from internal viewpoint 1**

Given Liddell Coal is complying with relevant criteria, no recommendations are proposed for this area.

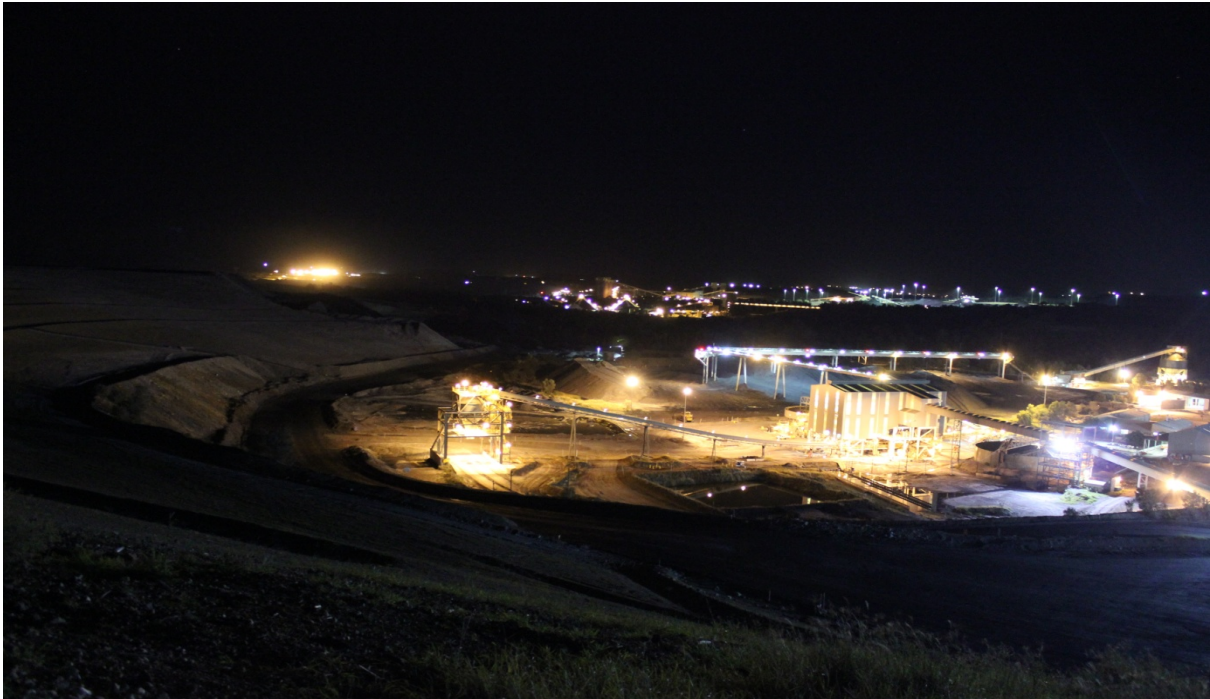
Although well lit with lighting on buildings, conveyors, light towers and the rail loading facility; the mine's CHPP is at a low reduced level with large ridges to the north and west. For this reason the CHPP is not directly visible from the closest sensitive receptors to the north and north-west. The CHPP may only be directly visible to infrequent transient receptors on the Old Hume Highway.

Lighting at the CHPP was appropriate and installed at the correct angles. To verify this, a lux reading was taken and returned a result of 0. Therefore, no recommendations are necessary for this area. It should be noted however, similar to internal viewpoint 1, the maintenance area and sheds look to be the most significant contributor of lighting at the mine.

Photograph 4.6 CHPP from internal viewpoint 2

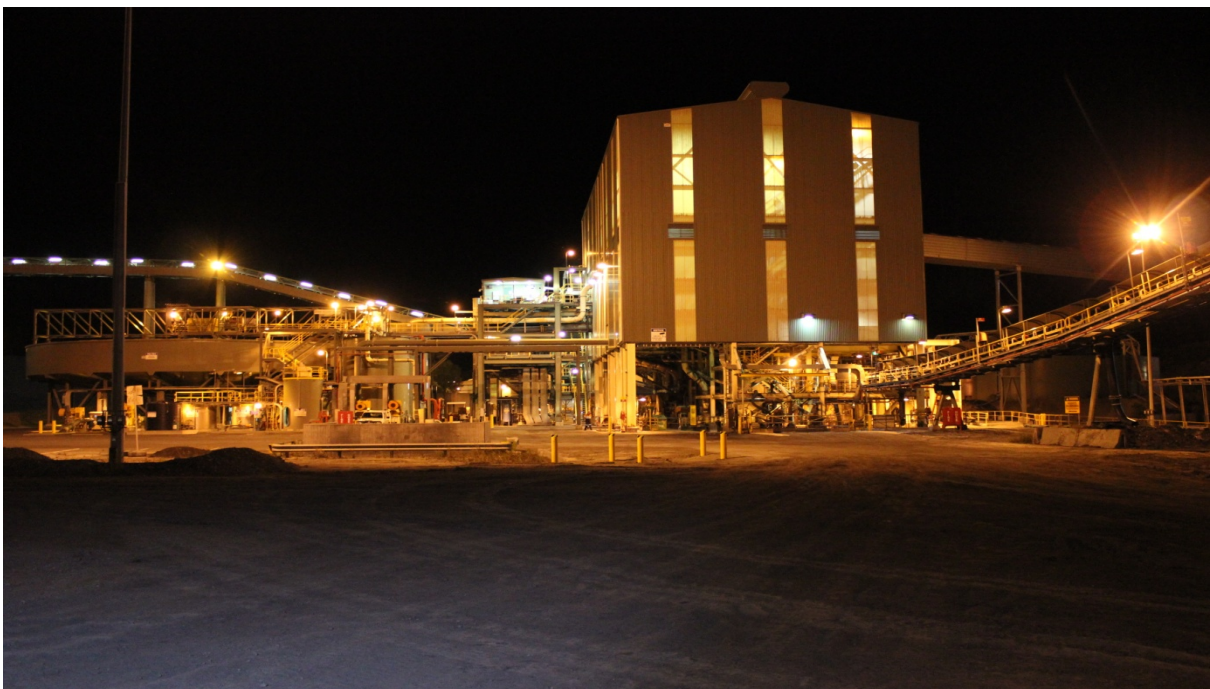
Internal viewpoint 3 was taken from within the CHPP to closer inspect the lighting within the area. Lighting was installed at the correct angles and appropriate. No recommendations are suggested for this area.

Photograph 4.7 CHPP from internal viewpoint 3

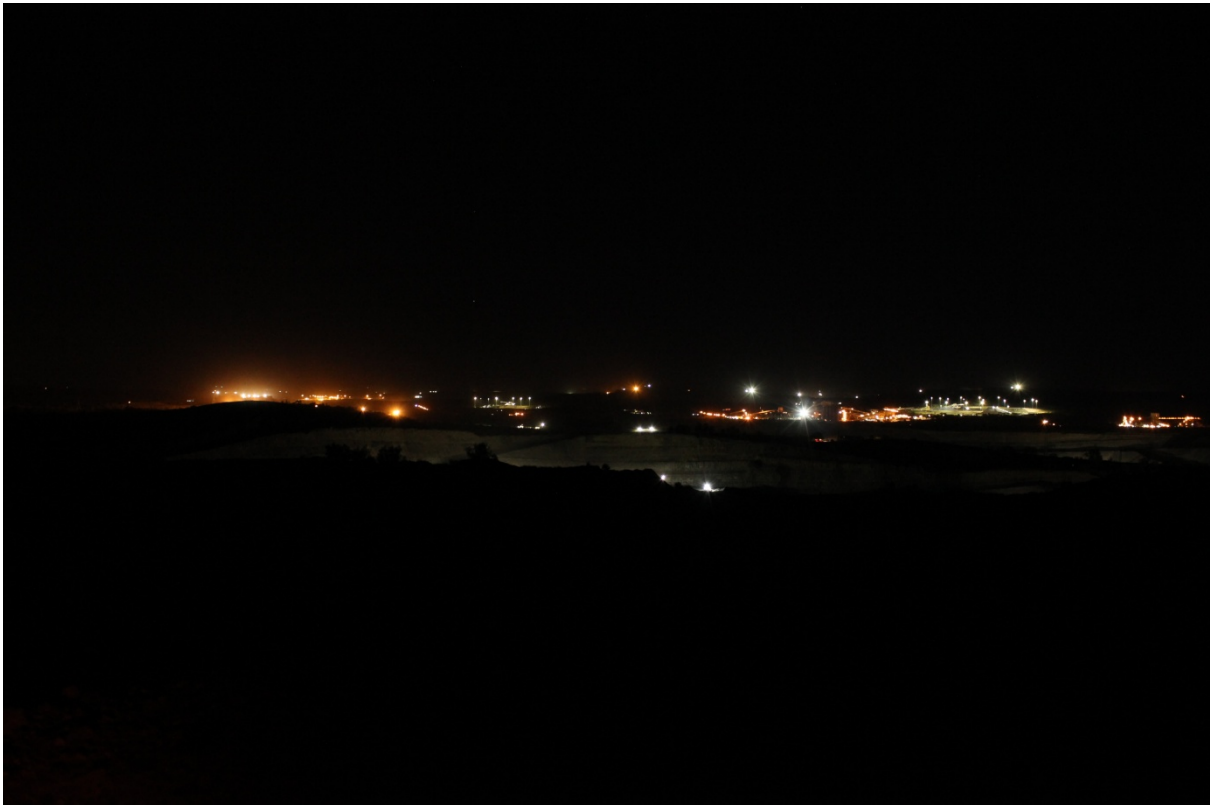
No in pit activities were visible from this viewpoint given the depth of operations. The ridge from where this viewpoint is located provides screening from direct light to all external receptors.

Photograph 4.8 Entrance Block pit from internal viewpoint 4

No recommendations are required for this area.

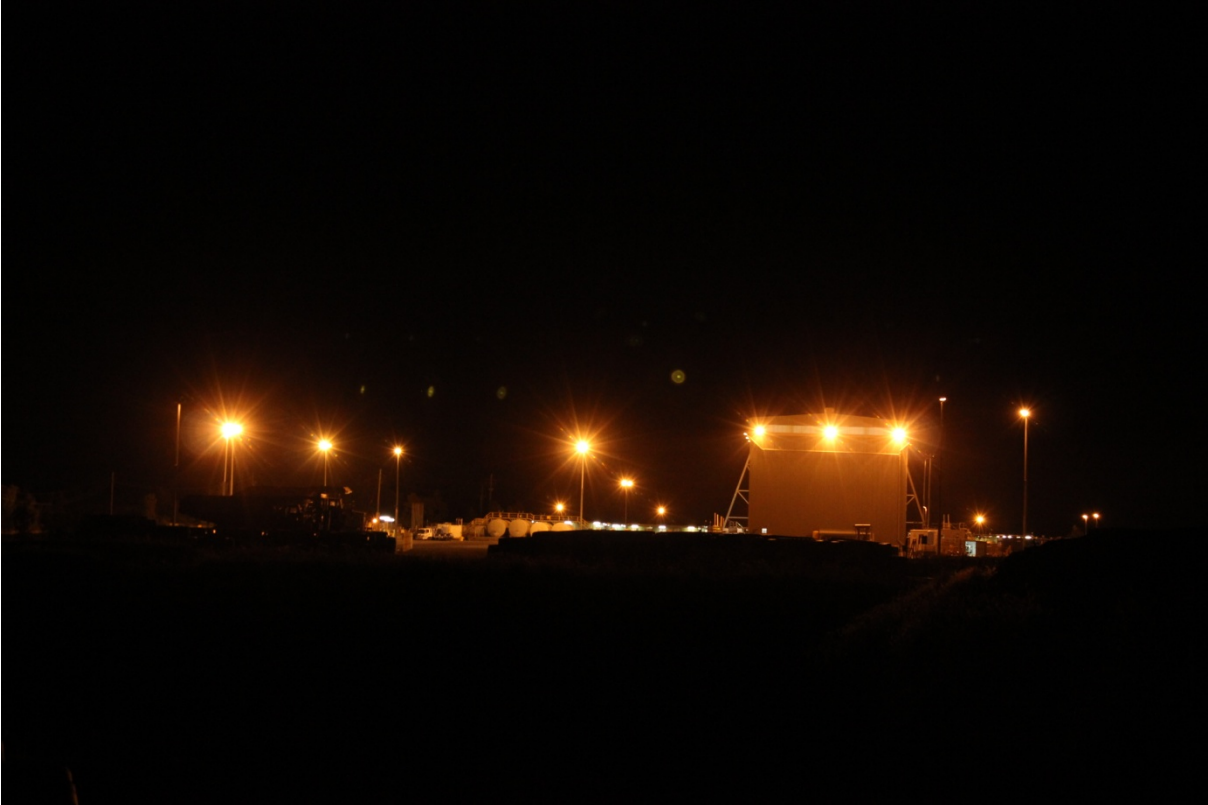
Given the high traffic volumes in the area, lighting around the maintenance area and sheds is required for safety. No external viewpoints were quantifiably impacted from the maintenance area and sheds nor is the area directly visible.

Although the maintenance area and sheds emit the most light from the mine, the current operations are complying with relevant criteria and there have been no recorded complaints regarding lighting. Therefore, no recommendations are proposed for this area.

Photograph 4.9 **Maintenance area and sheds**

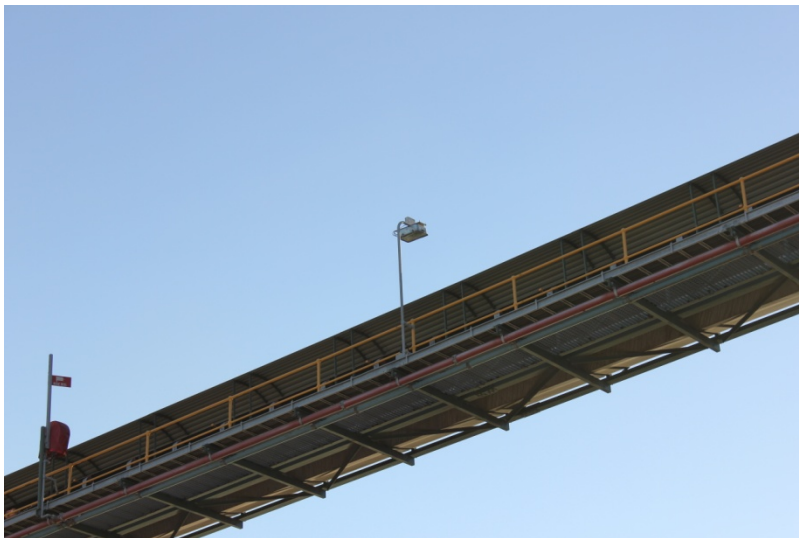
Internal site 3 (day) lighting on conveyor

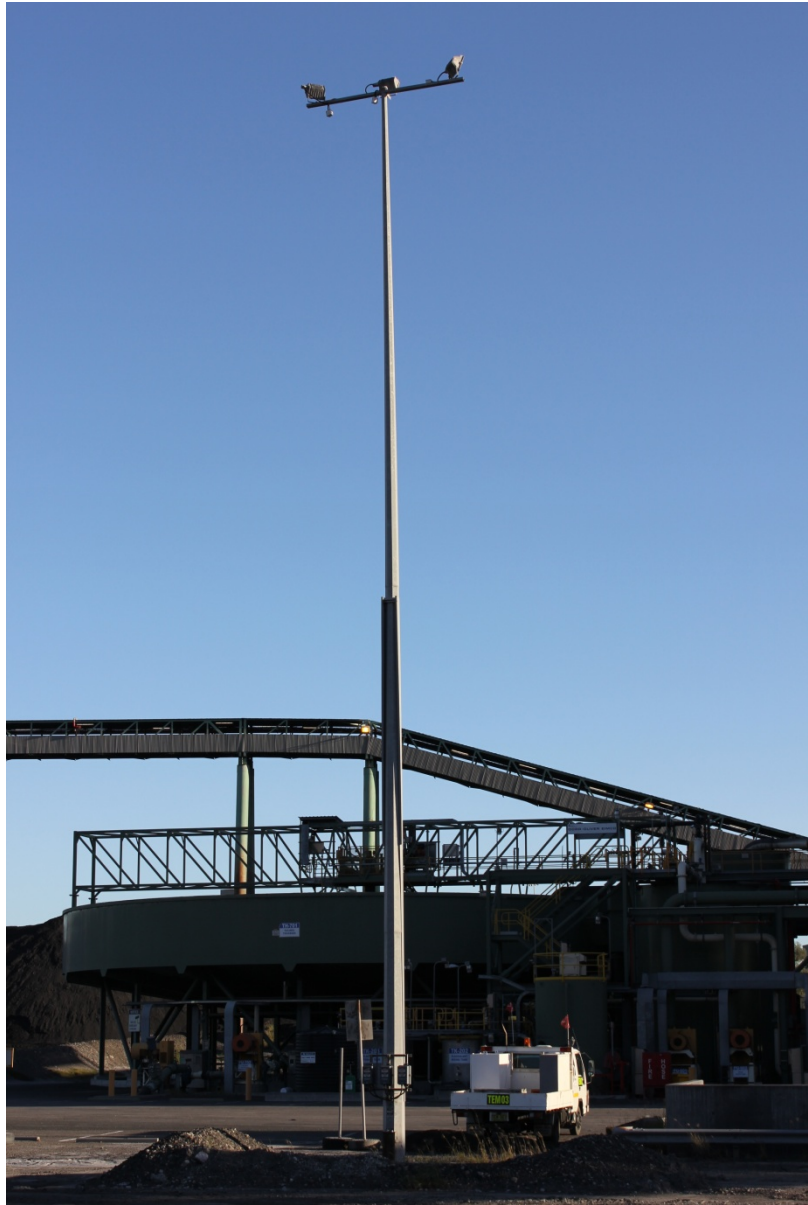
Internal site 3 (day) light tower at CHPP

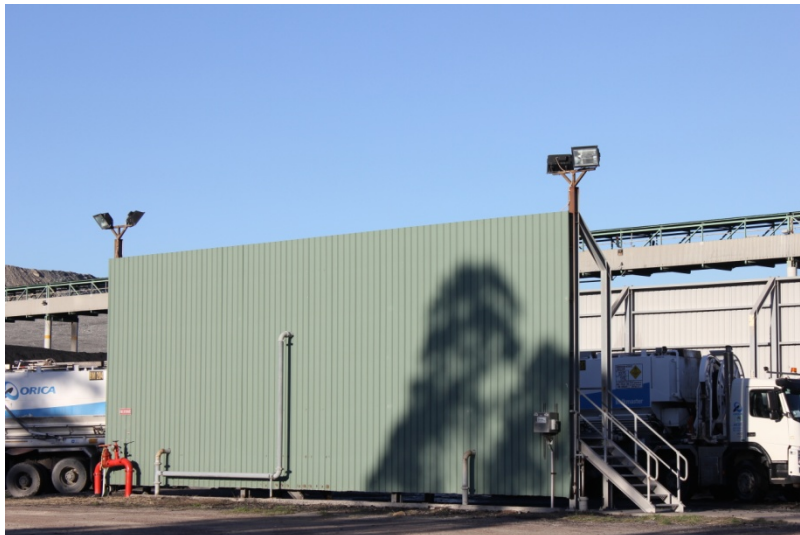
Internal site 3 (day) building lighting below horizontal
