# ENVIRONMENTAL MONITORING SUMMARY January – March 2012

In accordance with Schedule 5, Condition 9 of Project Approval 09\_0178 this report provides a summary of environmental monitoring results for Baal Bone Colliery, for the period 1 January - 31 March 2012. Baal Bone's licensed discharge and monitoring locations are identified in Drawing 1 and Drawing 2. Noise monitoring locations are identified in **Drawing 3.** Results included in this summary include – air quality, surface water quality and dewatering bore flow rates.

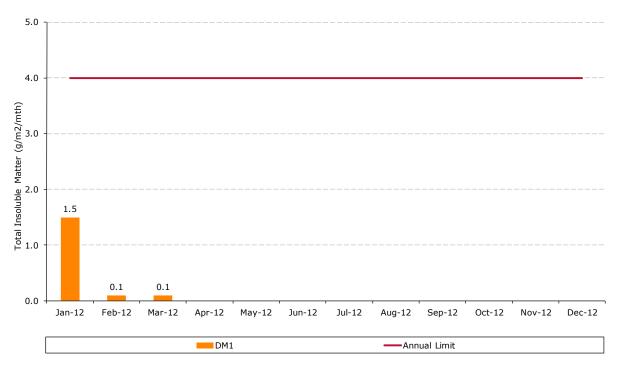
Figure 2.1: Dust monitoring gauge DM1 (EPL monitoring point No. 7)

Levels of deposited dust at Baal Bone's five gauges were below the 4g/m²/month criterion during the reporting period (refer to **Table 2.2**). Further, the maximum increase criterion of 2g/m²/month was not exceeded. **Figures 2.1 to 2.5** provide monthly results for each depositional dust gauge for 2012.

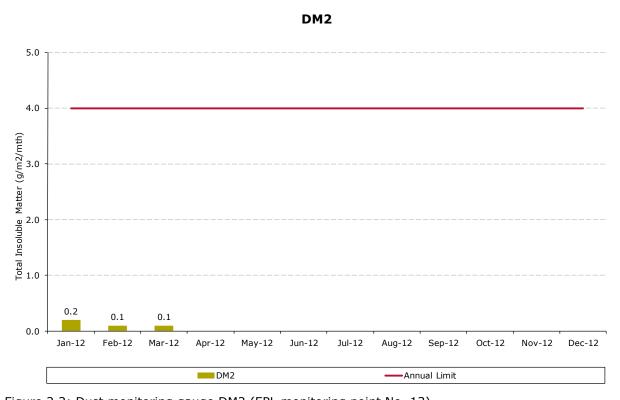
Figure 2.2: Dust monitoring gauge DM2 (EPL monitoring point No. 13)

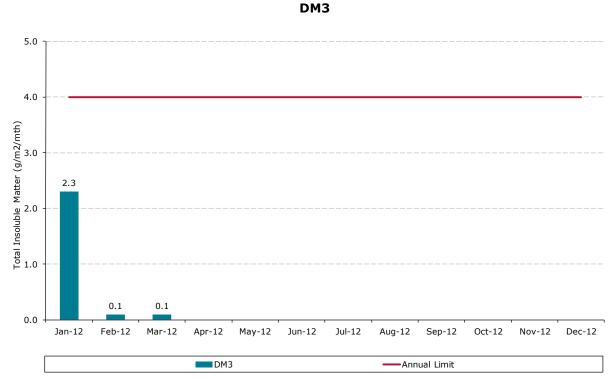
Figure 2.3: Dust monitoring gauge DM3 (EPL monitoring point No. 14)

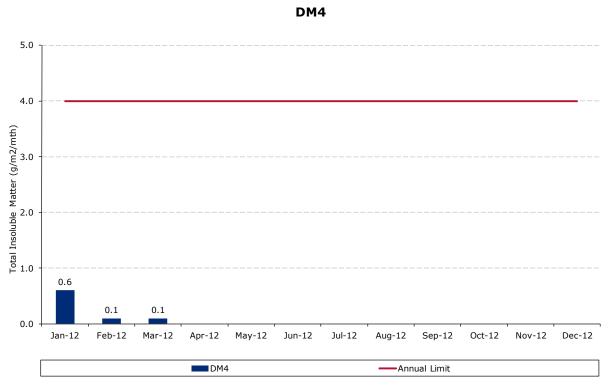
Figure 2.4: Dust monitoring gauge DM4 (EPL monitoring point No. 15)

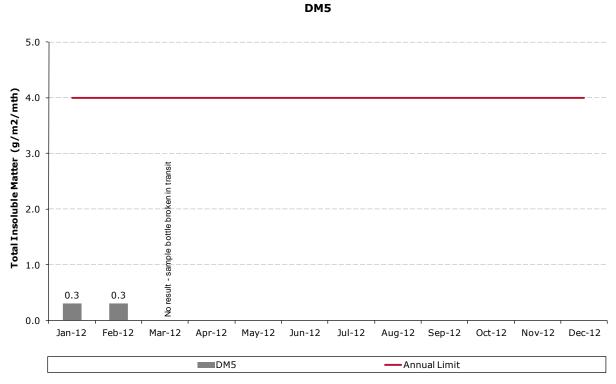
Figure 2.5: Dust monitoring gauge DM5 (EPL monitoring point No. 16)

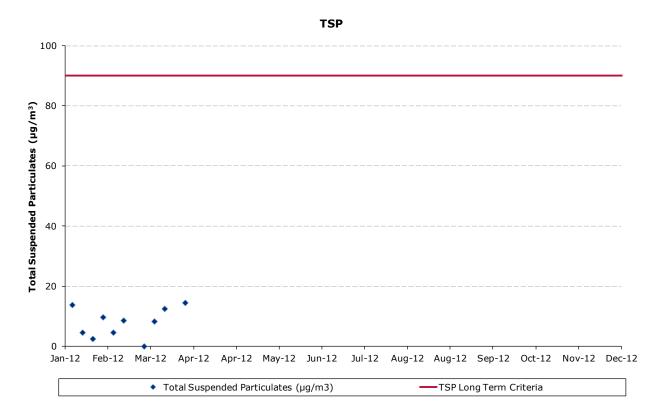
Figure 2.6: TSP Results

As illustrated at **Figure 2.6** the TSP levels during the reporting period were well below the long-term criteria, with the average TSP level for the January - March 2012 period being  $10.6 \,\mu\text{g/m}^3$ .

A high volume air sampler (HVAS) monitors total suspended particulates (TSP) at one location: DM2. HVAS run on a six-day cycle in accordance with EPA/OEH requirements.

Figure 2.6 shows the TSP results for the reporting period.

As the HVAS for monitoring TSP was installed in October 2011, the annual rolling average is not available for the current reporting period.

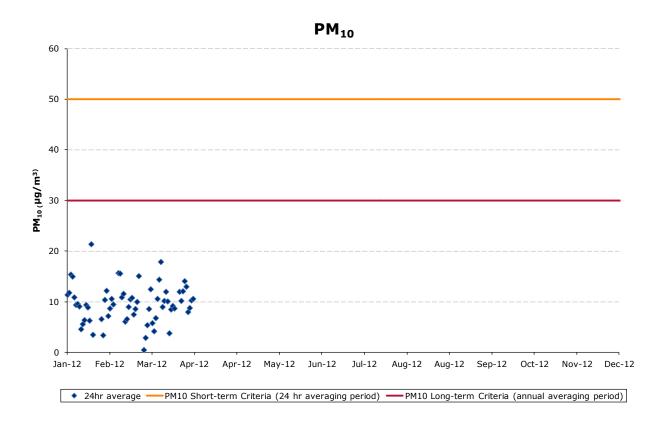
Figure 2.7: PM<sub>10</sub> 24 hour average results for the reporting period

As illustrated in **Figure 2.7** the  $PM_{10}$  levels during the reporting period were below the short-term assessment criteria (50  $\mu g/m^3$ ).

A Tapered Element Oscillating Microbalance Analyser (TEOM) measures particulate matter up to 10 microns in diameter ( $PM_{10}$ ) at one location: DM2.

**Figure 2.7** shows PM<sub>10</sub> 24 hour average results for the reporting period.

As the TEOM was installed in October 2011, the annual rolling average will not available until October 2012. However the average 24hr  $PM_{10}$  level for the January – March 2012 period was 10.7  $\mu g/m^3$ , well below the long-term assessment criteria of 30  $\mu g/m^3$ .

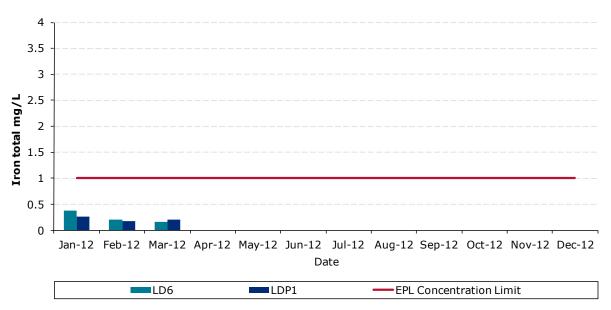
Figure 3.1: Total Iron levels

**Figures 3.1 to 3.4** provide monthly water quality results compared to EPL concentration limits.

All samples for iron at returned levels of 0.37 mg/L or less, below the concentration limit of 1.0 mg/L.

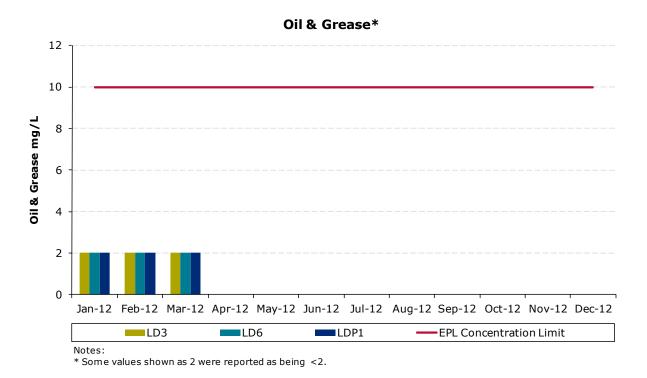
Figure 3.2: Oil and grease levels

- All samples for oil and grease at returned levels of 2 mg/L or less, well below the EPL concentration limit of 10 mg/L.
- All samples returned pH results that were within the upper and lower EPL limits (8.5 and 6.5 respectively).
- All TSS results were at or below 7 mg/L, well below the concentration limit of 50 mg/L.

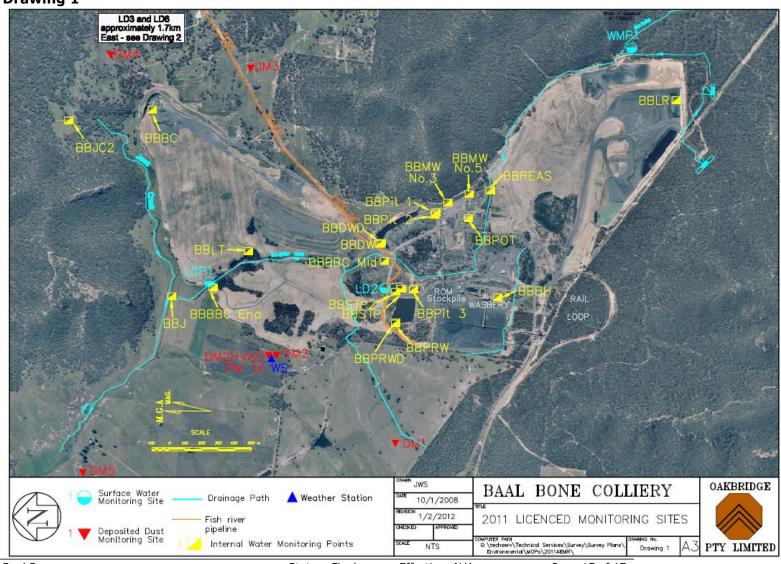
# Drawing 1

Locations of all air quality monitoring gauges are shown in **Drawing 1.**

Baal Bone maintains a network of five licensed discharge and monitoring points in accordance with EPL 765 (viz. LD2, LD3, LD6, LDP1 and WMP1)(**Drawing 1 and Drawing 2**).

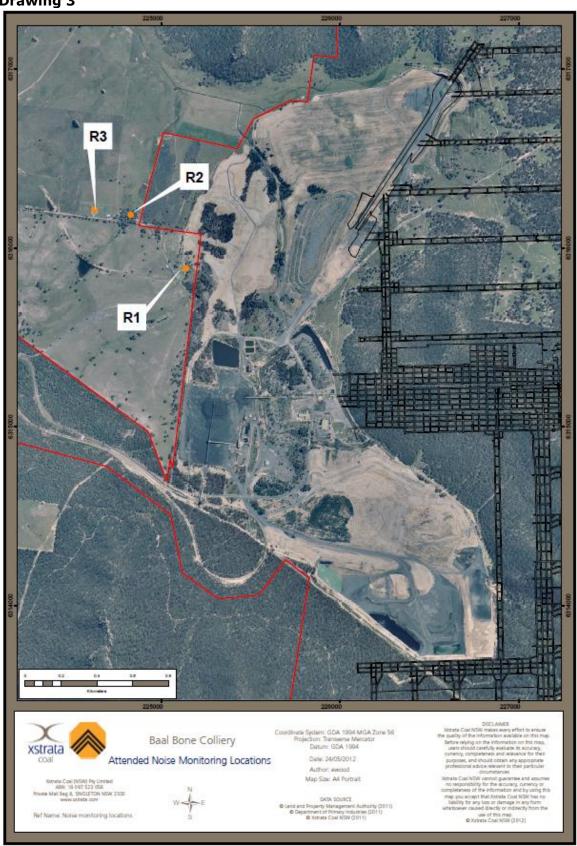
#### **Drawing 3**

As per the NMP Baal Bone Colliery operates a real time noise monitor at location R2. In addition to real time noise monitoring (which is supplementary to regulatory measurements), attended monitoring is undertaken on a quarterly basis at receptors R1 and R2/R3 (**refer to Drawing 3**).
