BAAL BONE UNDERGROUND

Q1 2021 Monitoring Summary

January to March 2021

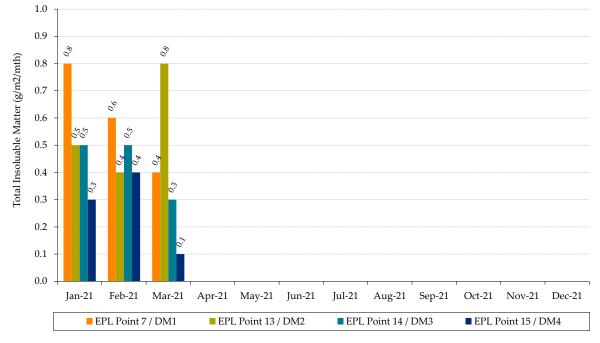
Figure 1: Monthly Total Insoluble Matter

Figure 1 provides the monthly deposited dust results for the year to date. **Figure 2** provides the twelve month rolling average.

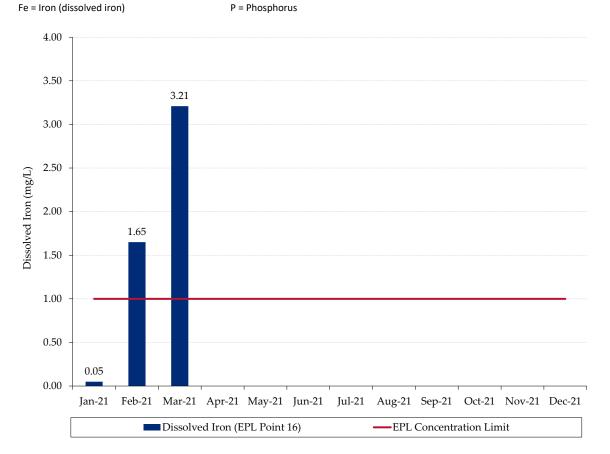
Figure 3: Monthly Dissolved Iron

Figure 3 to Figure 6 provide monthly results for each pollutant.

- All monthly TSS results were below the EPL concentration limit of 50 mg/L; and
- All Oil and grease levels were below the EPL concentration limit of 10 mg/L.
- February and March 2021 results for dissolved iron exceeded the EPL limit of 1mg/L with readings of 1.65 mg/L and 3.21 mg/L respectively.
- pH readings for January and February 2021 were within EPL concentrations limits, however the March 2021 sample returned a reading of 6.2 which is outside of the pH concentration limits.

Management actions in response to pH and dissolved iron readings outside of EPL concentration limits:

- Additional sampling has been carried out on 17 February 2021 and 29 March 2021 with both of these returning pH and dissolved iron results with the licence concentration limits.
- An external consultant, Gauge Scientific has advised that the levels have not caused material harm to the environment;
- Baal Bone Colliery is currently in the process of formally engaging Gauge Scientific to provide advice and any appropriate actions in regards to this matter;
- Water sampling frequency at LDP16 has been increased to weekly; and
- Written notification was provided to the EPA on 26 April 2021.

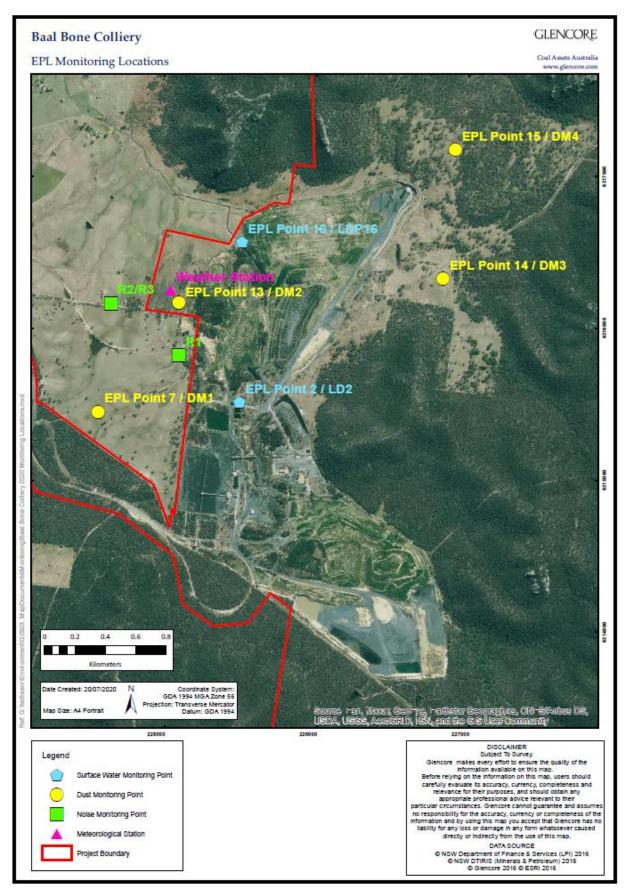
Figure 7: Baal Bone Colliery EPL Monitoring Points

In accordance with Schedule 5, Condition 9 of Project Approval 09_0178 this report provides a summary of environmental monitoring results for Baal Bone Colliery, for the period **1 January 2021 to 31 March 2021.** Baal Bone's licensed discharge and monitoring locations are identified in **Figure 7.**

Locations of the dust deposition gauges are shown in **Figure 7.**

From 2013 onwards attended monitoring is undertaken on an annual basis at receptors R1 and R2/R3, shown in **Figure 7**.
