BAAL BONE UNDERGROUND

Annual Review
2021

Name of Operation	Baal Bone Colliery
Name of Operator	Baal Bone Colliery
Project Approval Number	09_0178
Name of Holder of Project Approval	The Wallerawang Collieries Ltd
Mining Lease Number/s	CCL749, MPL261, CL391, ML1302, ML1389, ML1607
Name of Holder of Mining Lease/s	The Wallerawang Collieries Ltd
Water Licence Number/s	WAL27887, WAL34952, 80WA706034, 80WA706035
Name of Holder of Water Licence/s	The Wallerawang Collieries Ltd
MOP Start Date	20 th December 2019
MOP End Date	31 st December 2025
Annual Review Start Date	1 st January 2021
Annual Review End Date	31 st December 2021
<p>I, Elizabeth Fishpool, certify that this audit report is a true and accurate record of the compliance status of Baal Bone Colliery for the period 1st January 2020 to 31st December 2020 and that I am authorised to make this statement on behalf of Baal Bone Colliery.</p> <p><i>Note.</i></p> <p>a) <i>The Annual Review is an 'environmental audit' for the purposes of section 122B(2) of the Environmental Planning and Assessment Act 1979. Section 122E provides that a person must not include false or misleading information (or provide information for inclusion in) an

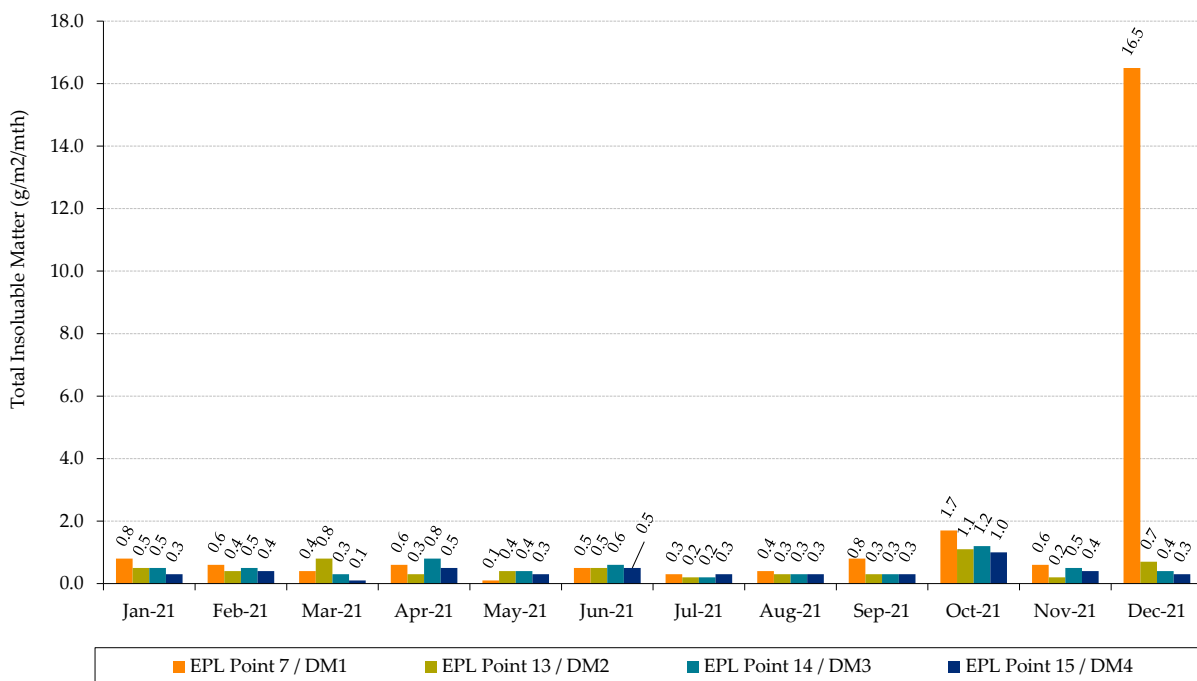
Figure 6.2: 2021 Deposited Dust Monthly Monitoring Results

Note: while a high deposited dust result was recorded in DM1 dust gauge in December 2021, when the annual average is applied all results are well within Project Approval limits –refer to **Figure 6.3**.

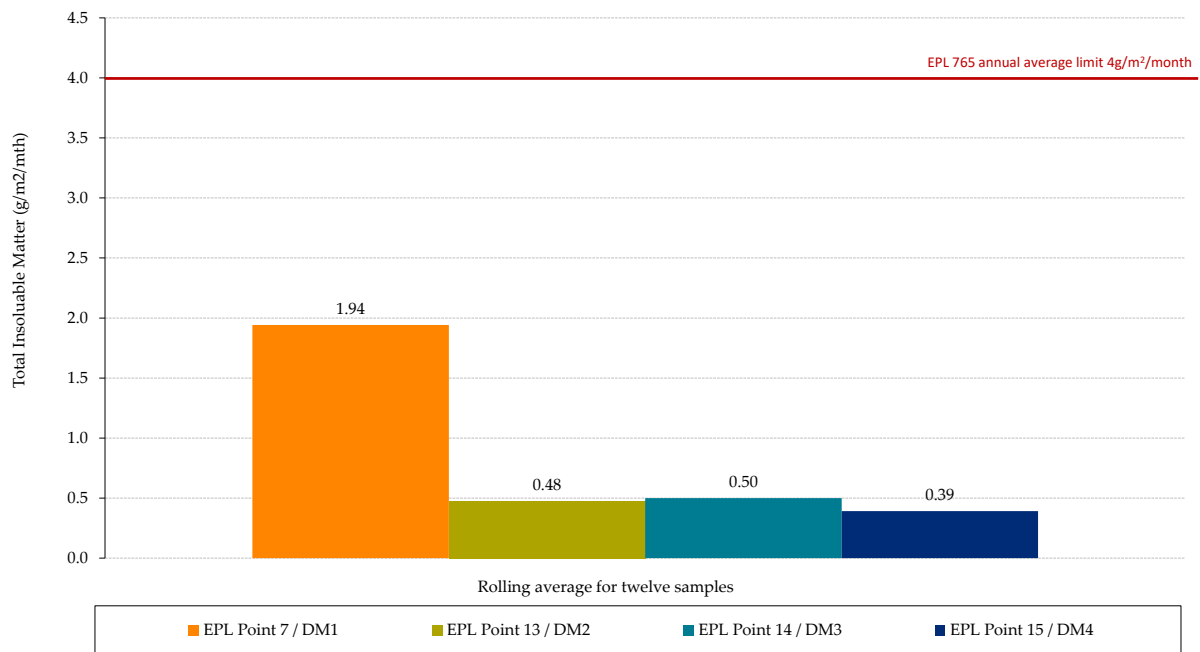
Figure 6.3: 2021 Annual Average Deposited Dust Results

Dust monitoring results for 2021 are below the maximum allowable annual average dust level of 4 g/m²/month, in accordance with Schedule 3, Condition 10 of Project Approval 09_0178.

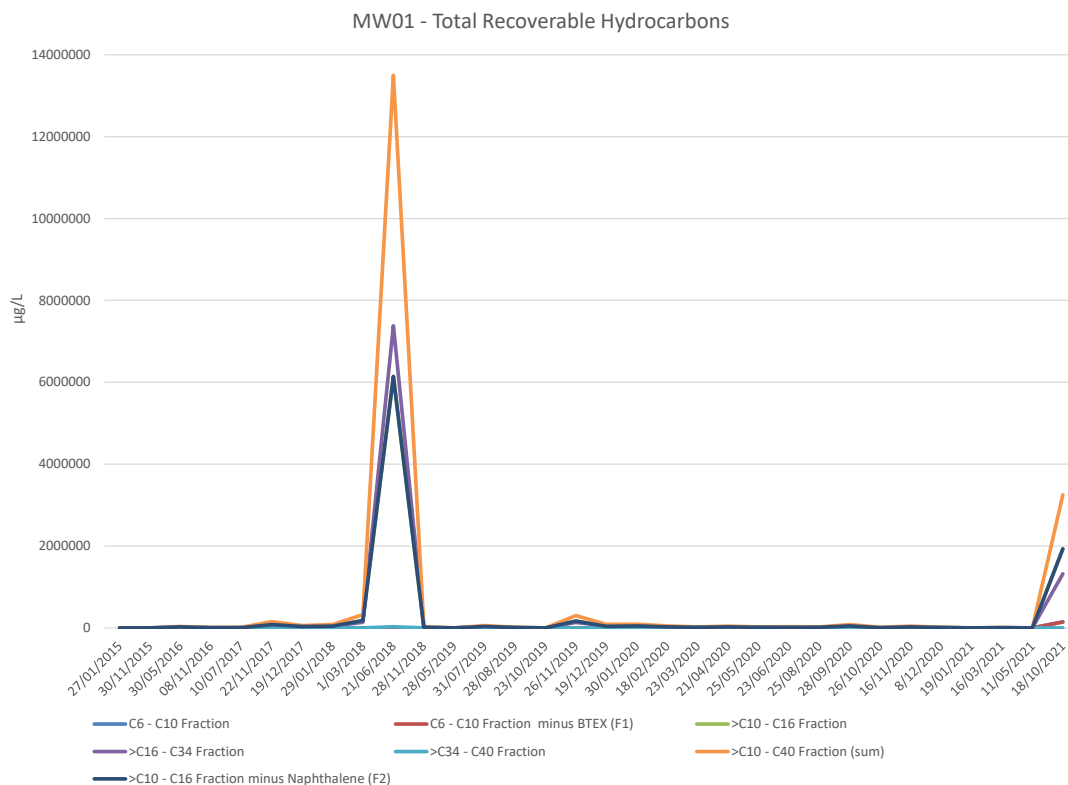
Figure 6.6: TRH results for MW01 (2015 to 2021)

In February 2022 the UST was removed and contaminated material excavated from the area surrounding the UST. The contaminated material was removed to an adjacent designated area onsite (Pip top grit trap) which has been configured as a land farm for bioremediation. A number of soil samples from the excavated pit were taken and analysed to confirm that all hydrocarbon contaminated material had been removed.

Validated materials from the bioremediation areas onsite (1) Pit top grit trap, and (2) STP ponds will be re-used onsite once sampling confirms hydrocarbon levels have reached acceptable levels.

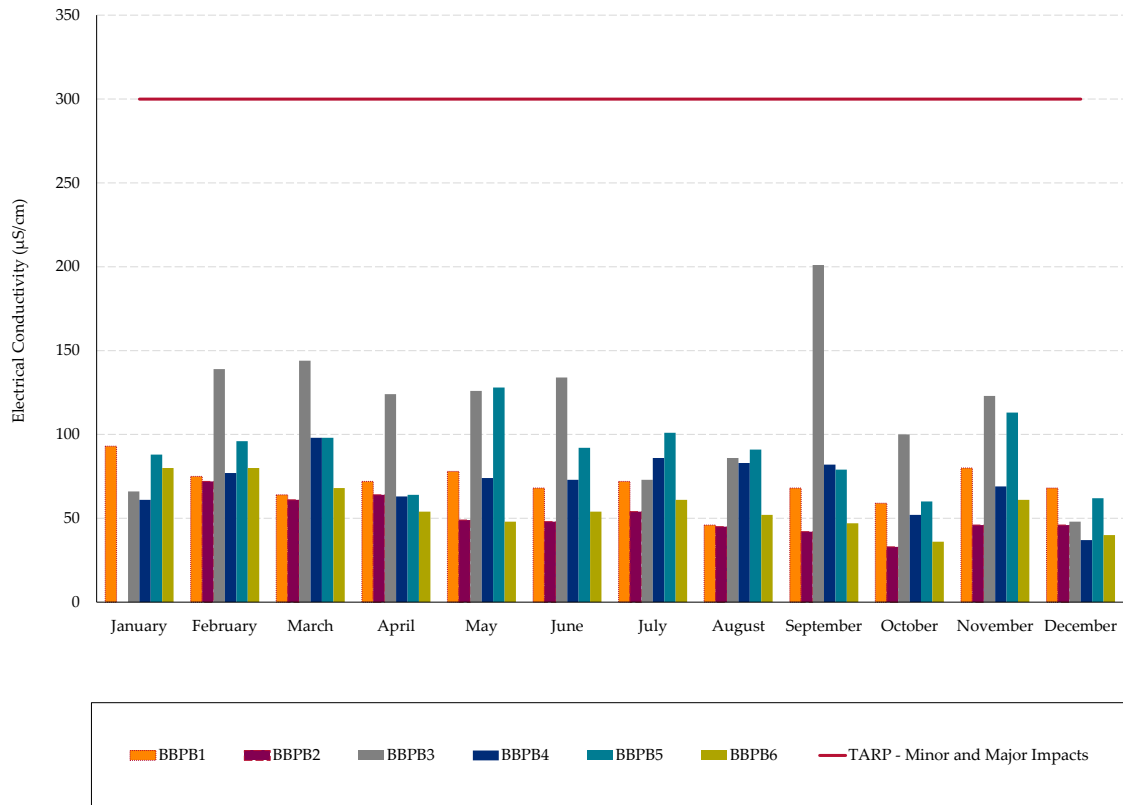
Figure 7.12: 2021 Groundwater Electrical Conductivity.

As shown in **Figure 7.12** above: electrical conductivity (EC) levels were within both the minor and major impact criteria for all groundwater monitoring bores during 2021.

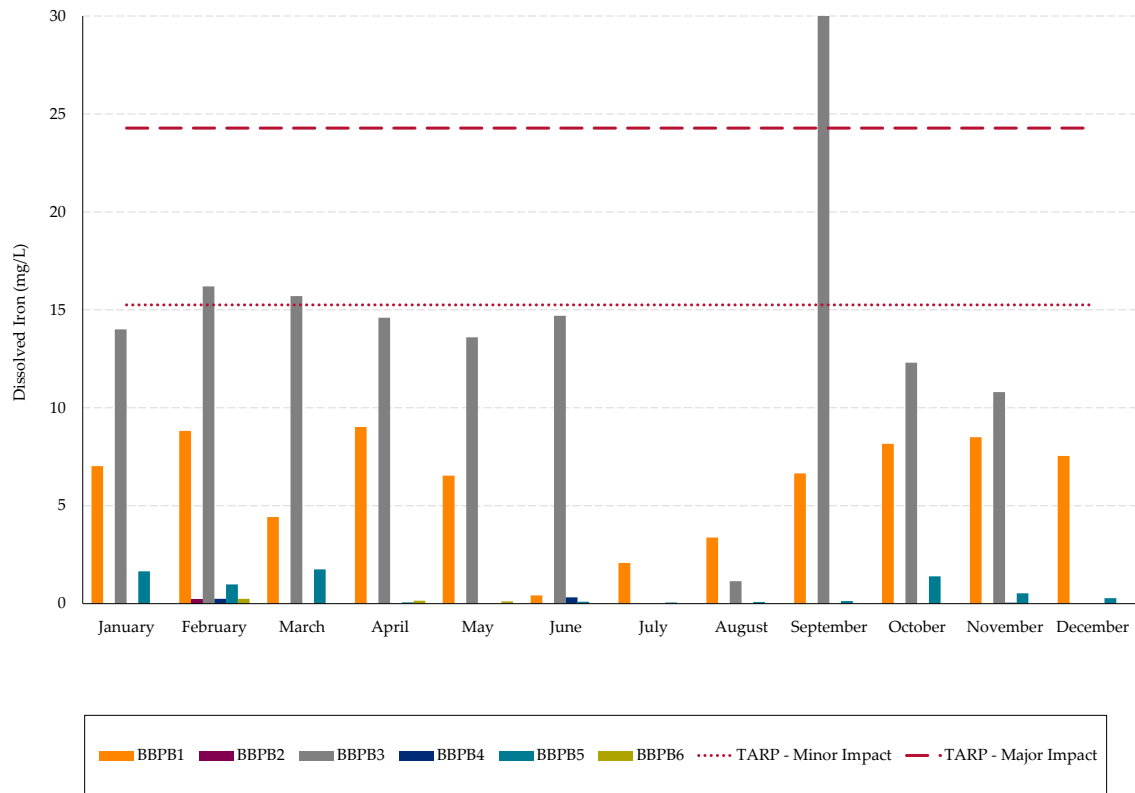
Figure 7.14: 2021 Groundwater Iron (dissolved) levels.

As shown above in **Figure 7.14**, 2021 iron levels were below the minor and major impact trigger levels for all bores except BBPB3. Dissolved iron levels at BBPB3 exceeded the minor impact trigger level in February and March 2021, and exceeded the major trigger level in September 2021. Due to the short duration of these exceedances no further action was undertaken.

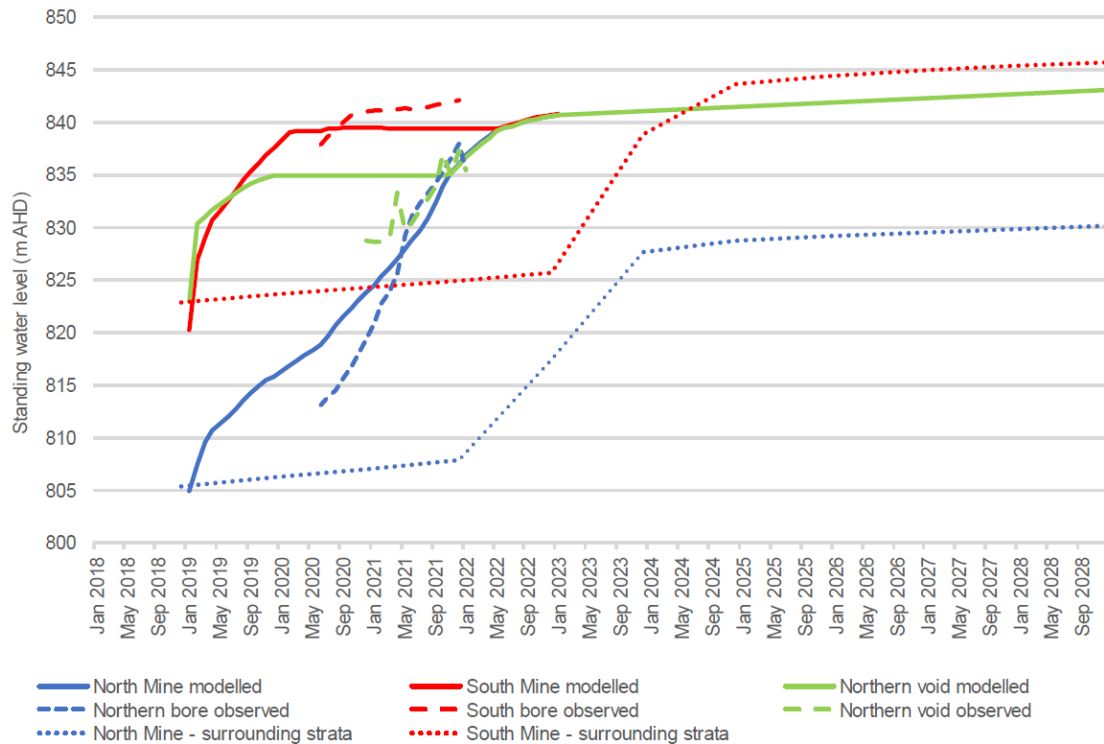
Figure 7.16 Observed and modelled post-closure groundwater level

The underground recovery water balance model was intended to provide a more realistic representation of water levels during the early part of the recovery, before the water level in the workings, goaf and surrounding strata equilibrated. Comparison of the observed and modelled water levels in Figure 7.16 shows that observed water levels are generally within 3 m of the predictions, although some uncertainty remains due to the partially dewatered initial conditions when dewatering ceased.”
