BAAL BONE UNDERGROUND

Annual Review 2016

Document Number: BBN SD REP 0002

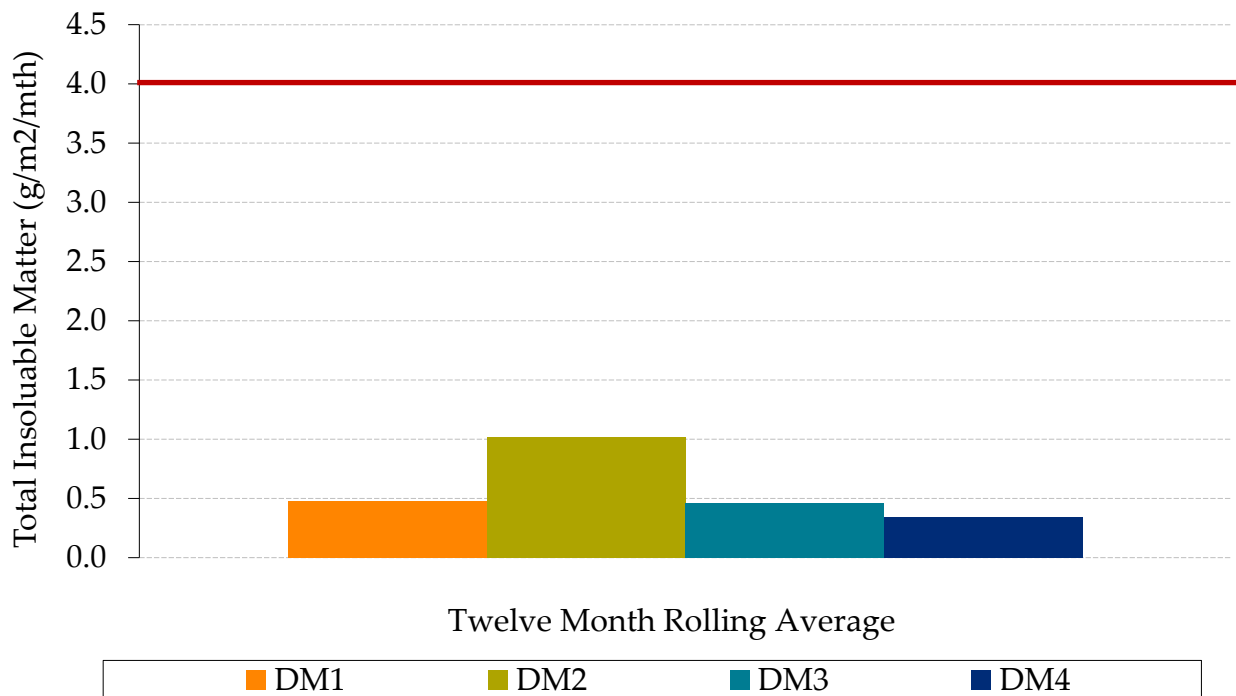
Figure 5.3: 2016 Annual Average Deposited Dust Results

All dust monitoring results for 2016, are below the maximum allowable annual average dust level of 4 g/m²/month, in accordance with Schedule 3, Condition 10 of Project Approval 09_0178.

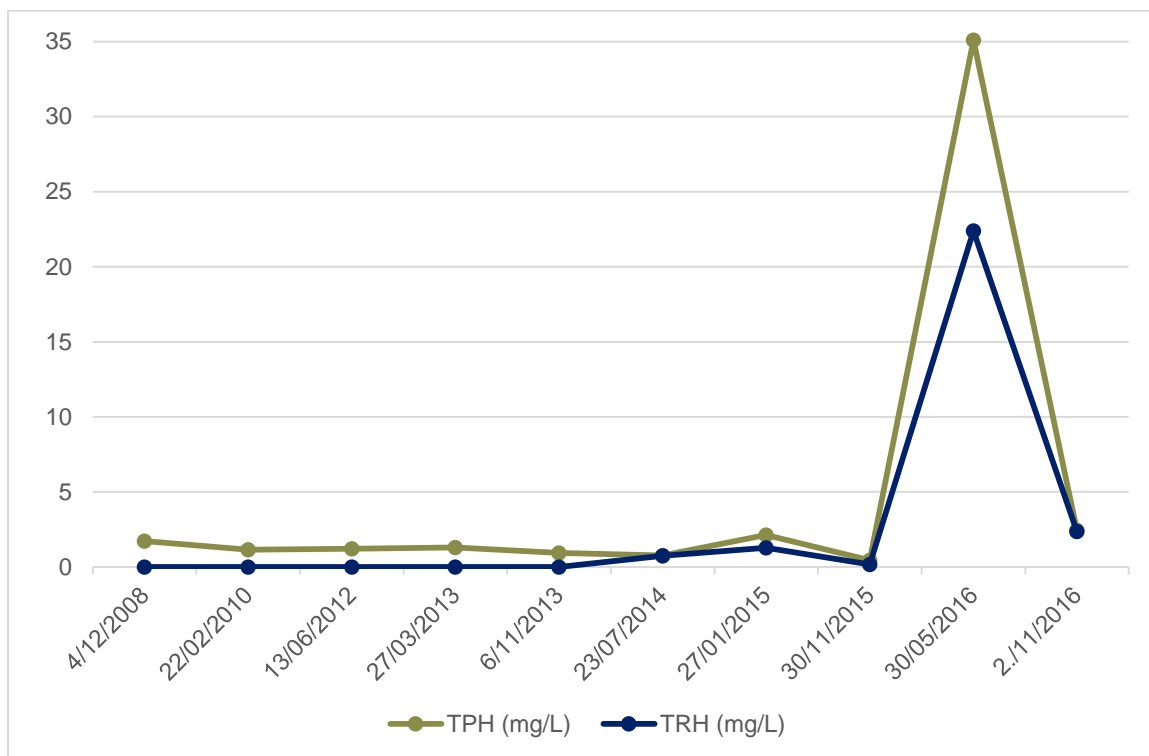
Figure 5.6: 2008 – 2016 TPH and TRH analysis results for MW01

Figure 5.6 shows the historical TPH and TRH data for MW01. Full analytical results from the November 2016 groundwater sampling event are given in **Appendix A** of this document.

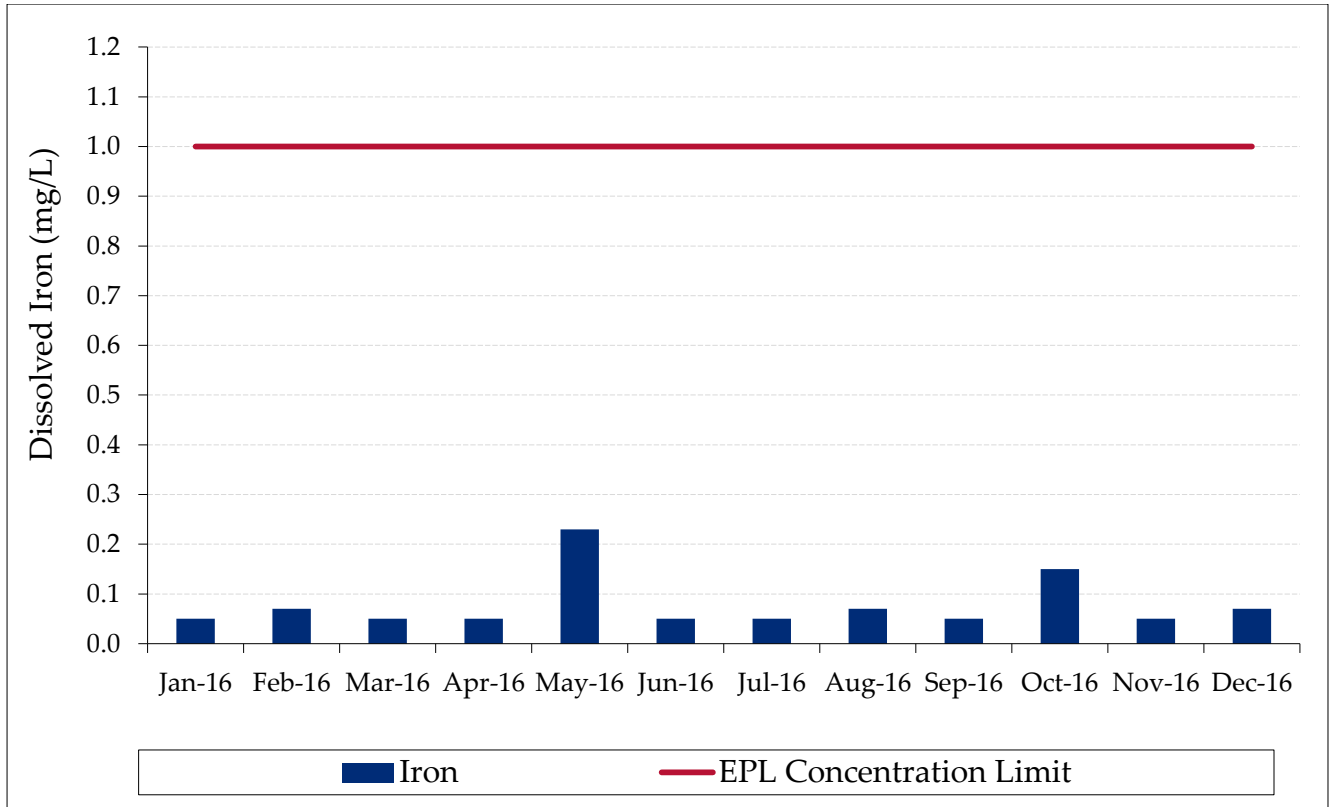
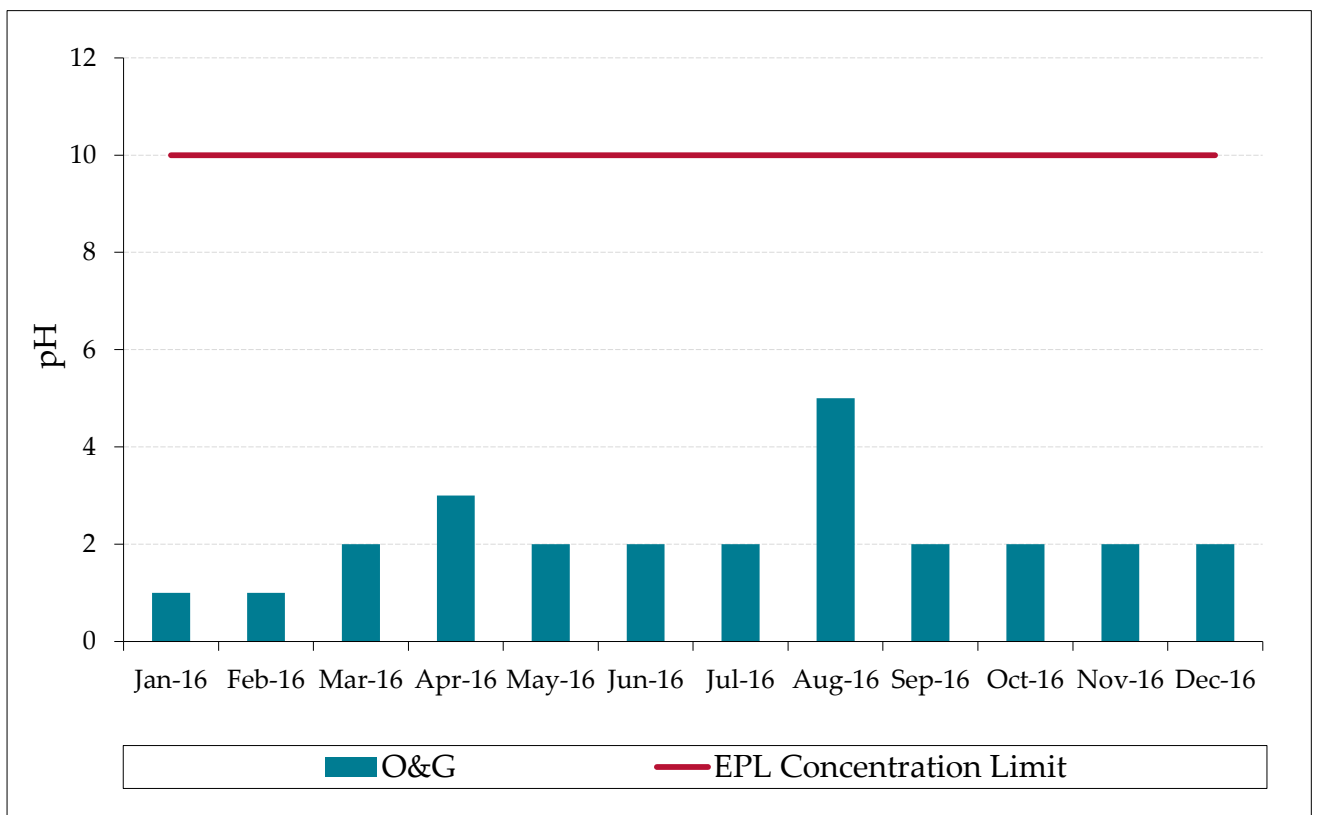
All samples recorded were within EPL concentration limits during the 2016 reporting period.

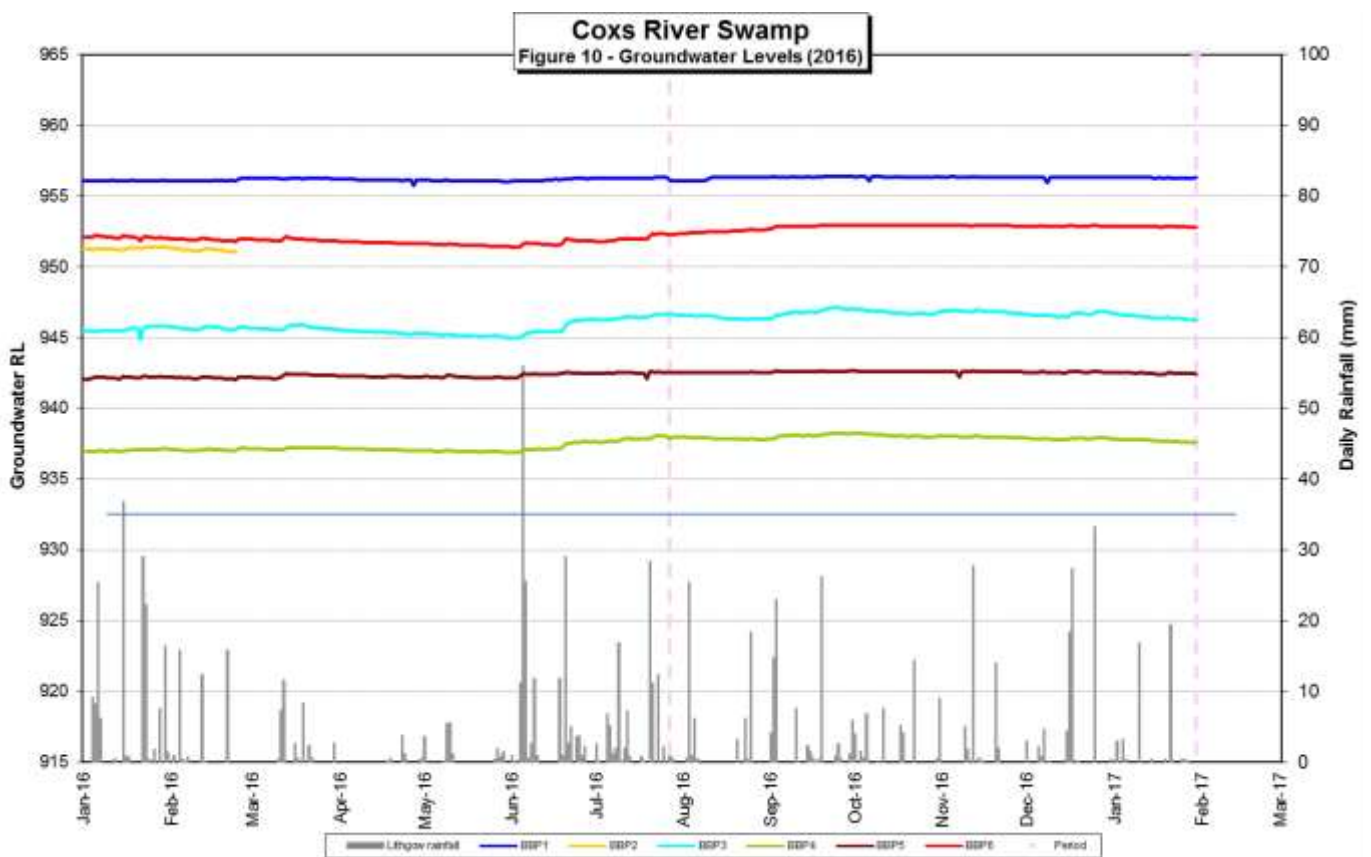
Figure 6.9: Groundwater levels 2016

Groundwater levels in the six groundwater monitoring piezometers during 2016 are presented in **Figure 6.9**. Long term trends of groundwater levels are shown in **Figure 6.10**.

The north – to – south downstream groundwater gradient has been broadly maintained over the current period (highest level observed in BBPB2 and lowest level observed in BBPB4), indicating that an overall flow has been maintained down through the swamp.

The rainfall deficit curve plots the cumulative difference between observed monthly rainfall and the long-term average. From May 2015 rainfall deficit has been trending steadily downward, into increased deficit, due to sustained dry conditions. This trend reversed in July 2016, due to good rain, with a deficit of -350 mm being maintained for the latter part of the year.
