BAAL BONE UNDERGROUND

GLENCORE

Annual Review
2022

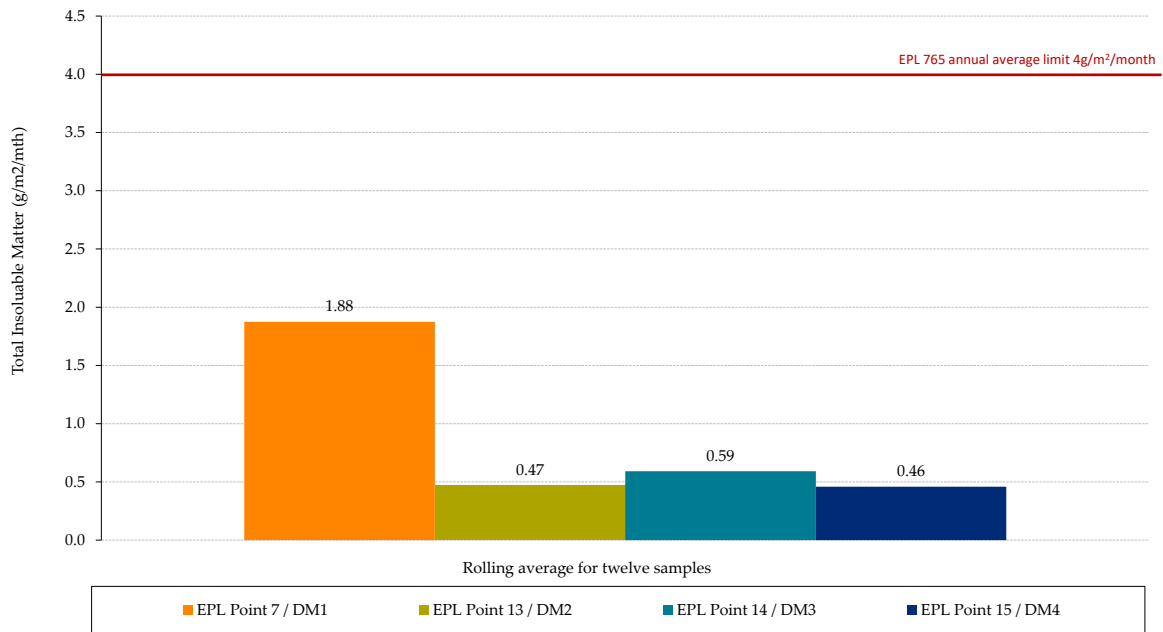
Figure 6.3: 2022 Annual Average Deposited Dust Results

Dust monitoring results for 2022 are below the maximum allowable annual average dust level of 4 g/m²/month, in accordance with Schedule 3, Condition 10 of Project Approval 09_0178.

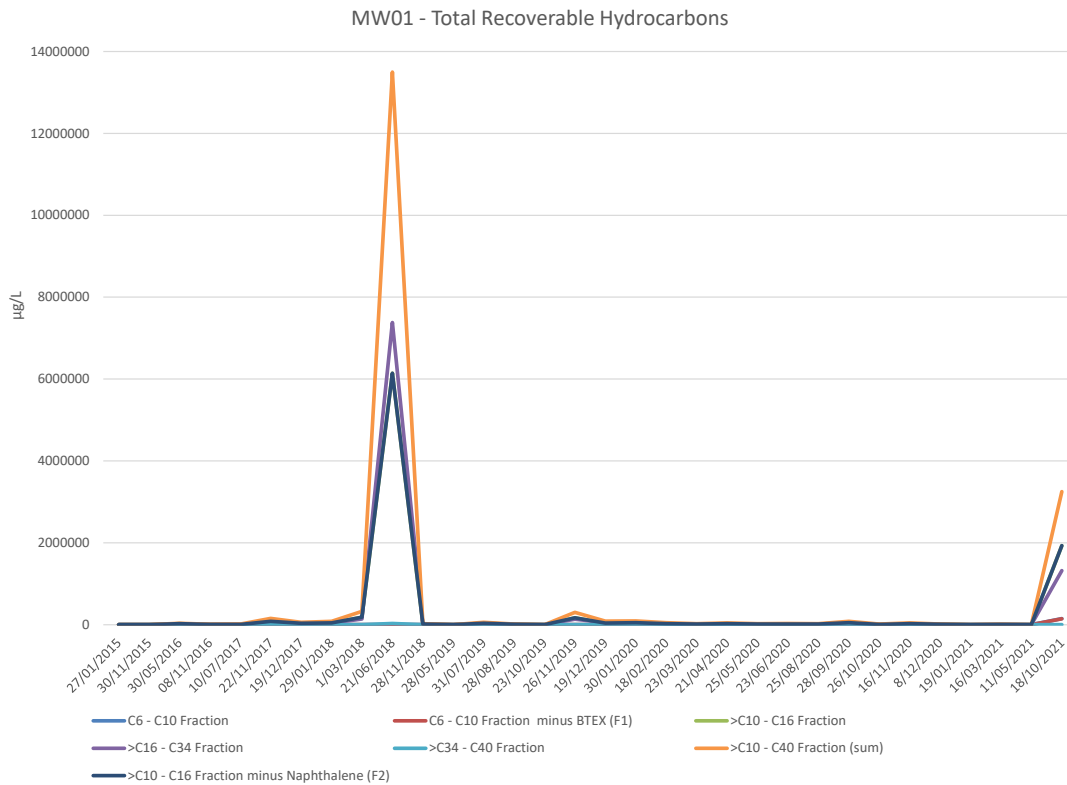
Figure 6.6: TRH results for MW01 (2015 to 2021)

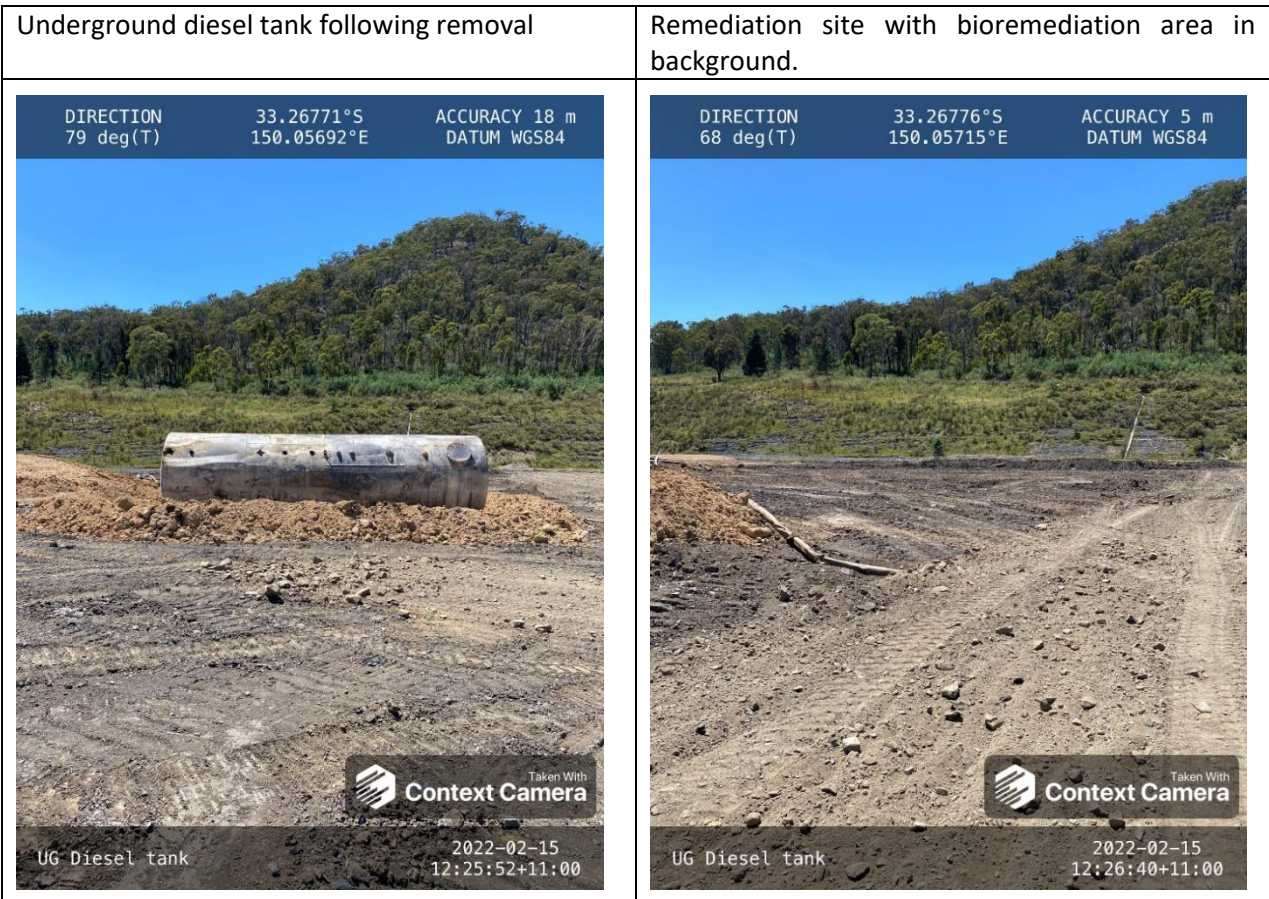
In February 2022 the UST was removed and contaminated material excavated from the area surrounding the UST. The contaminated material was removed to an adjacent designated area onsite (Pip top grit trap) which has been configured as a land farm for bioremediation. A number of soil samples from the excavated pit were taken and analysed to confirm that all hydrocarbon contaminated material had been removed.

Plate 1: Removal of UST

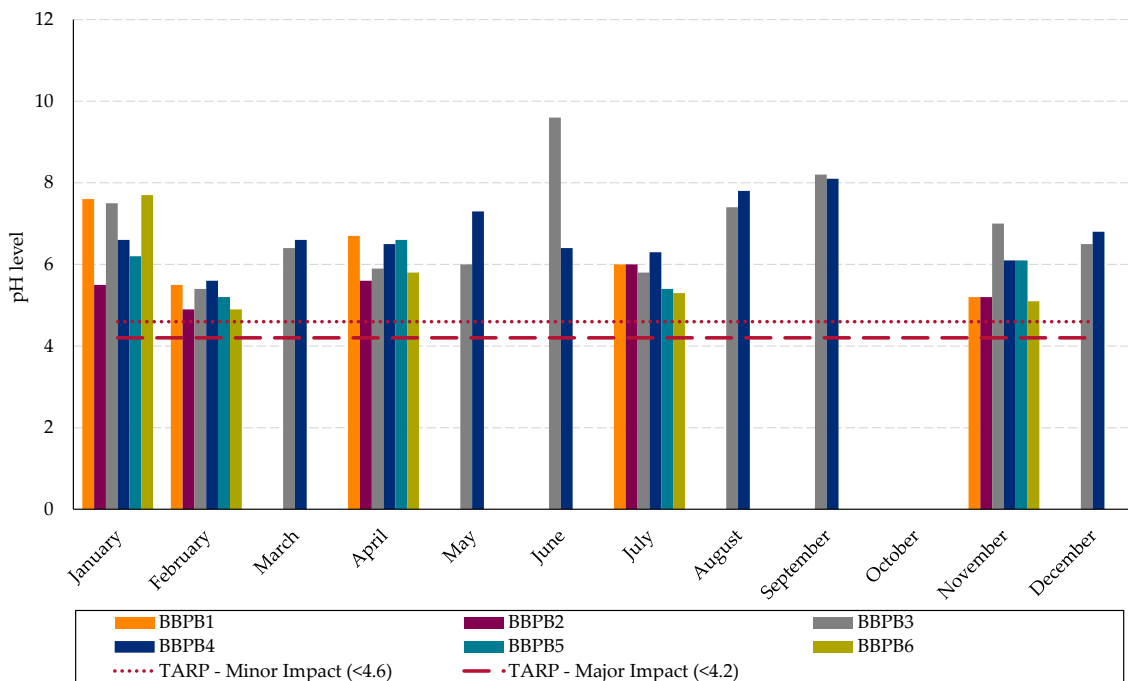
Figure 7.11: 2022 Groundwater pH levels.

As shown in Figure 7.11 above, all pH levels for all bores were within both the minor and major impact criteria during 2022.

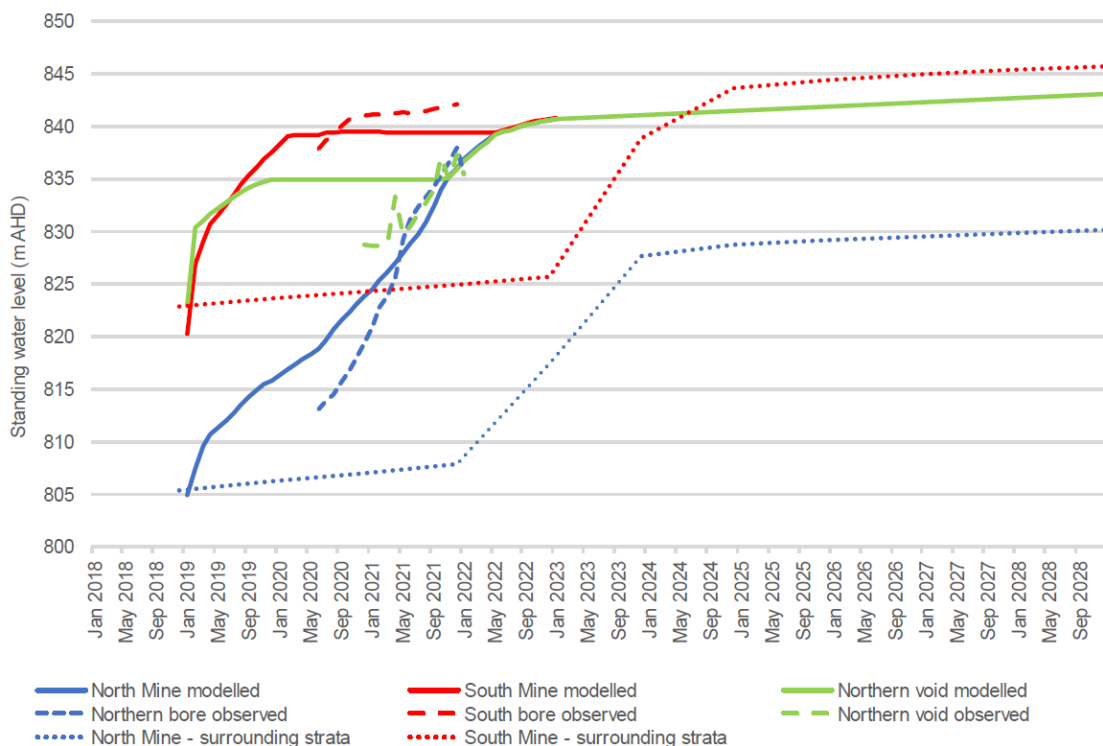
Figure 7.16 shows observed standing water levels compared to the water levels predicted by the hydrogeological model and the underground recovery water balance model.

Figure 7.16 Observed and modelled post-closure groundwater level

The underground recovery water balance model was intended to provide a more realistic representation of water levels during the early part of the recovery, before the water level in the workings, goaf and surrounding strata equilibrated. Comparison of the observed and modelled water levels in Figure 7.16 shows that observed water levels are generally within 3 m of the predictions, although some uncertainty remains due to the partially dewatered initial conditions when dewatering ceased.”

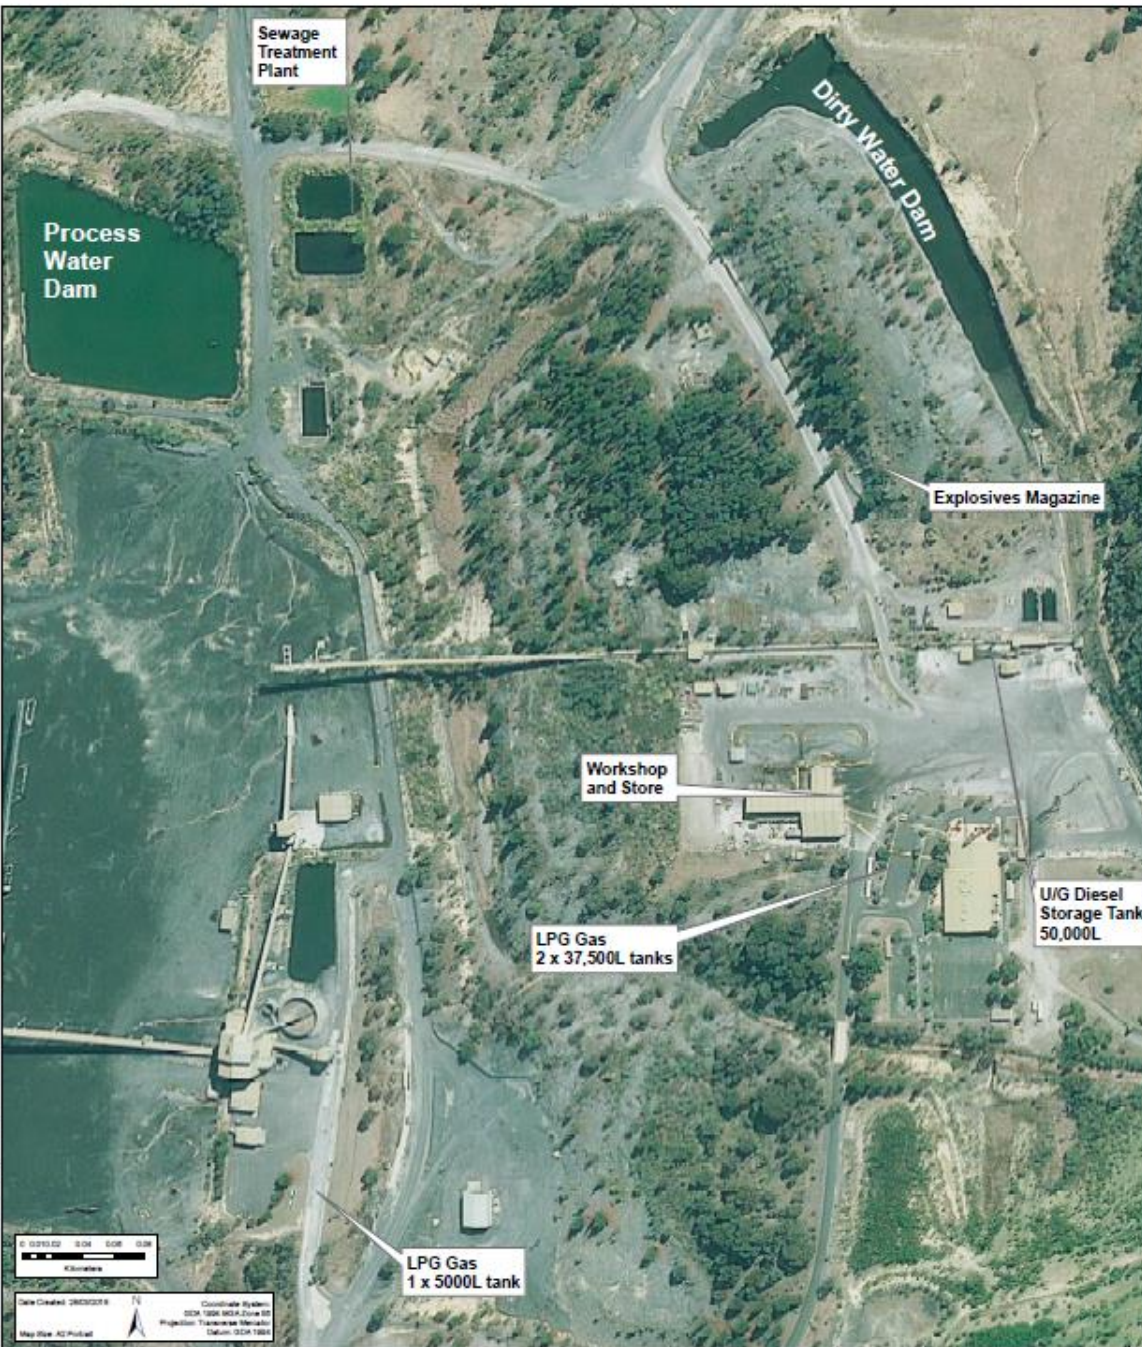
Plan 3 – Hazardous Materials (prior to demolition and closure activities)
