BAAL BONE COLLIERY

OPERATED BY THE WALLERAWANG COLLIERIES LTD

July to September 2013

Environmental Monitoring Summary

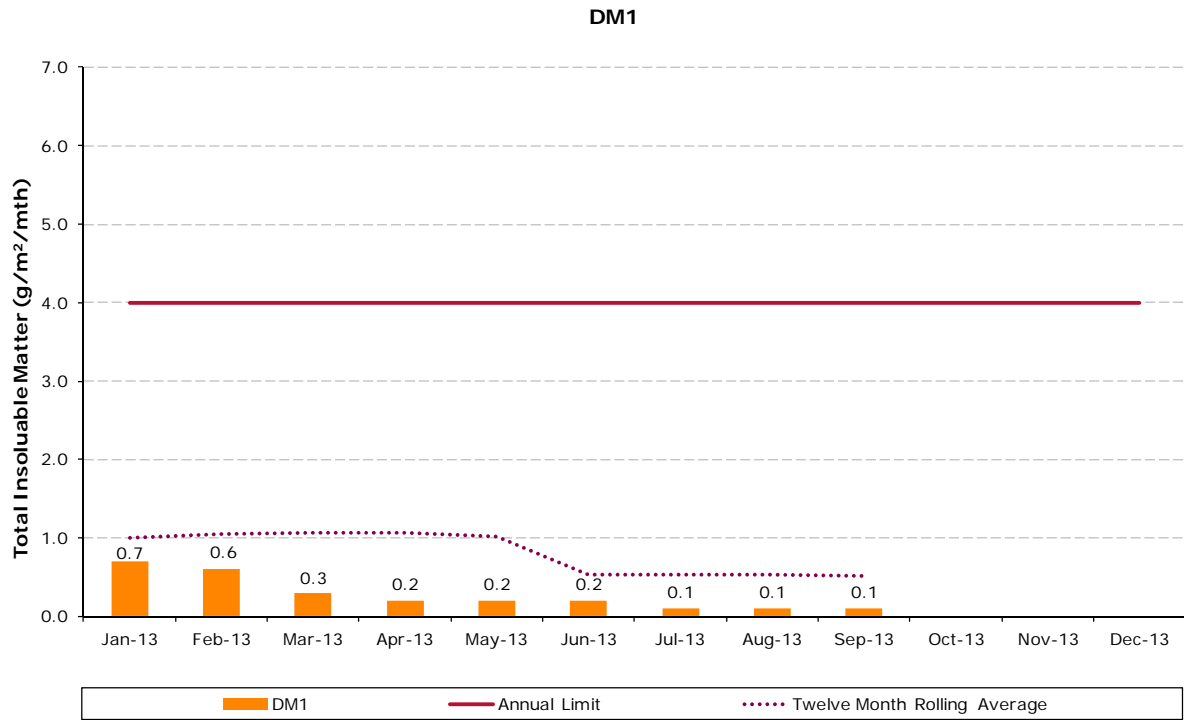
Figure 2.1: Dust monitoring gauge DM1 (EPL monitoring point No. 7)

Levels of deposited dust at Baal Bone's five gauges were below 4g/m²/month during the reporting period (refer to **Table 2.2**). Dust levels at all five gauges satisfied the criterion outlined in Project Approval 09_0178.

Figures 2.1 to 2.5 provide monthly results for each depositional dust gauge for 2013.

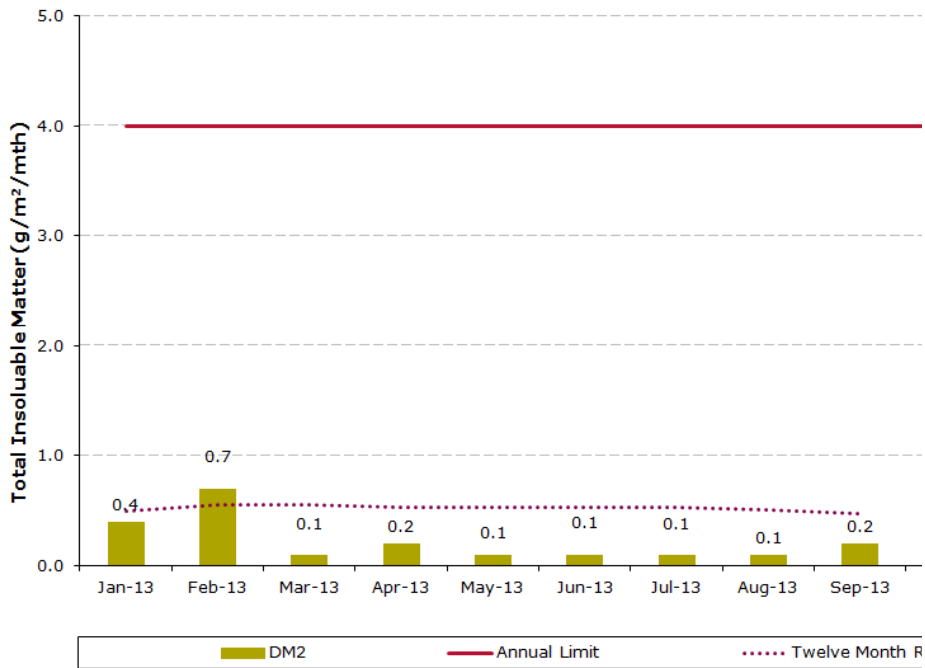
Figure 2.2: Dust monitoring gauge DM2 (EPL monitoring point No. 13)

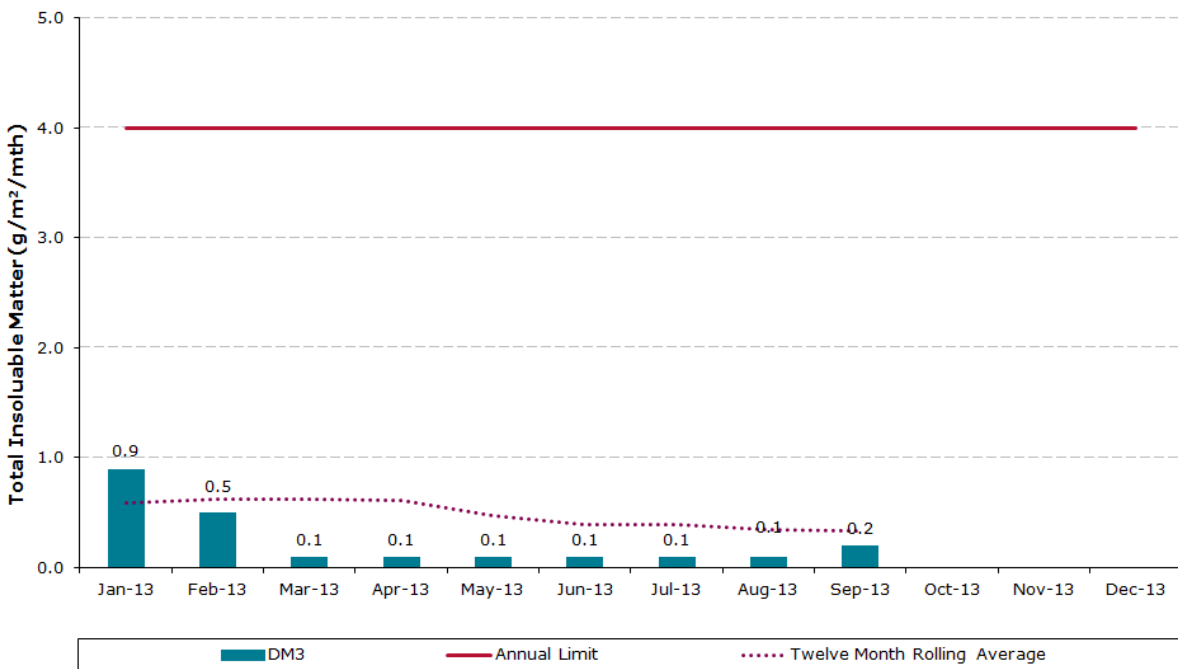
Figure 2.3: Dust monitoring gauge DM3 (EPL monitoring point No. 14)

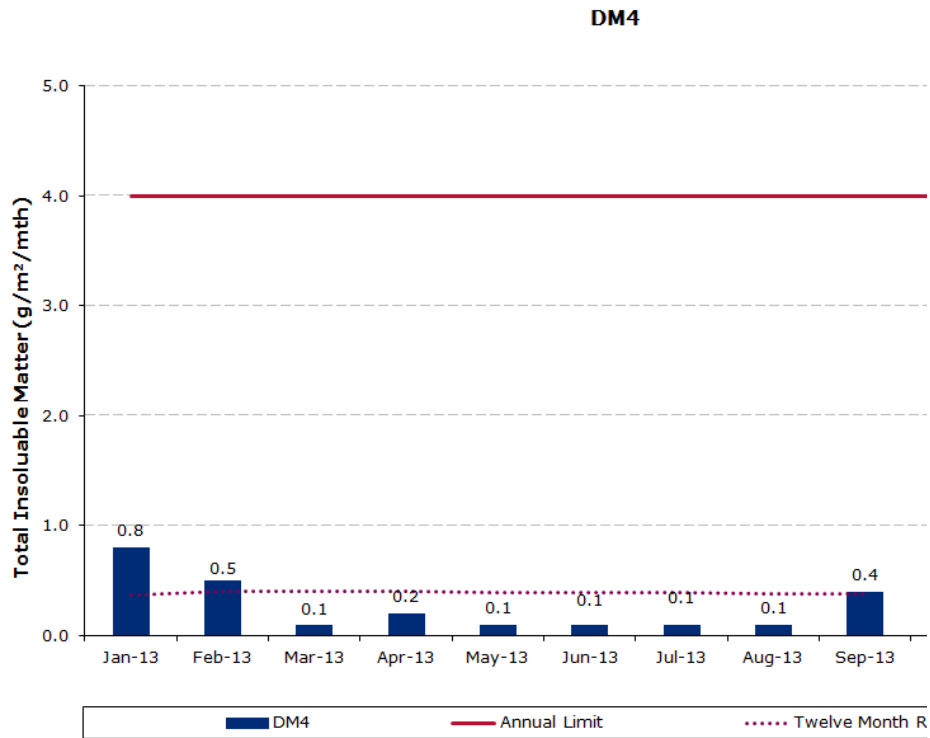
Figure 2.4: Dust monitoring gauge DM4 (EPL monitoring point No. 15)

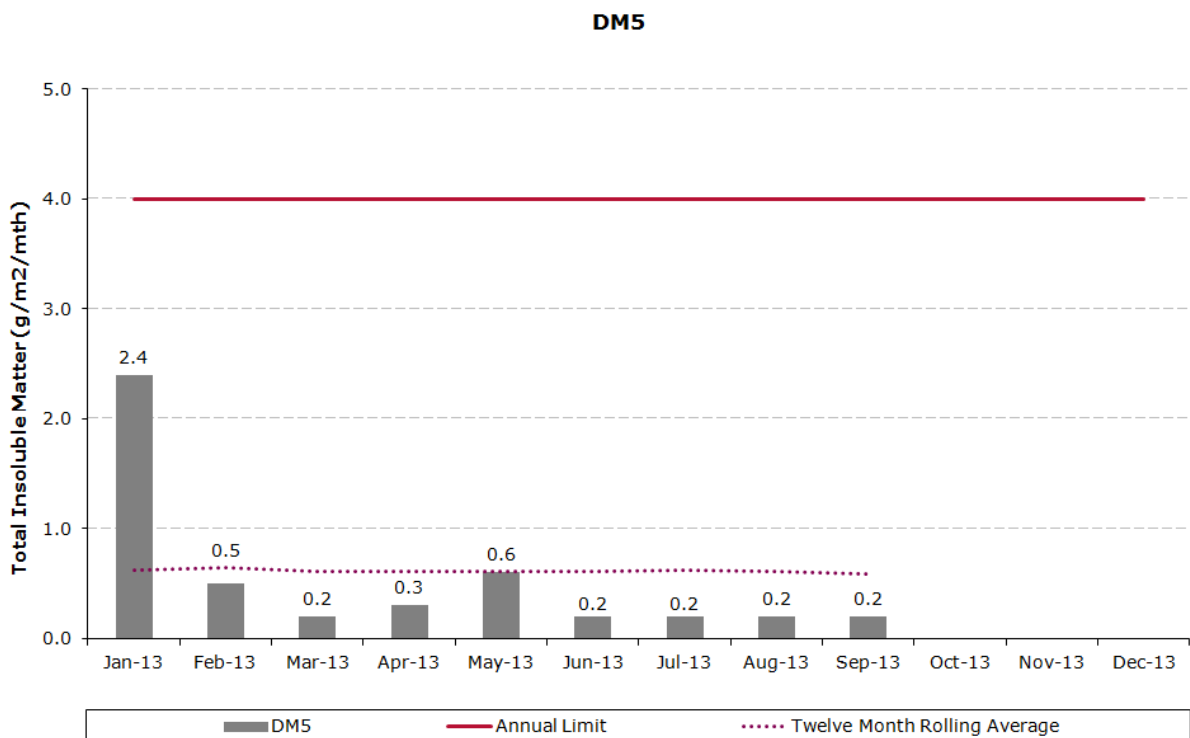
Figure 2.5: Dust monitoring gauge DM5 (EPL monitoring point No. 16)

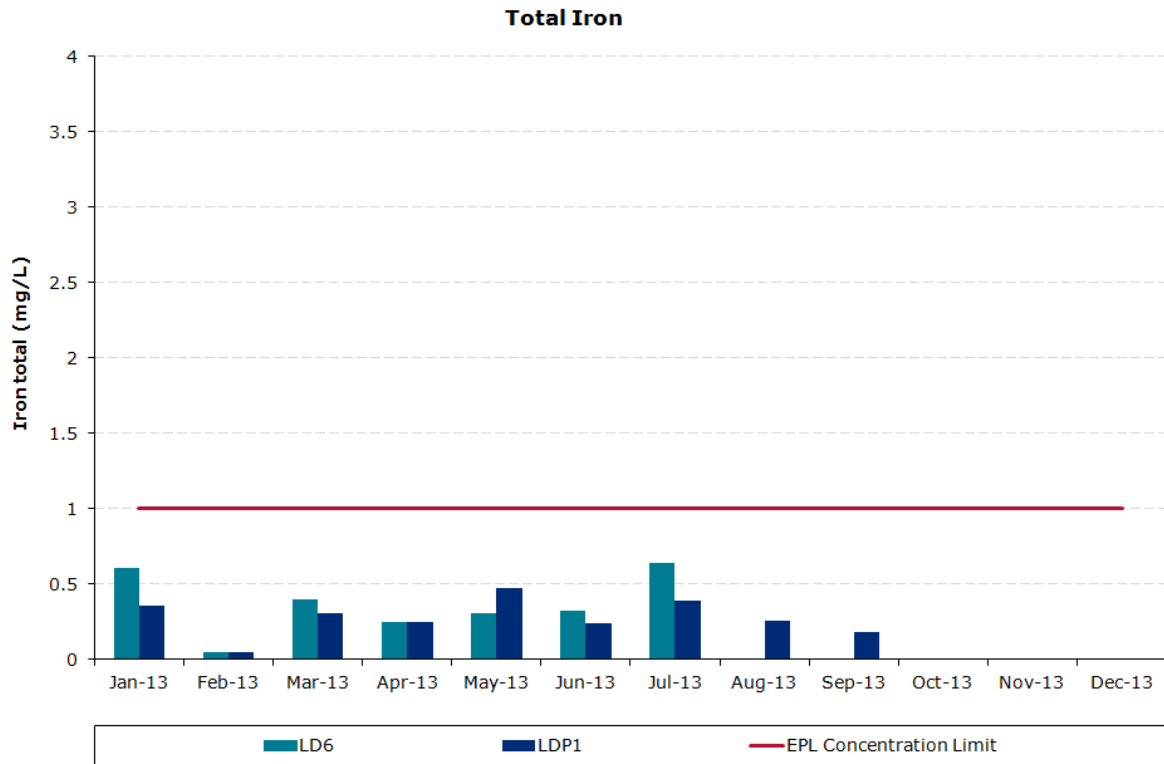
Figure 3.1: Total iron levels

Figures 3.1 to 3.4 provide monthly water quality results compared to concentration limits.

- The highest iron sample for the period was 0.64 mg/L (recorded at LD6 in July 2013), well below the concentration limit of 1 mg/L.
- Most samples for oil and grease at returned levels of 2 mg/L or less, well below the EPL concentration limit of 10 mg/L.
- All samples returned pH results that were within the upper and lower EPL limits (8.5 and 6.5 respectively).

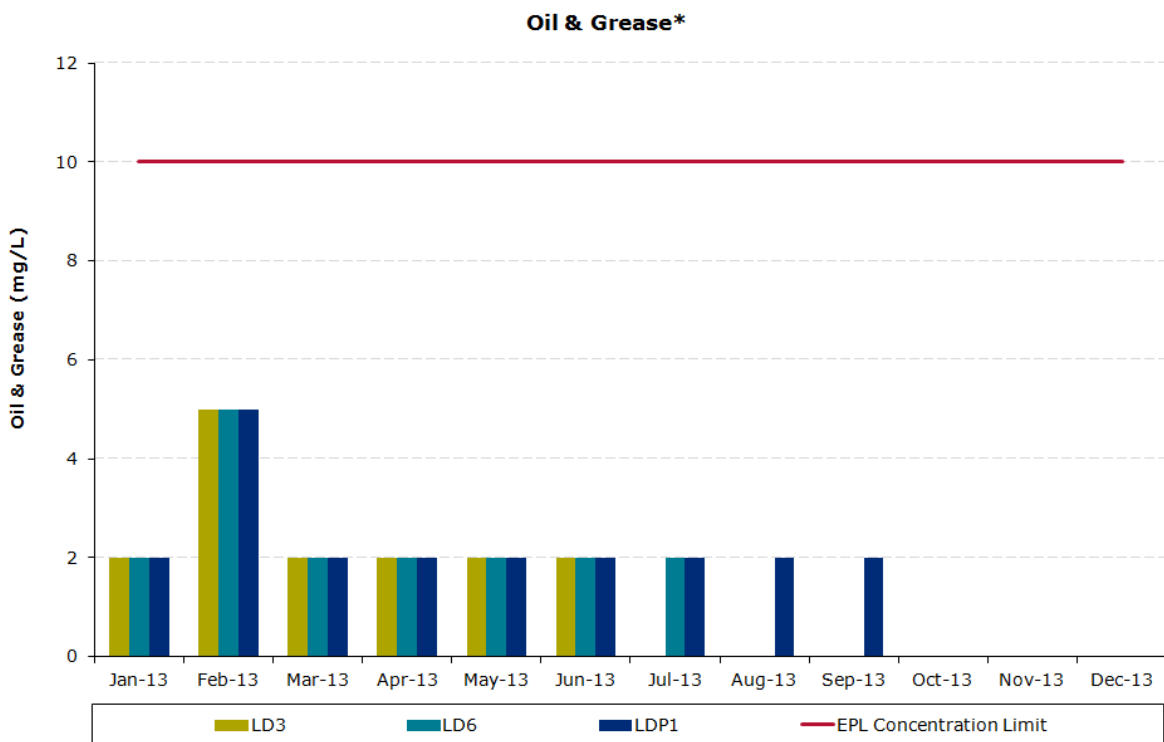
Notes:
* Some values shown as 2 were reported as being <2 (Refer to Table 3.2).

Figure 3.2: Oil and grease levels

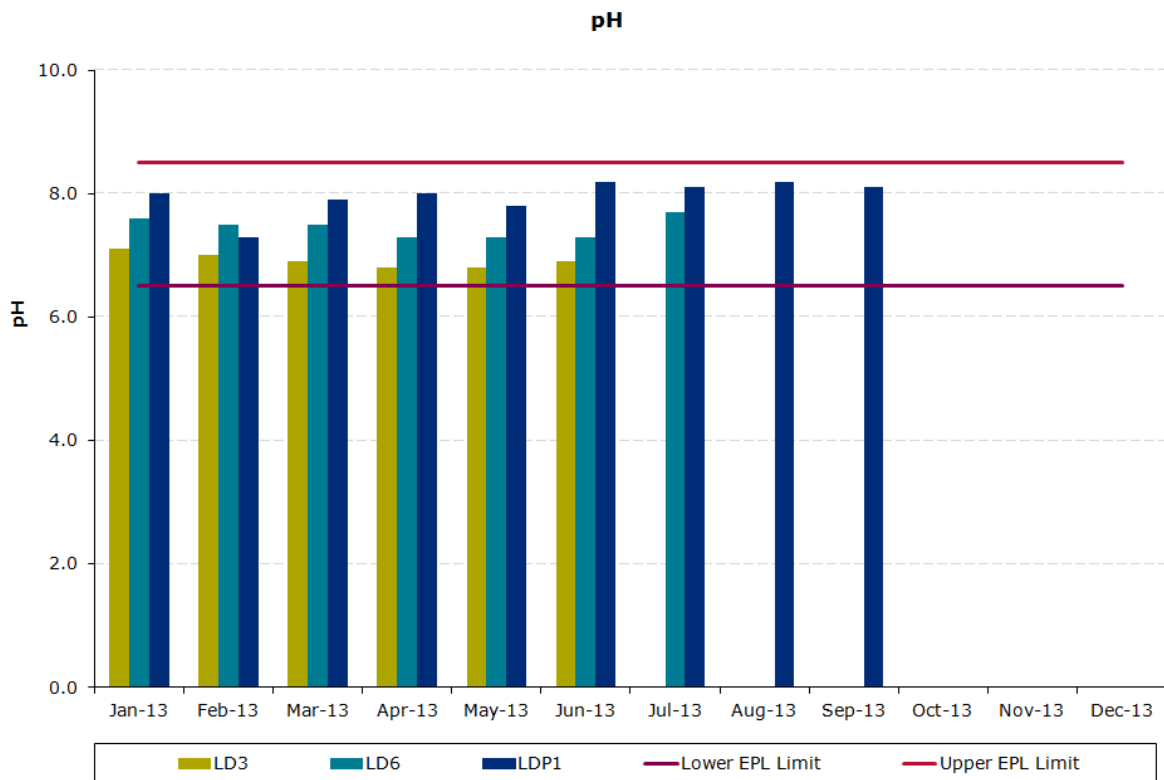
Figure 3.3: pH levels

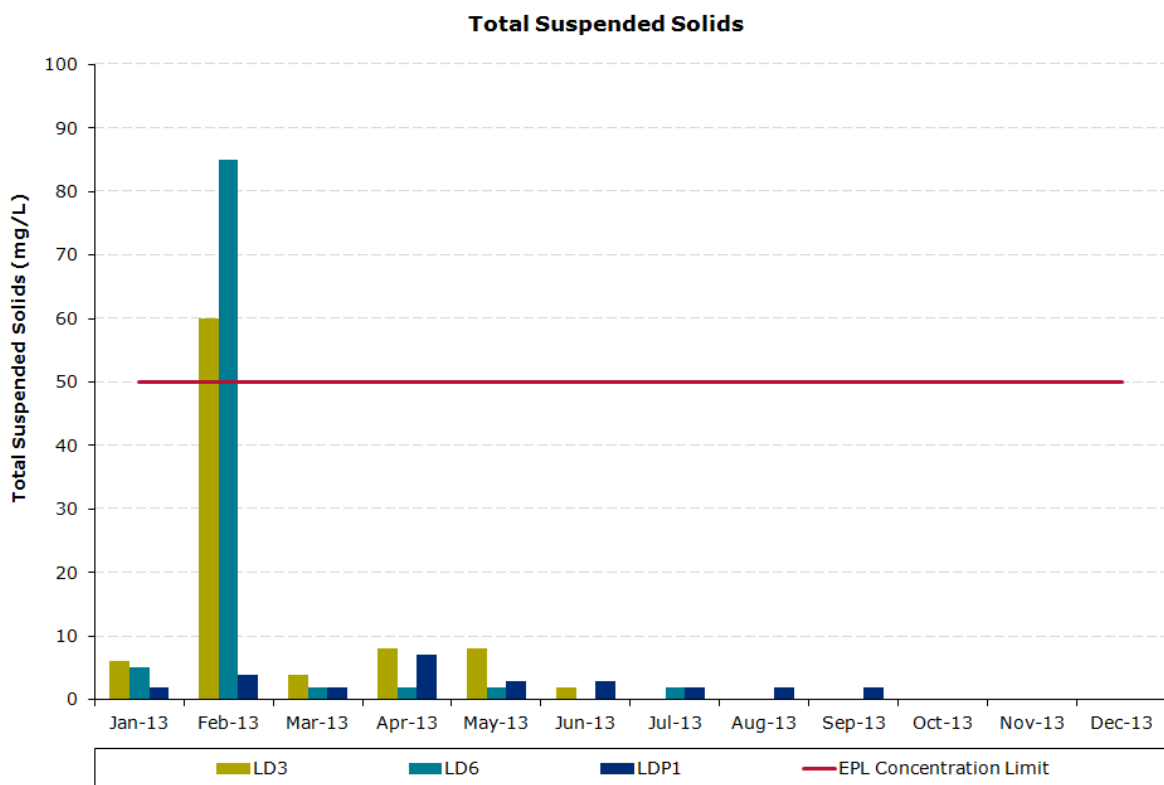
Figure 3.4: Total suspended solids levels

All samples recorded were within EPL concentration limits during the reporting period.

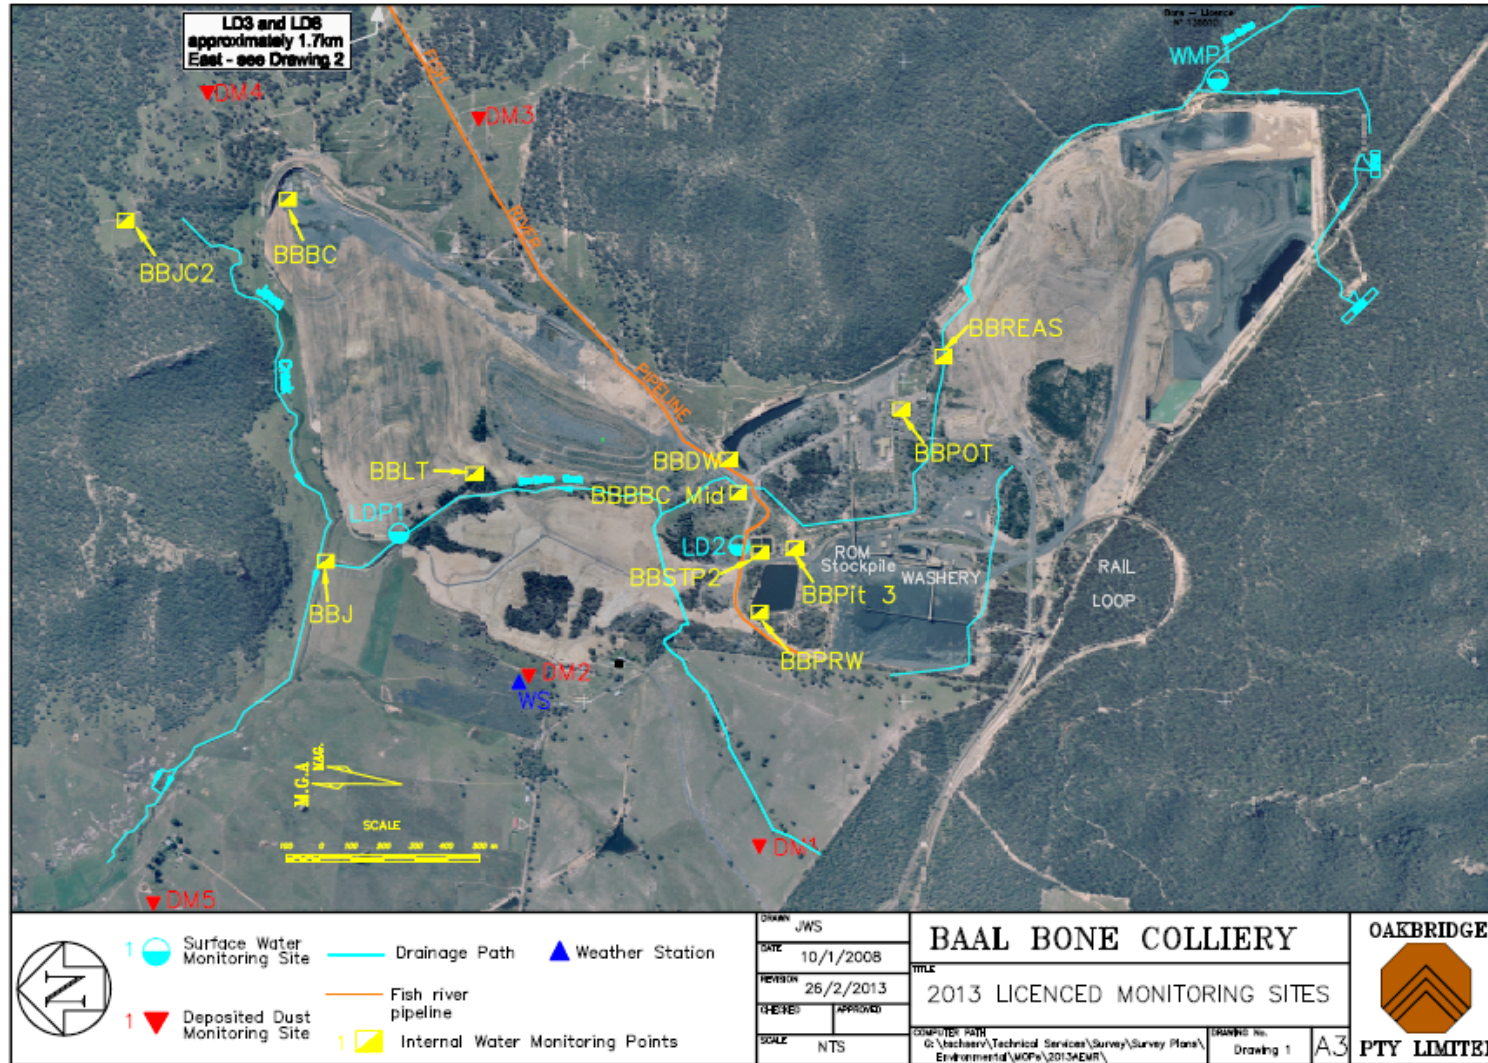
Drawing 1

In accordance with Schedule 5, Condition 9 of Project Approval 09_0178 this report provides a summary of environmental monitoring results for Baal Bone Colliery, for the period **1 July 2013 to 30 September 2013**. Baal Bone's licensed discharge and monitoring locations are identified in **Drawing 1**. Noise monitoring locations are identified in **Drawing 2**. Results included in this summary include – air quality, surface water quality and dewatering bore flow rates.

Locations of all air quality monitoring gauges are shown in **Drawing 1**.

Until 31st July 2013, Baal Bone maintained a network of five licensed discharge and monitoring points in accordance with EPL 765 (viz. LD2, LD3, LD6, LDP1 and WMP1)(**Drawing 1**). On 31st July 2013 both LDP03 and LDP06 (north and south boreholes) were relinquished. Mine water is now pumped back to the Baal Bone pit top and is managed through the site's water management system and discharged through LDP01

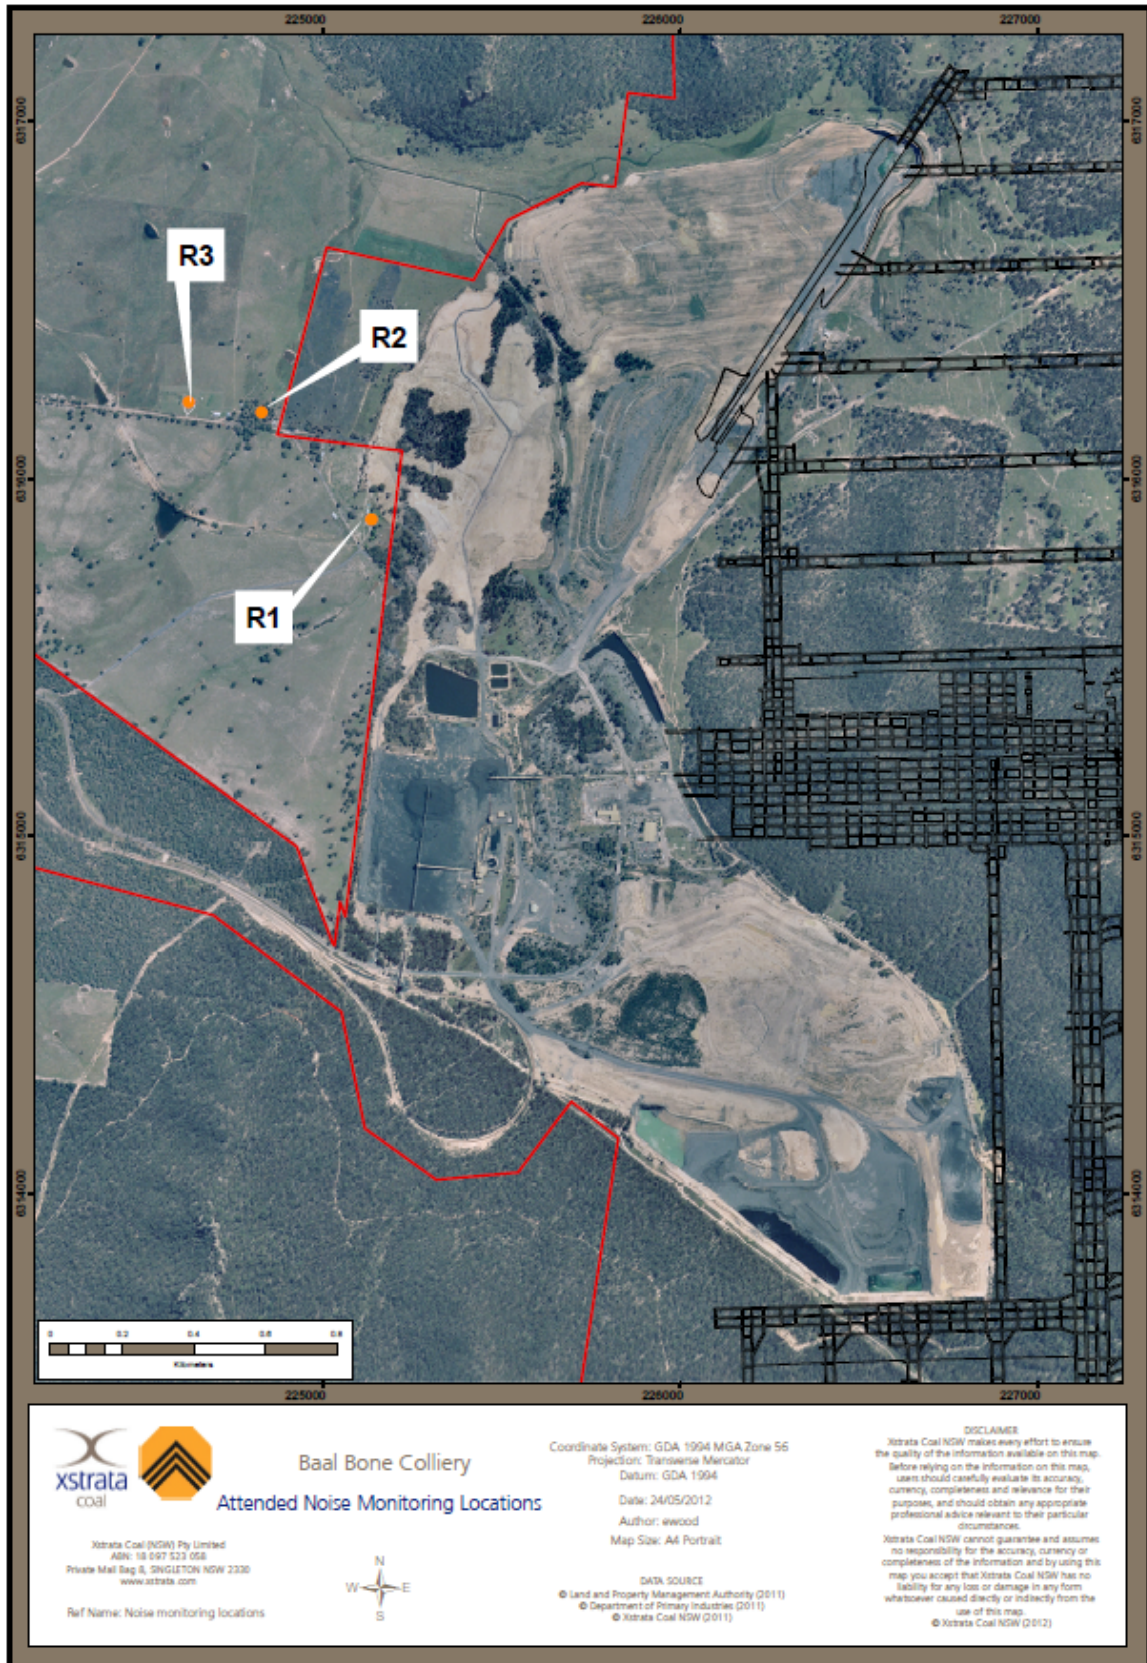
Drawing 2

As per the NMP Baal Bone Colliery operates a real time noise monitor at location R2. In addition to real time noise monitoring (which is supplementary to regulatory measurements), from 2013 onwards attended monitoring is undertaken on an annual basis at receptors R1 and R2/R3 (refer to Drawing 2).
