## **BAAL BONE COLLIERY**

April to June 2014  
Environmental Monitoring Summary

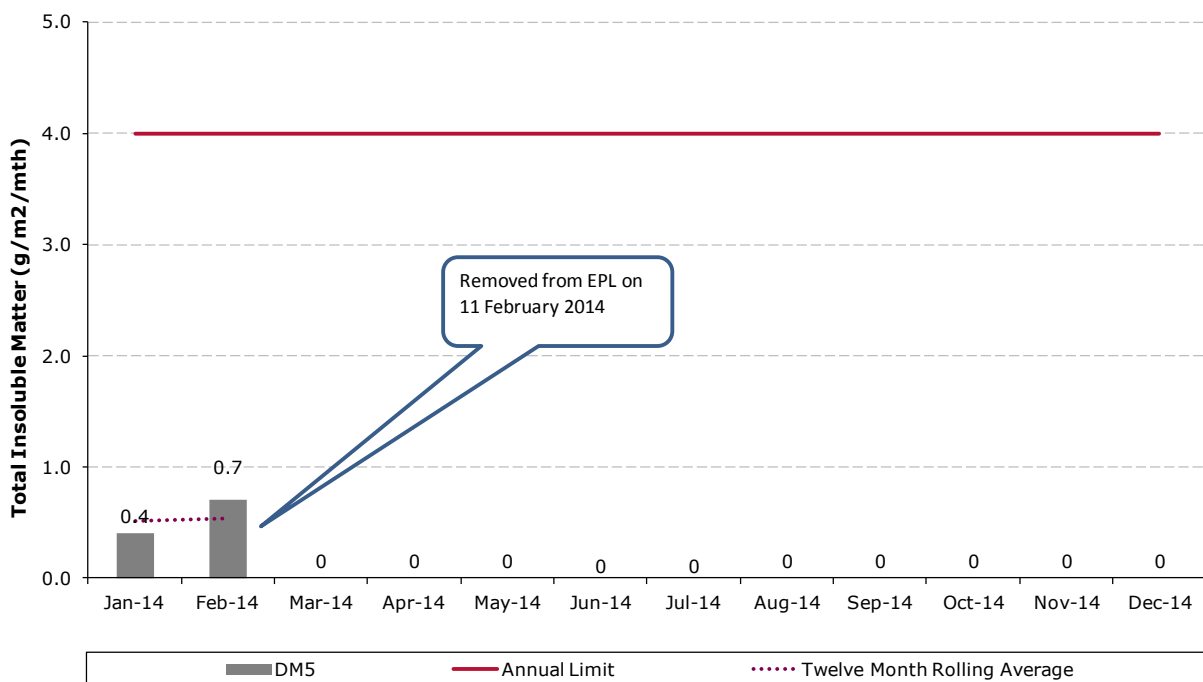
## DM5

Figure 2.5: Dust monitoring gauge DM5 (Previous EPL monitoring point No. 16)

On November 2013, Baal Bone Colliery requested permission to remove sample location DM5 from the sampling regime. The basis for the request was due to the ongoing issues the laboratory had with gaining access to the monitor located on adjoining private land. A review of the monitoring data for DM5 indicated no exceedance at this site since its inception in September 2011.

Approval to remove DM5 from the EPL was granted by the EPA on the 11<sup>th</sup> February 2014. From February onwards, DM5 will no longer be sampled and reported on.

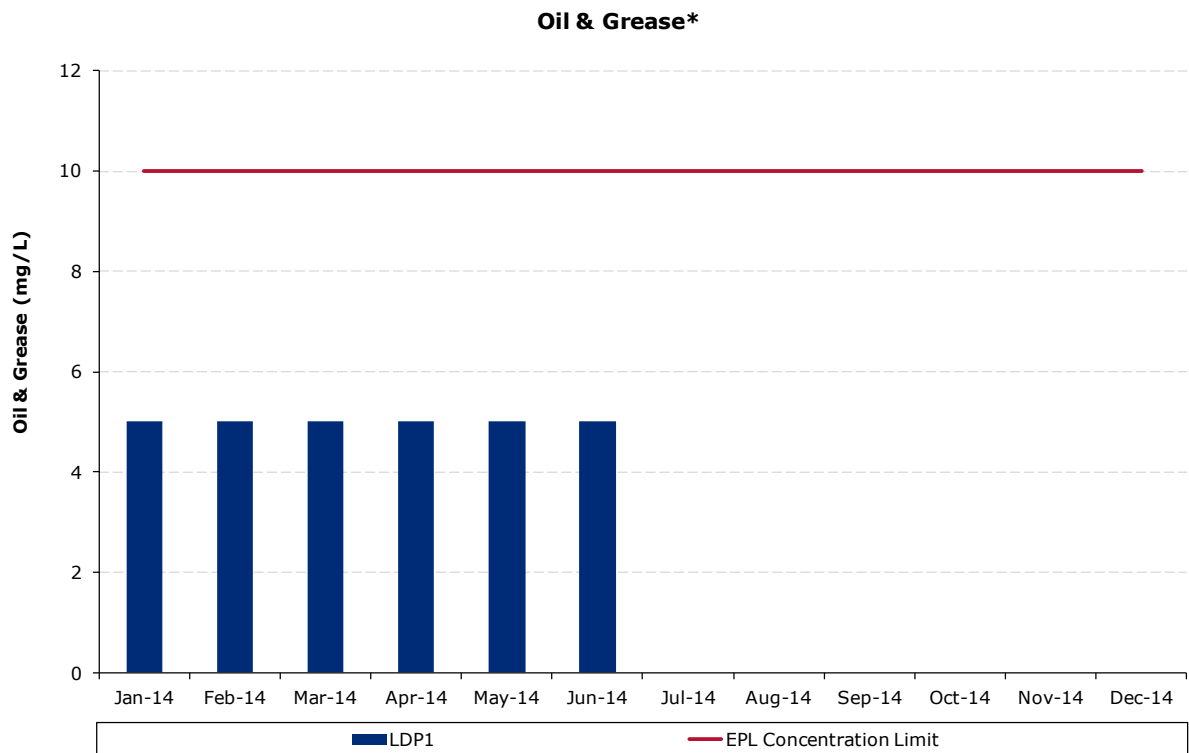
Notes:  
\* Some values shown as 5 were reported as being <5 (Refer to Table 3.2).

Figure 3.2: Oil and grease levels

Figures 3.1 to 3.4 provide monthly water quality results compared to EPL concentration limits.

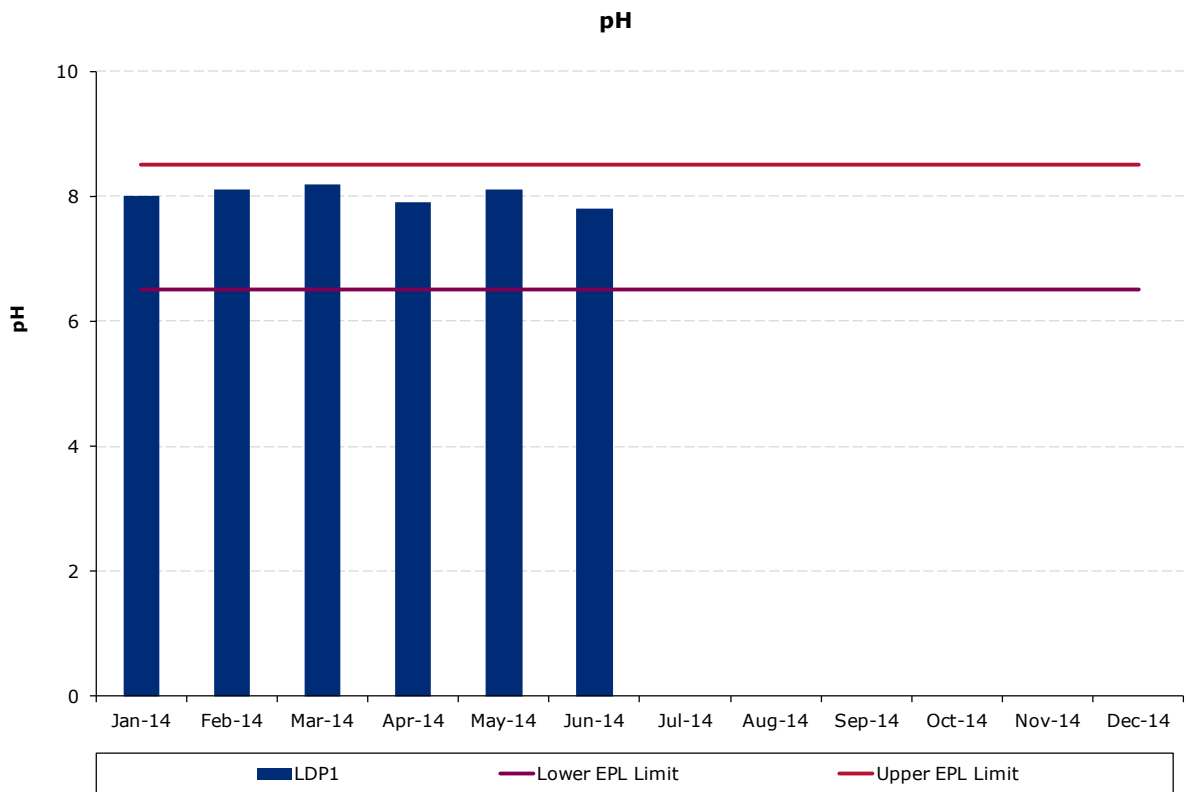
Figure 3.3: pH levels

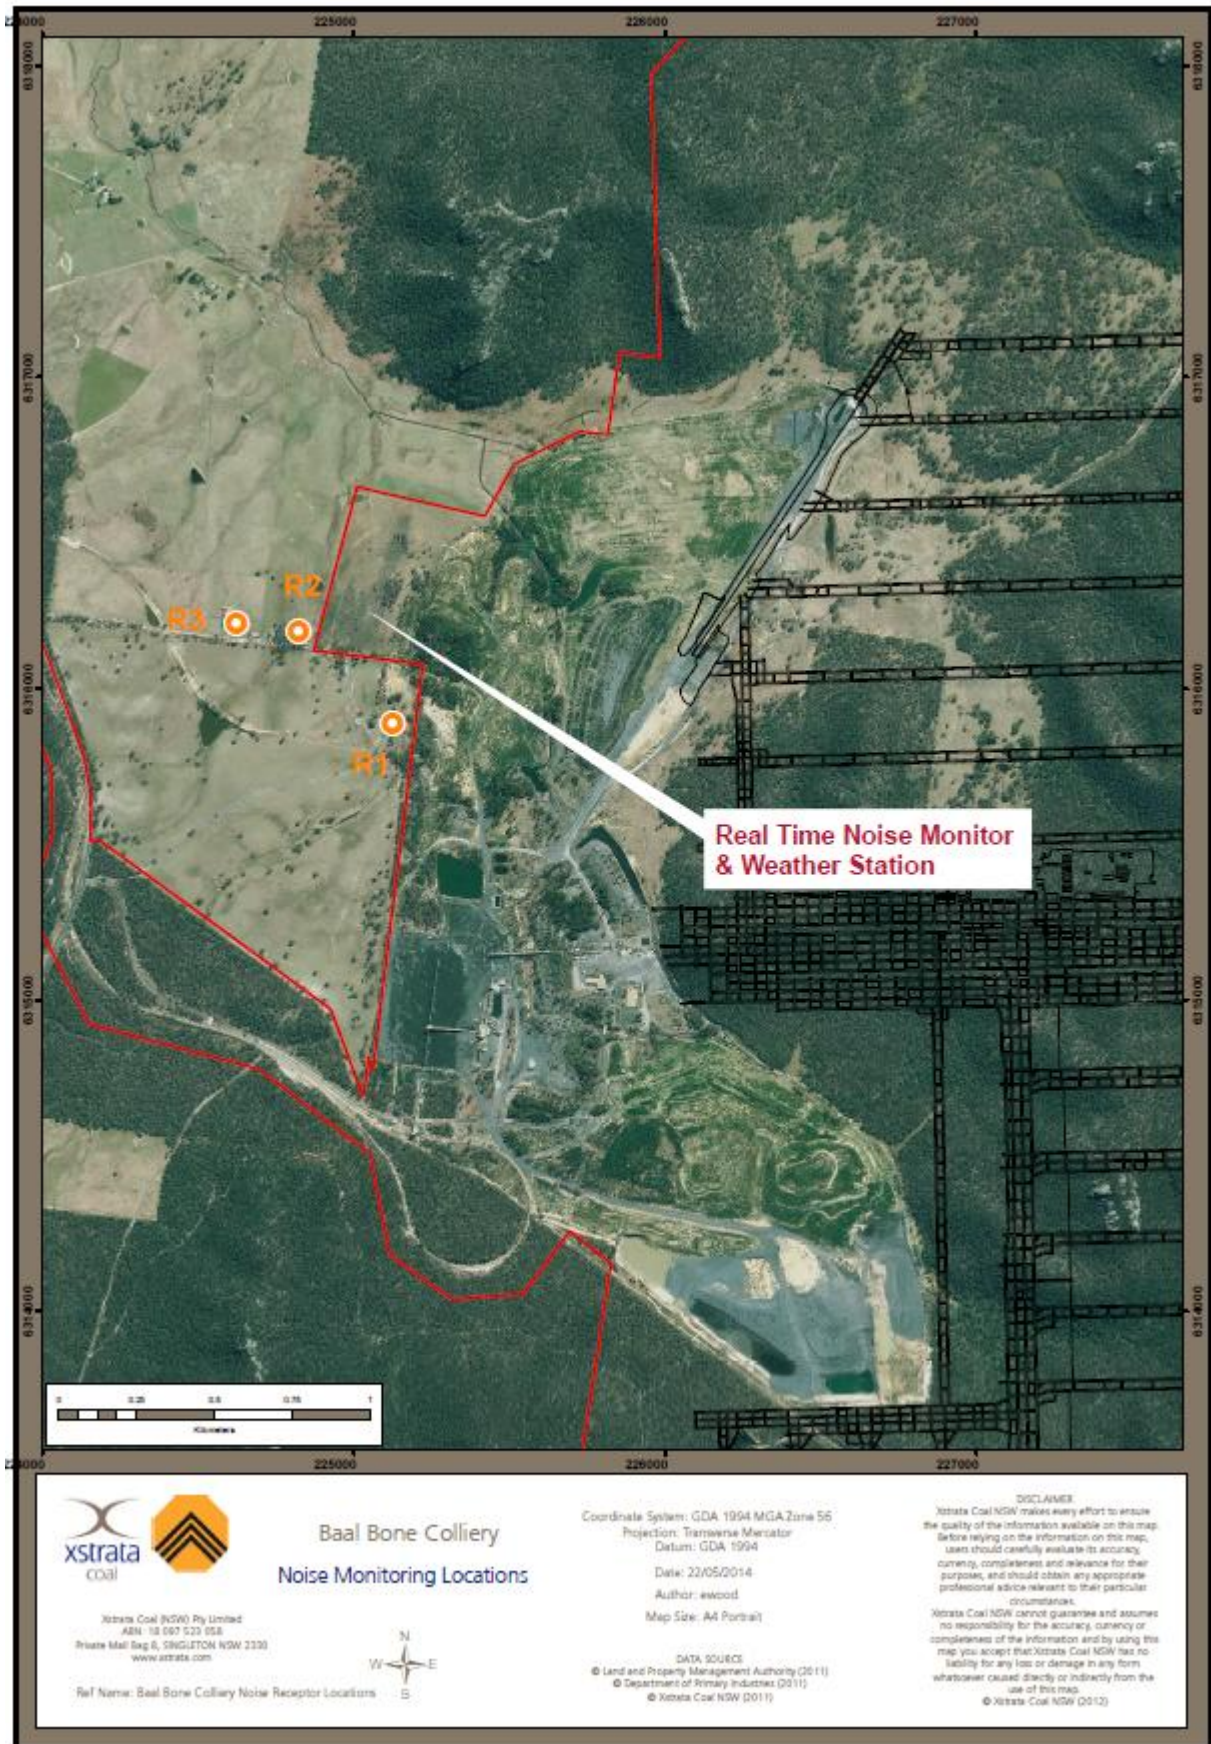
Drawing 3

## Baal Bone Colliery Noise Monitoring Locations

Ref Name: Baal Bone Colliery Noise Receptor Locations

As per the NMP Baal Bone Colliery operates a real time noise monitor at location R2. In addition to real time noise monitoring (which is supplementary to regulatory measurements), from 2013 onwards attended monitoring is undertaken on an annual basis at receptors R1 and R2/R3 (refer to **Drawing 2**).
