BAAL BONE UNDERGROUND

Q4 2021 Monitoring SummaryOctober to December 2021

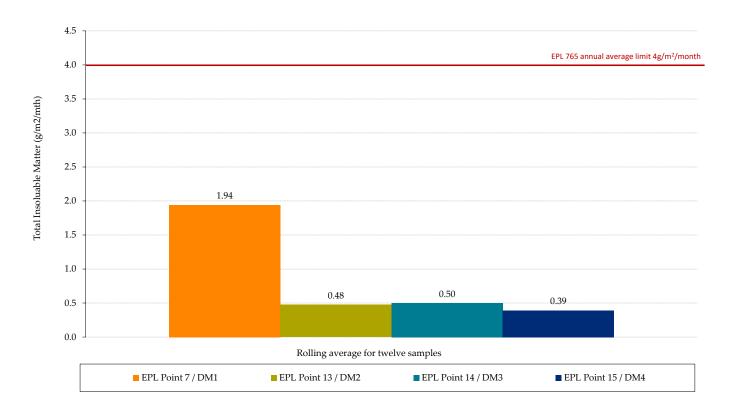
Figure 2: Rolling Average Total Insoluble Matter (12 samples until December 2021)

Figure 1 provides the monthly deposited dust results for the year to date. **Figure 2** provides the twelve month rolling average compared to

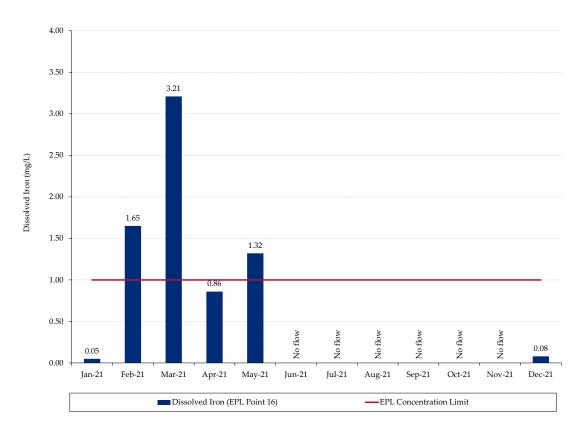
Figure 3: Monthly Dissolved Iron

Figure 3 to Figure 6 provide monthly results for each pollutant.

- All monthly TSS results were below the EPL concentration limit of 50 mg/L; and
- All Oil and grease levels were below the EPL concentration limit of 10 mg/L.
- February, March and May 2021 results for dissolved iron exceeded the EPL limit of 1mg/L with readings of 1.65 mg/L, 3.21 mg/L and 1.32 mg/L respectively.
- March 2021 sample returned a pH reading of 6.2 which is outside of the pH concentration limits.
- From June to September 2021, there was no flow at EPL Point 16 (LDP1) during monthly sampling events as such no samples were able to be taken.

- An external consultant: Gauge Scientific was commissioned and has provided a report to Baal Bone Colliery investigating the iron exceedances, and providing monitoring and management recommendations;
- Gauge Scientific has advised that the increased iron concentrations have not caused material harm to the environment;
- Water sampling frequency at LDP16 was increased to weekly (when flowing) for a period of time;
- Additional monitoring points were implemented around the suspected source of increased iron concentrations and sampled for a period of time; and
- Written notifications were provided to the EPA on 26 April 2021 and 16 June 2021.
- December 2021 monitoring showed that iron concentrations at BBLDP16 had returned to within EPL limits.

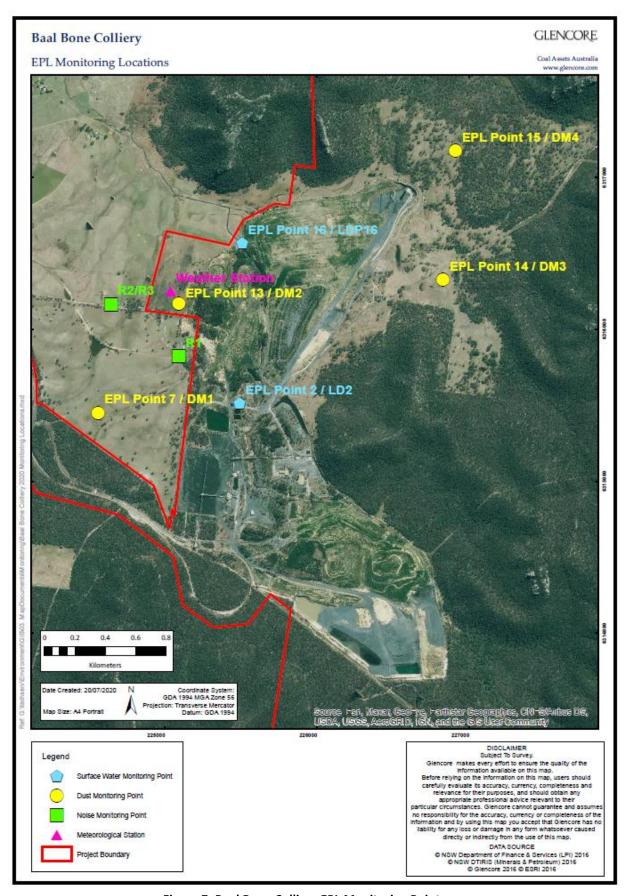
Figure 7: Baal Bone Colliery EPL Monitoring Points

In accordance with Schedule 5, Condition 9 of Project Approval 09_0178 this report provides a summary of environmental monitoring results for Baal Bone Colliery, for the period **1 October 2021 to 31 December 2021.** Baal Bone's licensed discharge and monitoring locations are identified in **Figure 7.**

Locations of the dust deposition gauges are shown in Figure 7.

From 2013 onwards attended monitoring is undertaken on an annual basis at receptors R1 and R2/R3, shown in **Figure 7**.
