## **BAAL BONE COLLIERY**

January to March 2020 Environmental Monitoring Summary

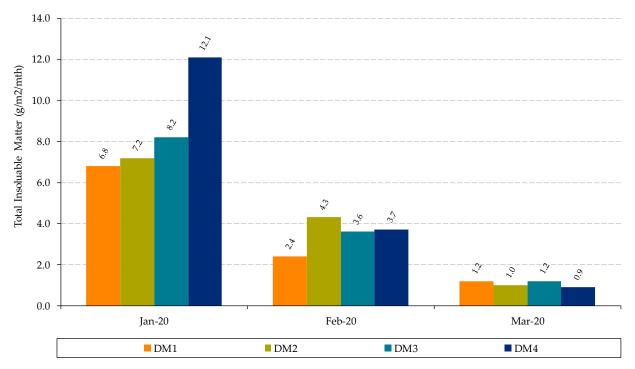
Figure 1: Monthly Total Insoluble Matter

**Figure 1** provides the monthly deposited dust results for the year to date. **Figure 2** provides the twelve month rolling average.

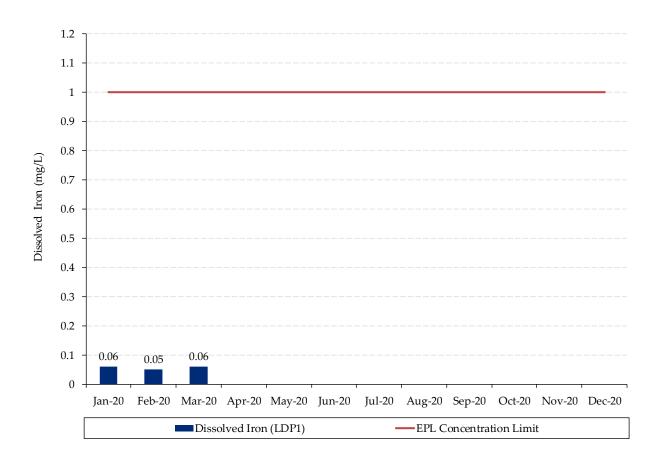
Figure 3: Monthly Dissolved Iron

- All dissolved iron samples were well below the concentration limit of 1 mg/L;
- All samples returned pH results that were within the upper and lower EPL limits (8.5 and 6.5 respectively);
- All monthly TSS results were below the EPL concentration limit of 50 mg/L;
- Oil and grease levels in January 2020 exceeded the EPL concentration limit of 10mg/L, with a result of 11 mg/L. Oil and grease results for February and March 2020 were <5mg/L.</li>

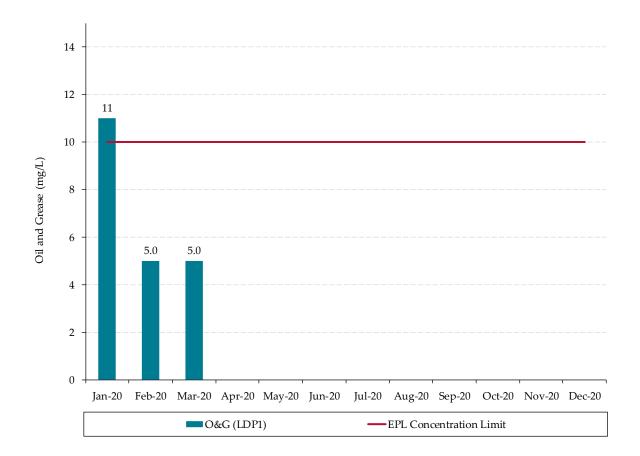
Figure 4: Monthly Oil and Grease

There has been no record of recent exceedances with a review of oil and grease levels back to 2014 all identifying results under 5 milligrams per litre. The results appear to be an anomaly, however as rainfall had recently occurred after an extended dry period it is possible that this was a contributing factor. There had been 40.44mm of rain the week leading up to the sampling and

Baal Bone Colliery has contacted the laboratory who conducted the analysis to determine if they knew of anything that may assist. Of interest was that they noted that another site who sample on the same day also had a high oil and grease result. They suggested that potential contributors may have been the extended dry spell and recent rainfall, the bushfires moving through the area as well as vehicles and machinery on site.

A notification was sent to the Environment Protection Agency and the Department of Planning, Industry and Environment on 24/02/2020 regarding the oil and grease exceedance. An investigation was undertaken into this exceedance which included an immediate inspection of the area which showed no signs of hydrocarbons being present. Routine inspections with no noticeable signs had also been undertaken in this area on 6 January 2020, 20 January 2020 and 4 February 2020.

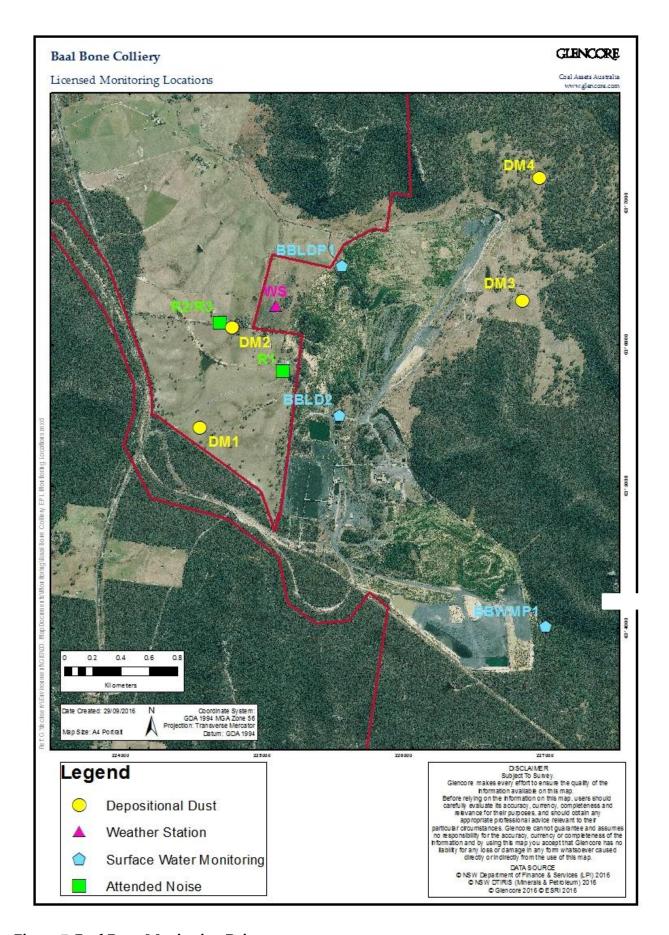
Figure 7. Baal Bone Monitoring Points

In accordance with Schedule 5, Condition 9 of Project Approval 09\_0178 this report provides a summary of environmental monitoring results for Baal Bone Colliery, for the period **1 January 2020 to 31 March 2020.** Baal Bone's licensed discharge and monitoring locations are identified in **Figure 7**.

Locations of the dust deposition gauges are shown in Figure 7.

From 2013 onwards attended monitoring is undertaken on an annual basis at receptors R1 and R2/R3, shown in **Figure 7**.
